WATTLE RANGE COUNCIL

Appendix 1 - Rivoli Bay

Assessment of Existing Coastal Structures

301015-03541 – 001

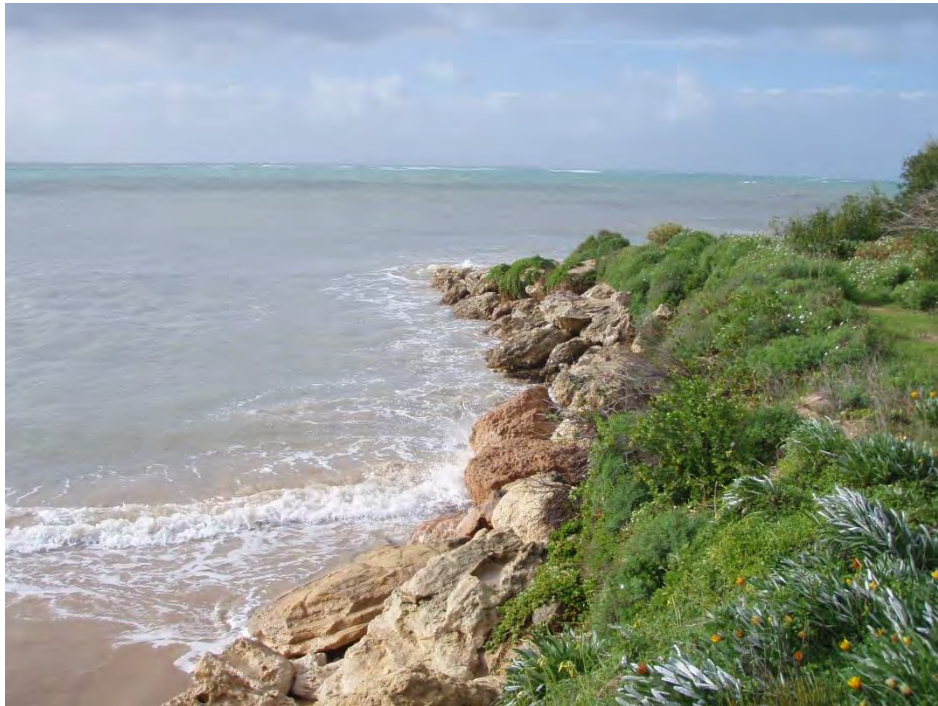
The groyne appeared to be armoured with limestone rock, with a median diameter of 500 mm at the tip of the groyne. Littoral drift was bypassing the groyne. At the landward end of the groyne, larger limestone rock armour of median diameter 1000 mm had been placed on the downdrift side. The core of the groyne was exposed in some places with smaller rock fragments visible through the gaps between the larger armour stones. The groyne was observed to be in a poor to fair condition. Sand had built up on the updrift side of the groyne and dune vegetation had become established on top of the groyne as can be seen in Figure 2.

Figure 2 – Groyne 2 looking out from downdrift side

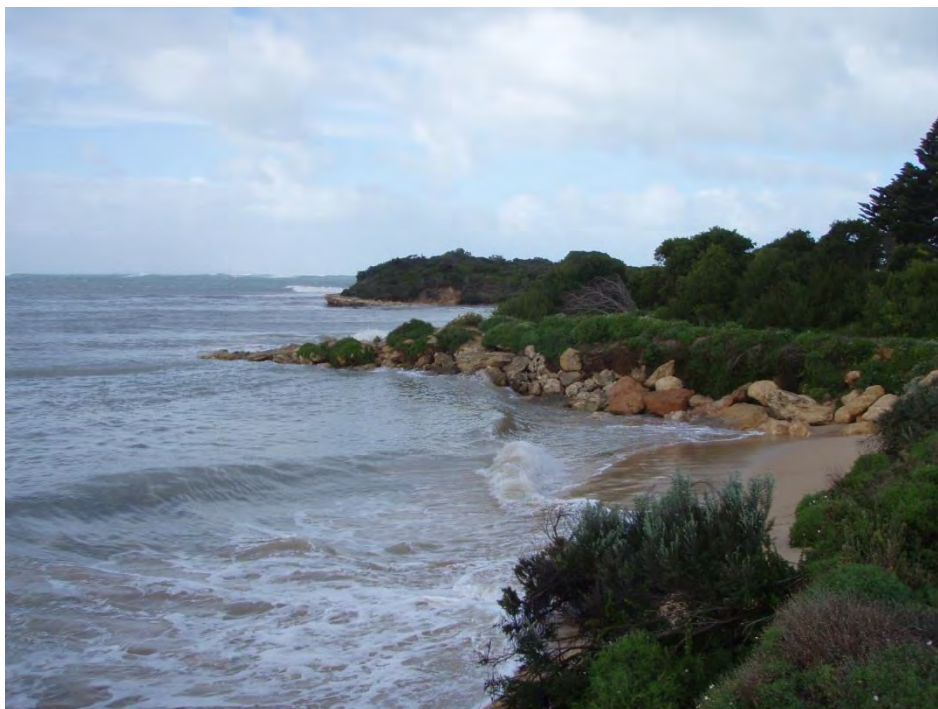
Figure 3 – Groyne 2 looking south toward Glen Point

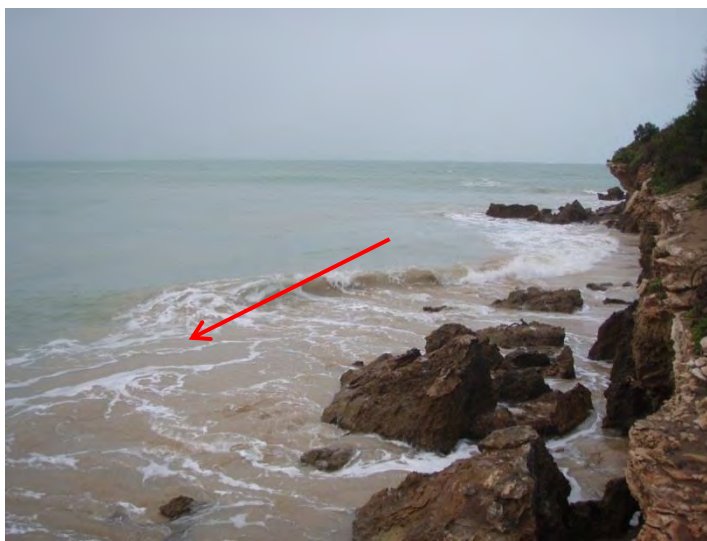
The dune between Glen Point and Groyne 2 was accreted, despite the presence of an erosion scarp having formed during the storm of 24 June. The dune was relatively well vegetated on both the updrift and downdrift sides of the groyne. Littoral drift was actively transported by wave action from around Glen Point, and around the tip of Groyne 2, as indicated in Figure 4 and Figure 5. There was also some minor erosion observed as a result of an informal access on the downdrift side of the groyne.

Figure 4 – Sand transport from south to north around Glen Point, 25 June

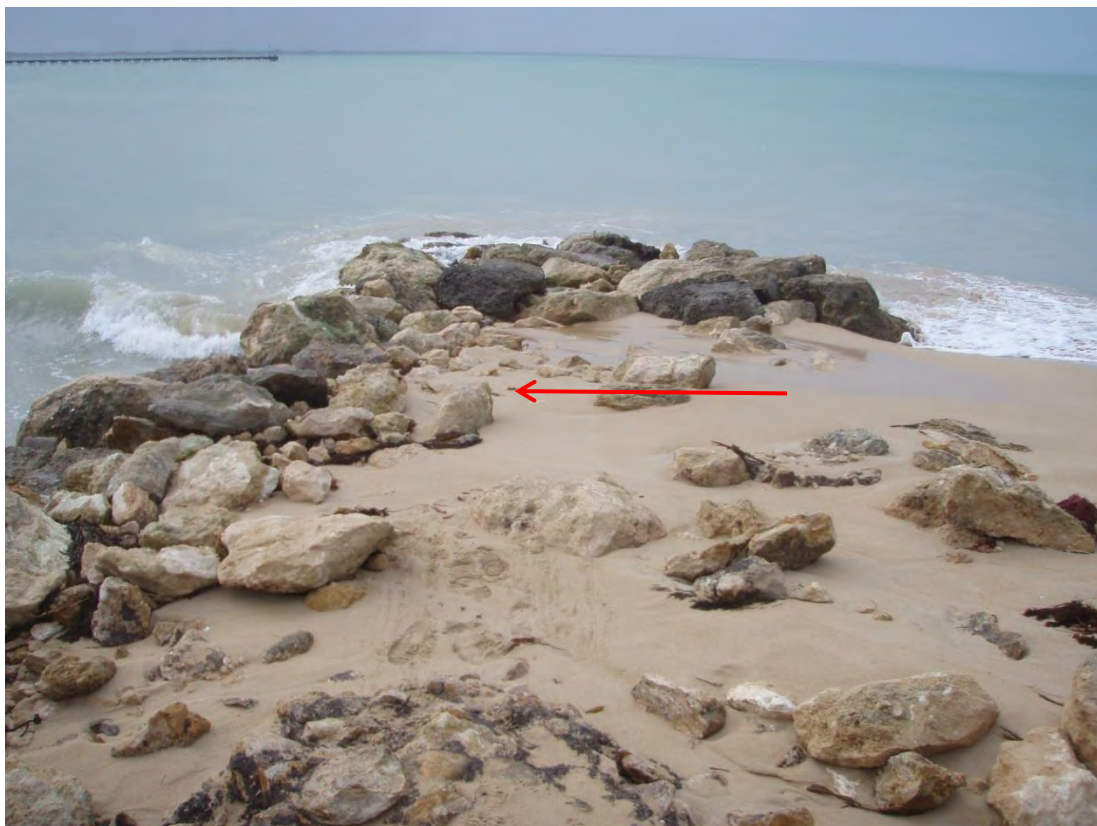
Groyne 3 was inspected on 25 June 2014 and was considered to be in poor condition. The groyne was covered with sand on the updrift side and was actively bypassing (Figure 6). The groyne comprised limestone armour rock with a median diameter of 1000 mm, but many smaller core/underlayer rocks were observed to have been exposed and the armour has slumped along sections of the groyne trunk (Figure 8). The groyne appeared to have a clay core which has become exposed and devoid of armour (Figure 9). On the downdrift side of the structure, at the landward end of the groyne severe erosion had occurred which is threatening to outflank the groyne on the landward side (Figure 7). Ad hoc rubble and concrete pieces were observed to have been placed at the base of this erosion escarpment, possibly in a previous attempt to arrest the erosion at this location. Given the height of the erosion escarpment on the landward edge of the groyne, it is considered that there is a risk of the erosion scarp collapsing and an associated risk of public injury. The dune within Beach 3 on the downdrift side of the groyne was observed to be suffering from severe erosion, with an erosion scarp around 1.5 m high, formed possibly as a result of the storm event on 24 June (Figure 10).

Figure 6 – Tip of Groyne 3 covered with sand showing sand transport direction

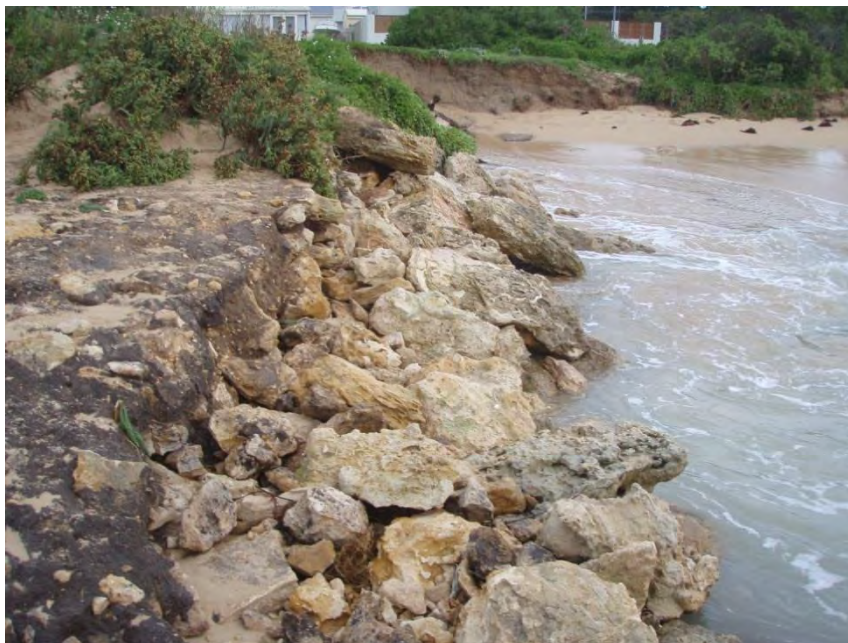
Figure 8 – Groyne 3 looking landward. Note armour rock has slumped along trunk of groyne; clay core and smaller underlayer rock has been exposed and core has been significantly eroded (25 June 2014)

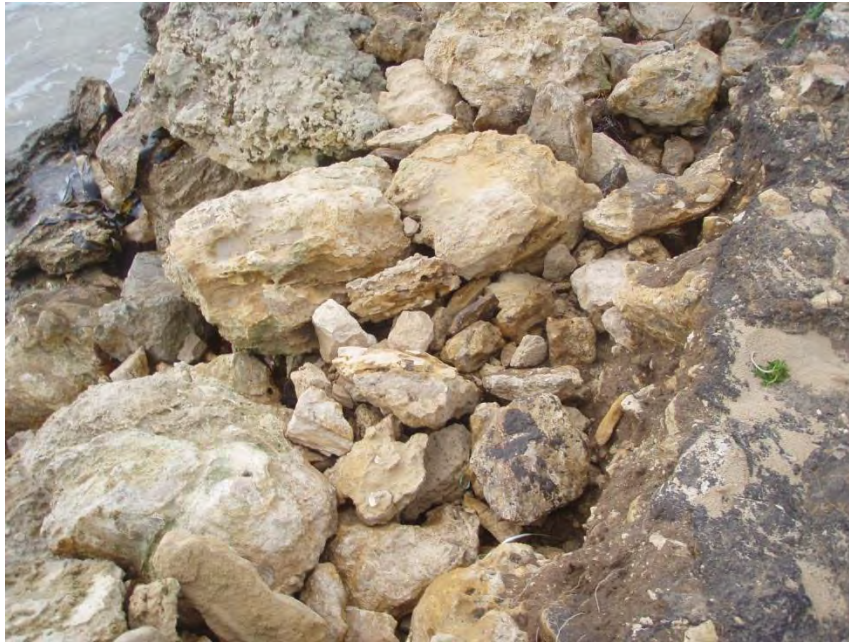
Figure 9 – Close view of trunk of Groyne 3, showing exposure of small underlayer rock and clay core (25 June)

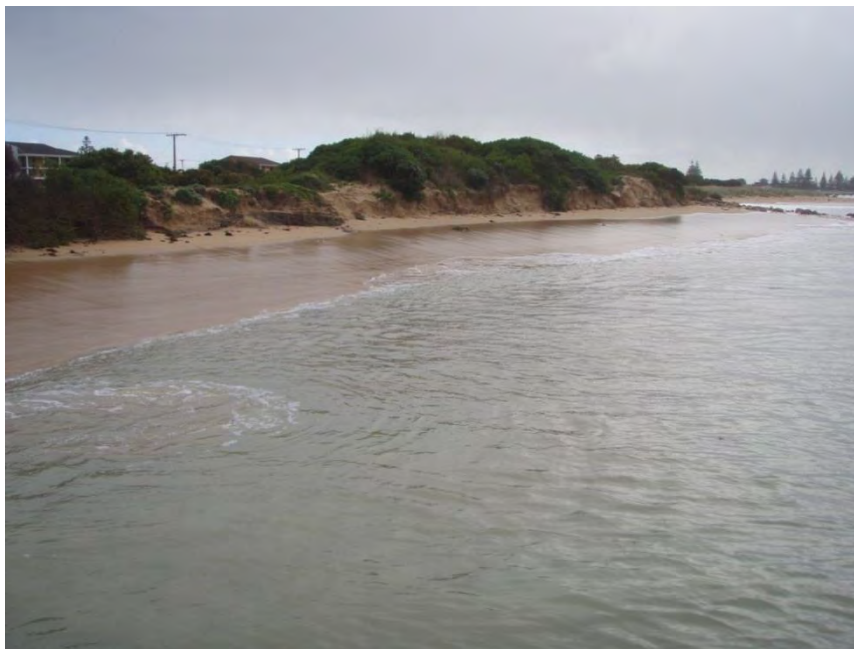
Figure 10 – View of Beach 3 downdrift of Groyne 3, showing eroded dune (25 June)

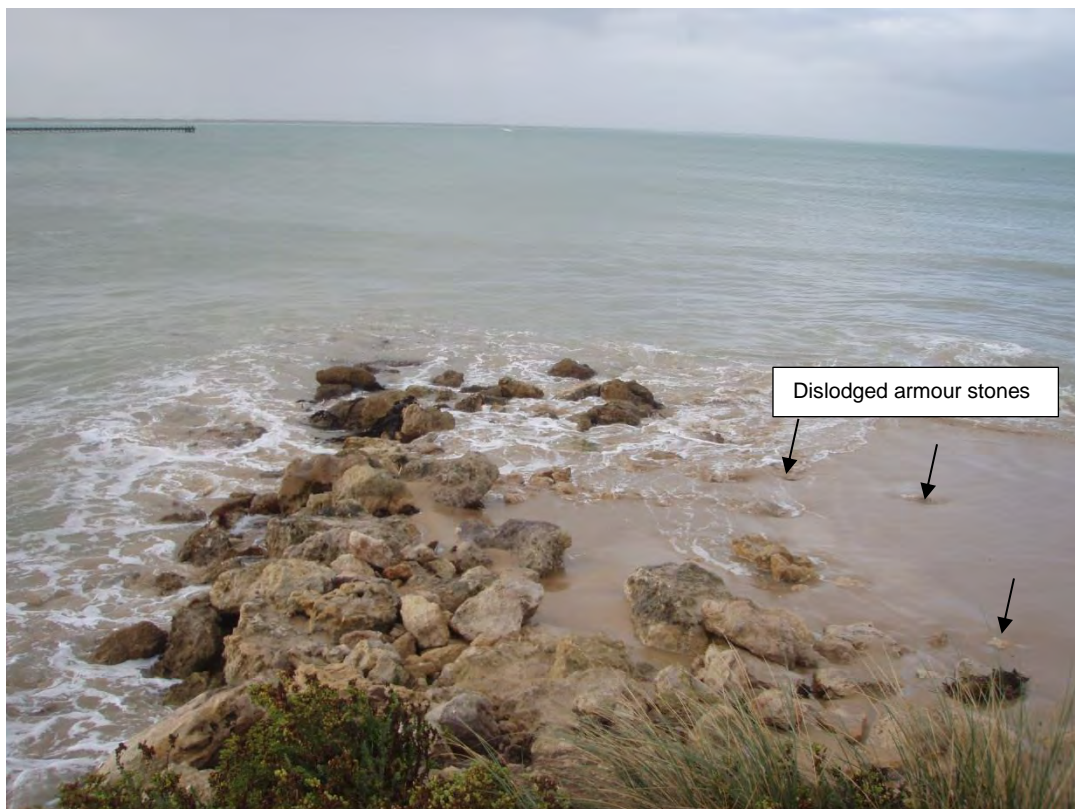
Groyne 4 was observed on 25 June 2014 and was considered to be in poor condition. The groyne was covered with sand on the updrift side and was actively bypassing (Figure 11 and Figure 12). Waves were observed to be breaking directly onto the groyne head. The groyne comprised limestone armour rock with a median diameter of 1000 mm, but many smaller core/underlayer rocks were observed to have been exposed, especially on the groyne trunk. There was an eroded dune escarpment on the updrift side approximately 1.5 m high. Rock armour was observed to have been dislodged from the groyne, and the armour appeared to form a very steep side slope on the groyne of approximately 1V:1H (Figure 13). As is the case with Groyne 3, the groyne appeared to have a clay core which has become exposed and devoid of armour (Figure 14). Sand has accumulated within the dune on the updrift side of the groyne, with dune vegetation growing on top of the landward side of the groyne (Figure 14). The dune within Beach 4 on the downdrift side of the groyne was observed to be in good condition, with no erosion scarp visible, despite the occurrence of a severe storm event on the previous day and erosion occurring on the surrounding beaches (Figure 15).

Figure 11 – Tip of Groyne 4 showing sand bypassing over the groyne and dislodged armour stones

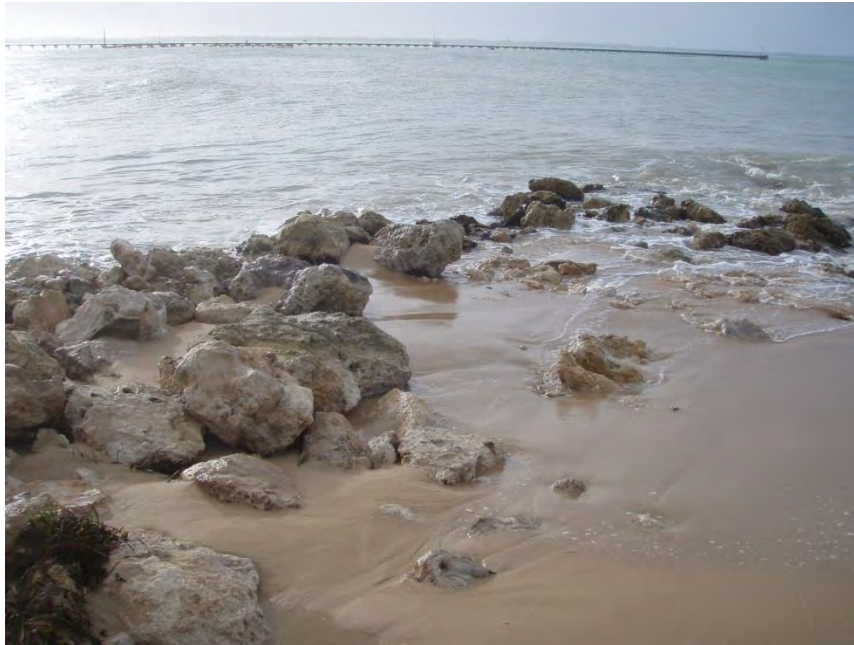
Figure 12 – View of Groyne 4 from updrift side showing sand bypassing over groyne

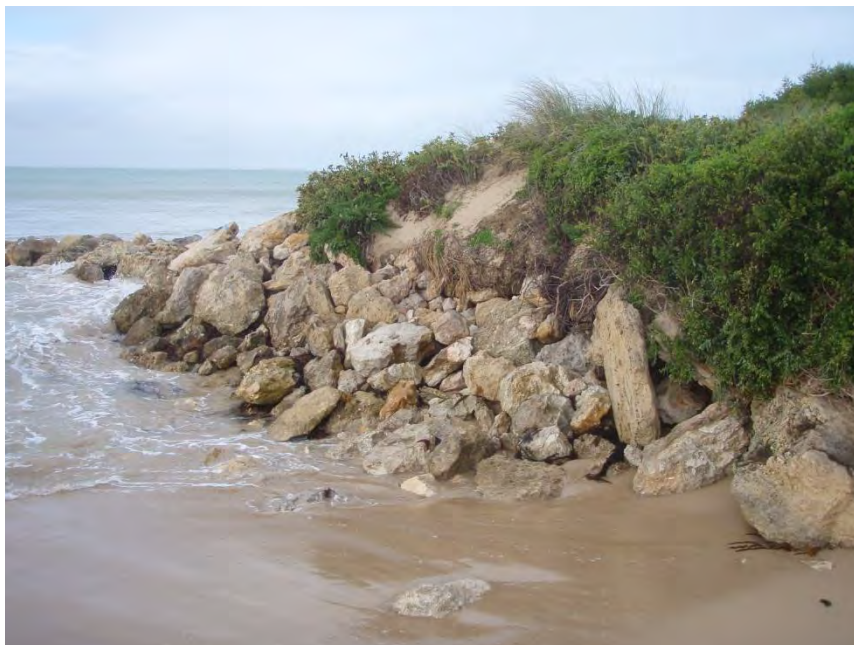
Figure 13 – View of Groyne 4 trunk from downdrift side, showing steep side slopes, dune vegetation and exposed small armour stones

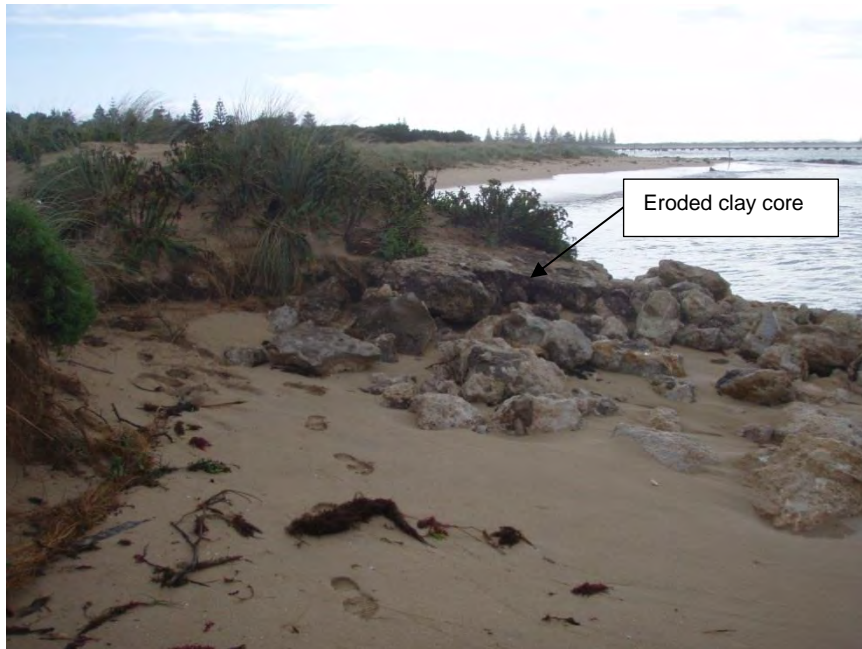
Figure 14 – View of Groyne 4 trunk from updrift side showing eroded clay core and dune vegetation

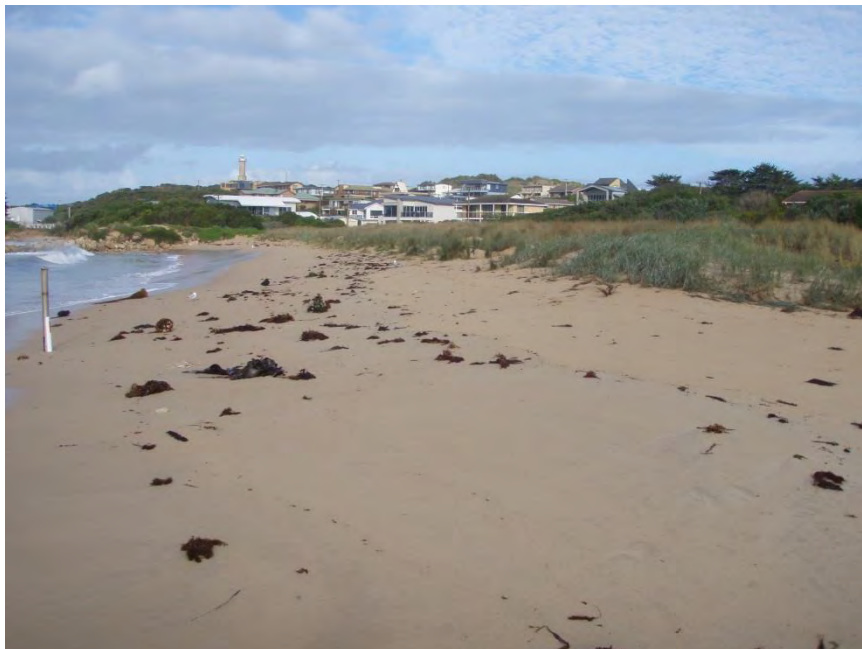
Figure 15 – View of Beach 4 looking updrift toward Groyne 4 showing vegetated dune and beach monitoring pole

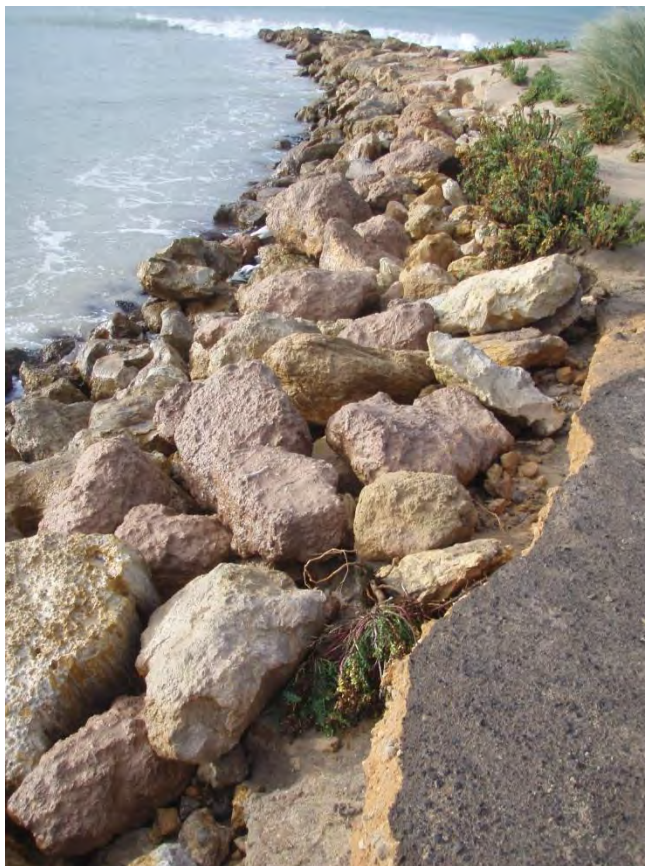
Figure 17 – Groyne 5 looking along trunk of groyne. Note erosion of road base at crest of groyne and windblown dune sand on groyne trunk

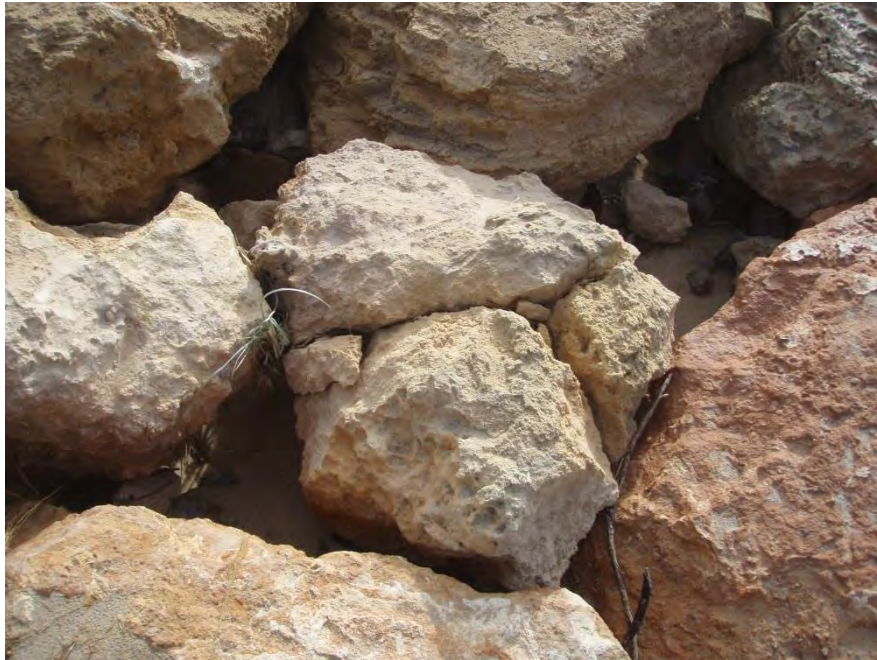
Figure 18 – Armour stones on Groyne 5 – note breakage of individual armour stones

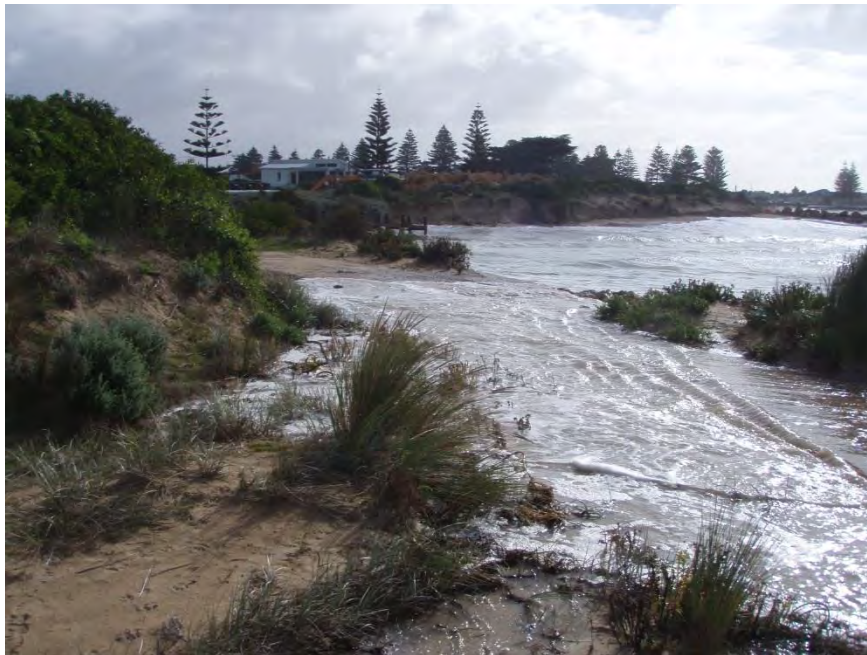
Groyne 5 was inspected on 25 June 2014 and was considered to be in good condition. The armour appeared to be well packed with good interlocking between individual stones (Figure 16). The groyne comprised rock armour of median diameter 1200 mm near the tip of the groyne, with a large vegetated dune and build up of sand within Beach 4 on the updrift side. Along the groyne trunk on the downdrift side, smaller rock armour of median diameter 800 mm was visible and erosion was occurring at the landward end of the groyne (Figure 17). There was evidence of breakage of individual armour stones within the groyne, as can be seen in Figure 18. A timber pedestrian walkway extended down onto Beach 5 and this was damaged in the large wave event of 22 June. The crest of the groyne was covered in road base to provide vehicular access to the end of the groyne and beach. Inundation due to wave runup was observed to be impacting on the landward side of this groyne during the large wave event of 24 June (Figure 19).

Figure 19 – Wave runup onto landward end of groyne 24 June 2014

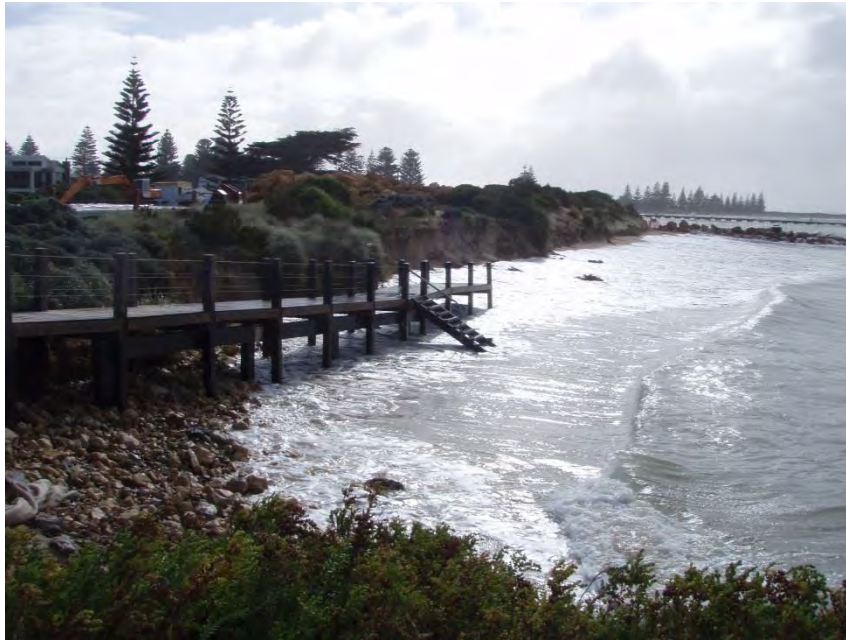
Figure 20 – Pedestrian accessway, small armour stones and eroded dune escarpment at Beach 5

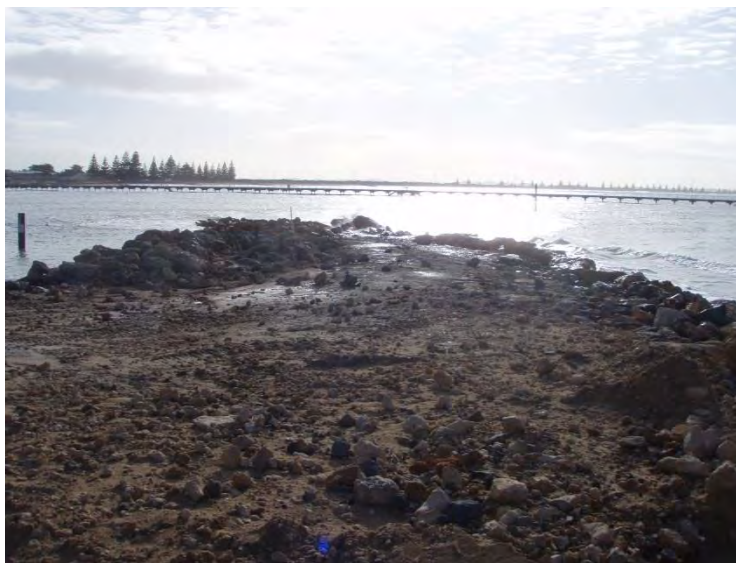
Figure 21 – Looking down trunk of Groyne 6 under construction

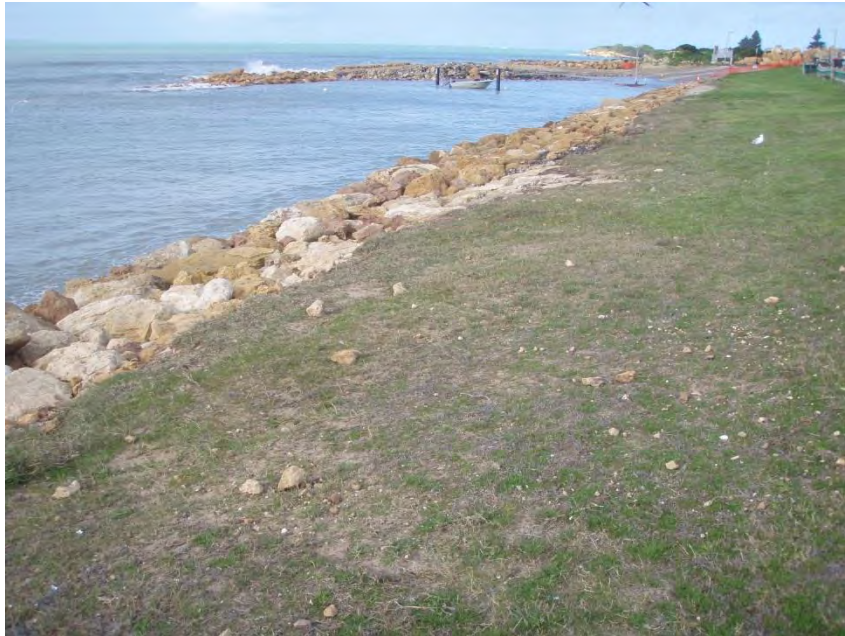
Figure 23 – Evidence of wave overtopping with strewn rock debris thrown up behind revetment

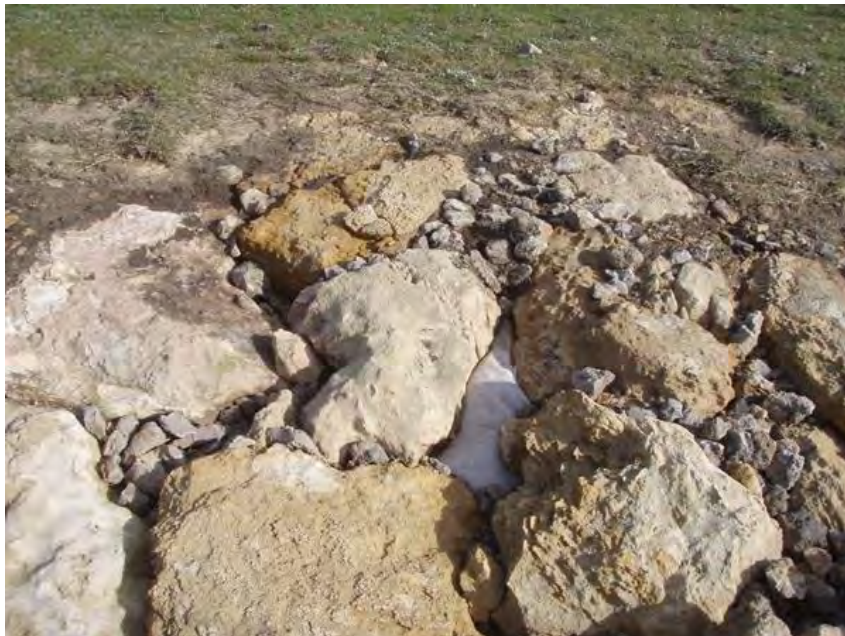
Figure 24 – Geotextile and small underlayer rock visible within armour interstices at rock revetment

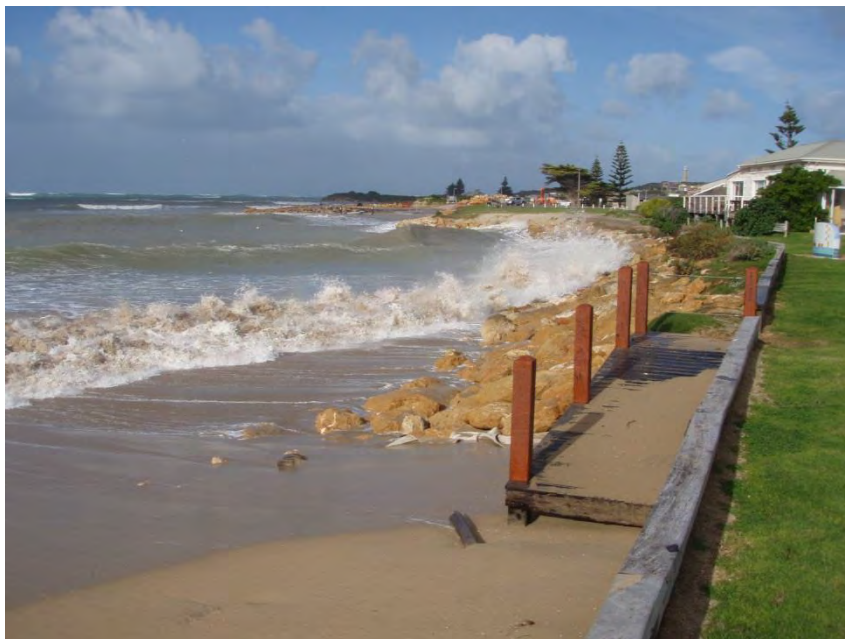
wave overtopping and rainfall (Figure 26). Beaches 6 and 7 were completely denuded of sand and waves were observed to be breaking directly onto the revetment (Figure 27). At the northern end of this revetment, a timber pedestrian access extended onto the beach and the rock revetment was backed by a vertical timber seawall (Figure 28).

Figure 28 – Wave attack onto revetment, timber seawall and pedestrian access at northern end of revetment wall, 24 June.

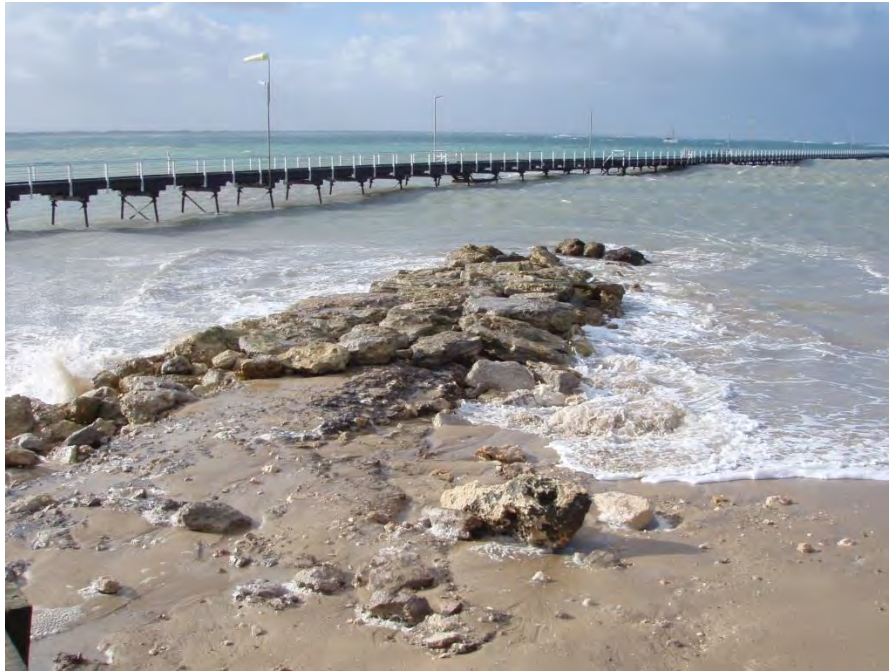
Figure 29 – Groyne 8 showing exposed clay core

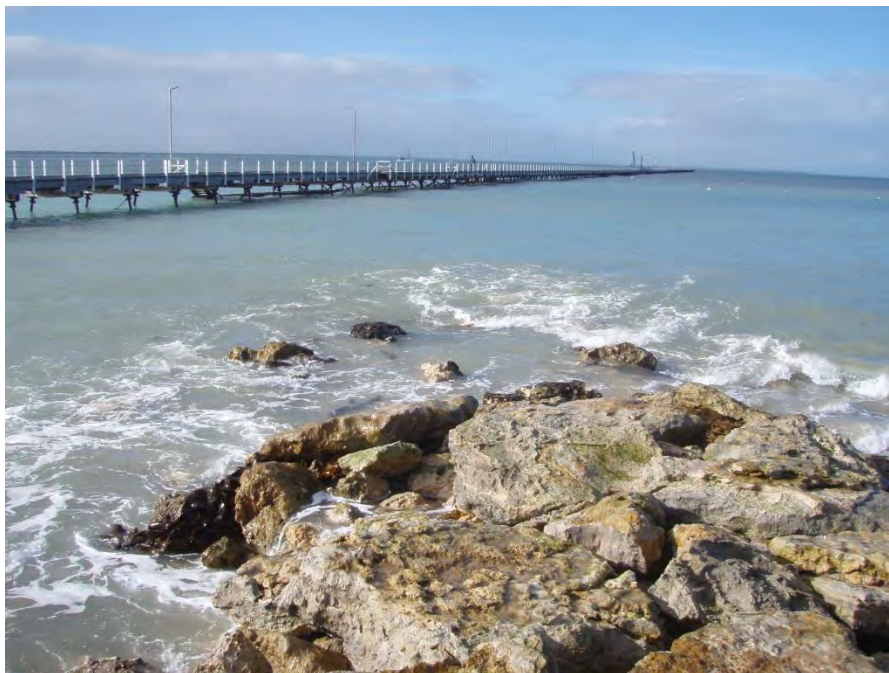
Figure 30 – Submerged tip of Groyne 8 showing dislodged rock armour

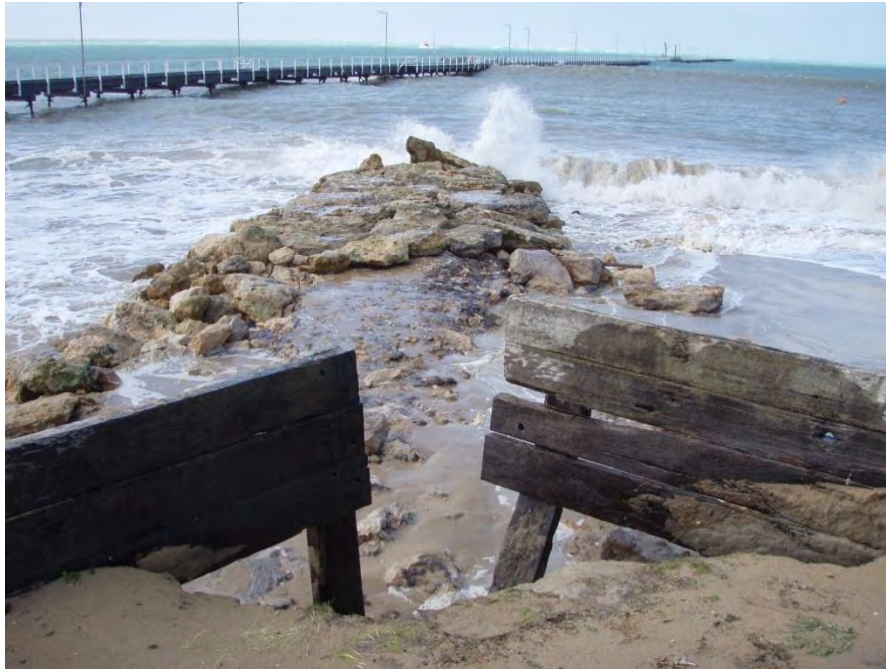
The timber seawall on the landward side of this groyne had been undermined and was severely damaged in the storm event of 24 June (Figure 31, Figure 32). The clay core of the groyne was exposed on the landward side of the groyne, and was subject to direct wave attack.

Figure 31 – Groyne 8 showing direct wave attack and adjacent undermined timber seawall

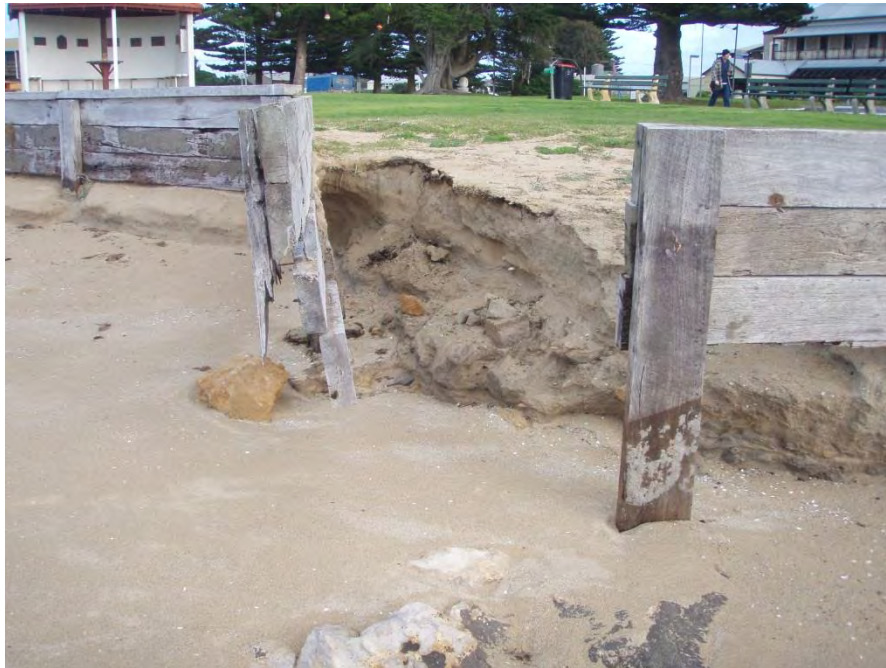
Figure 32 – Damaged and undermined timber seawall and erosion

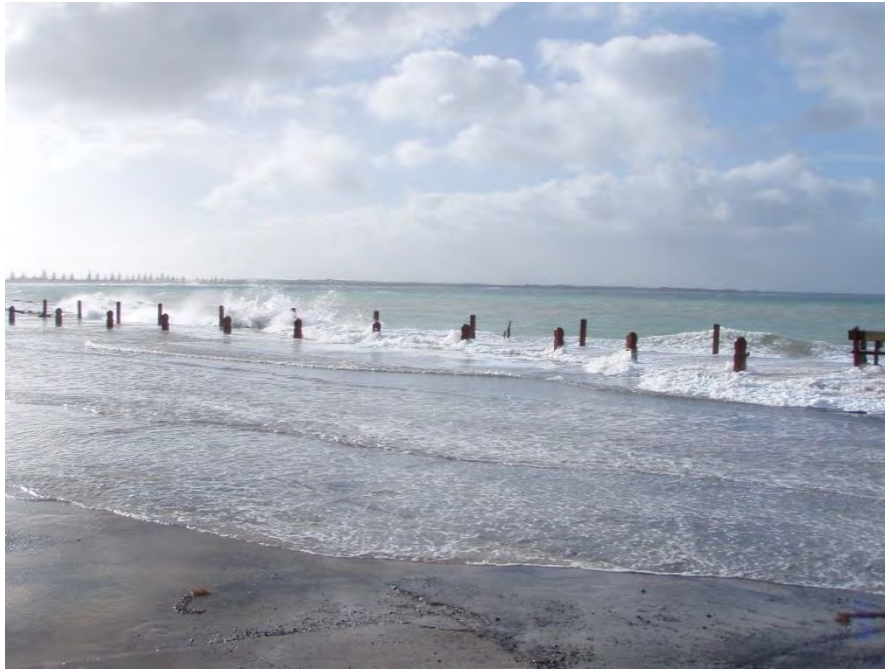
Figure 33 – Wave overtopping at Beach Road 24 June

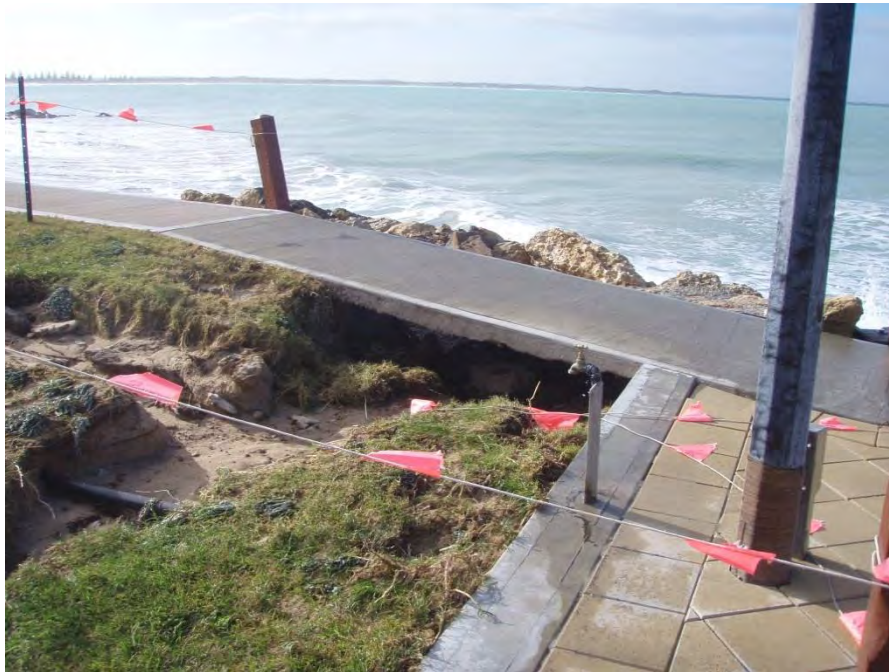
North of the jetty and at the northern end of the timber seawall, severe erosion had undermined the concrete footpath along the foreshore and damaged stormwater infrastructure on 24 June (Figure 34). Council had installed emergency protection works comprising geotextile sandbags and large limestone rock armour with median diameter 1500 mm in an attempt to protect Beach Road from further erosion damage (Figure 35).

Figure 34 – Undermined concrete footpath at northern end of timber seawall

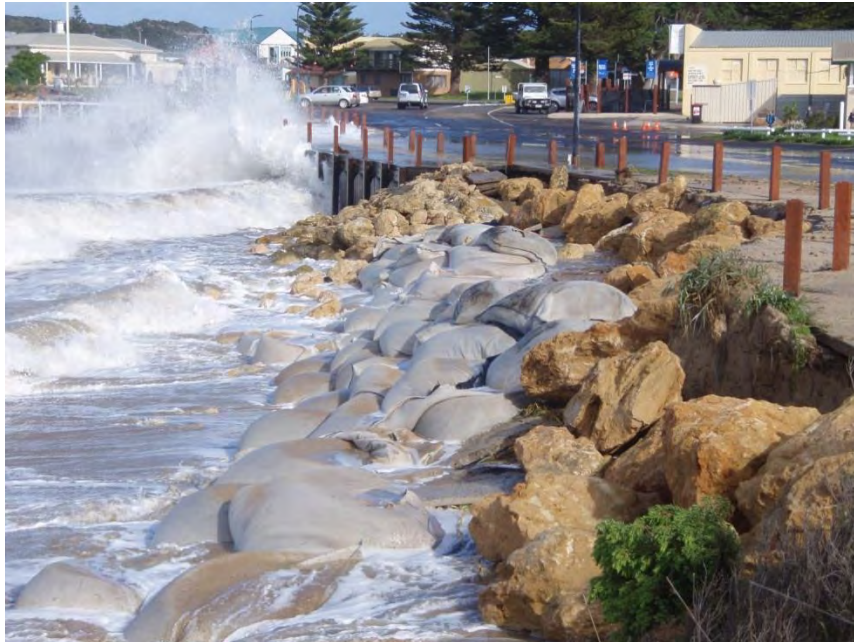
Figure 35 – Emergency protection works installed 24 June comprising large rock armour and geotextile sandbags

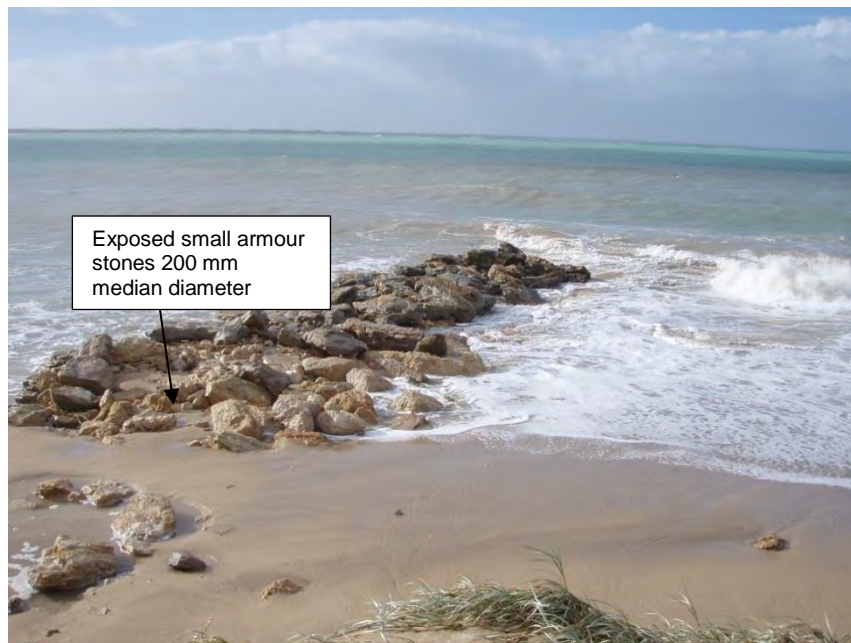
The groyne is approximately 60 m long and consists of limestone rock armour with median diameter of 800 mm. Within this groyne, smaller underlayer rock with median diameter of 200 mm was observed (Figure 36). The groyne was observed to be in poor condition, with dislodged rock armour observed on the beach berm on both sides of the groyne. The rock armour along the groyne trunk was observed to be very steep with a slope of 1V:1H.

Figure 36 – Groyne 9 showing mix of small and large armour stones

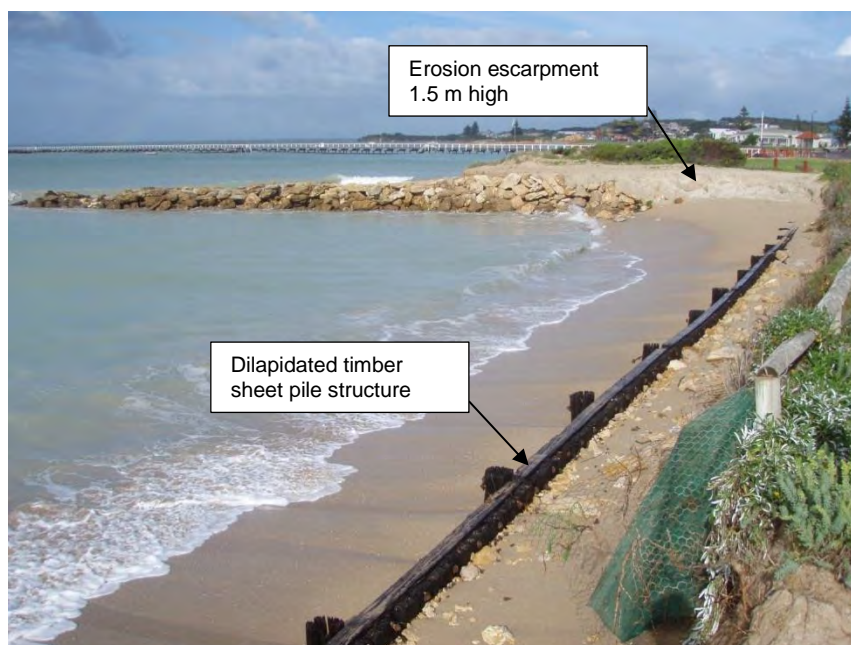
On the landward end of the northern (downdrift) side of the groyne, a 1.5 m sandy erosion scarp was evident along the landward side of the groyne trunk (Figure 37). Along the Beach 9 foreshore north of the groyne, a dilapidated timber sheet pile structure was observed at the base of the erosion escarpment (Figure 37). The concrete foreshore path in this area had been undermined by erosion with large rock armour (median diameter 1000 mm) placed as emergency coastal protection under the undermined path (Figure 38).

Figure 37 – Looking south toward Groyne 9 showing timber sheet pile wall and erosion escarpment

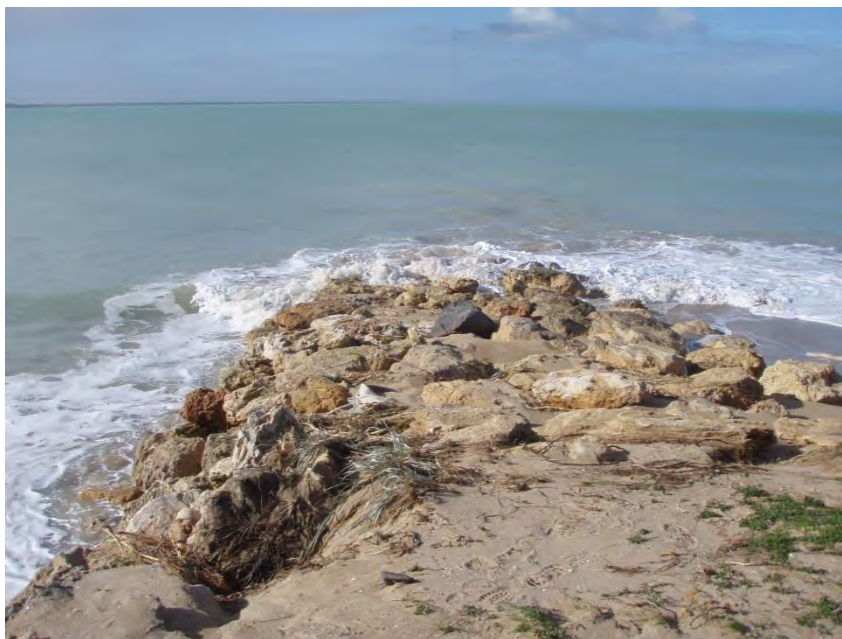
Figure 40 – Groyne 10 tip

Groyne 10 was a relatively short rock groyne (approximately 40 m long) in fair condition (Figure 39). The median diameter of rock armour within this groyne was estimated to be around 1000 mm, with the rock armour comprising limestone. Concrete pieces were observed within the armour of the northern side of the groyne. The tip of the groyne was submerged and not visible. The groyne was partially covered in sand and was actively bypassing (Figure 40). Significant gaps between individual armour stones were visible, these gaps being filled with sand. The beach on the updrift (southern) side was backed by a vegetated dune which had been damaged by erosion, with a dune escarpment 1.5 m high.

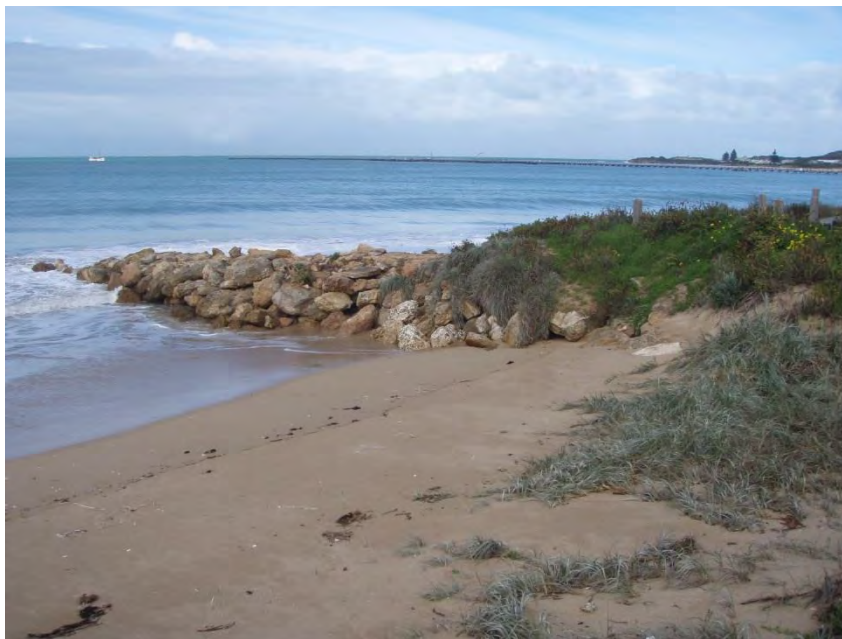
The groyne was in poor condition with many gaps within the armour and exposure of the clay core at the landward side of the groyne. Armour rock had been dislodged from the main trunk of the groyne. Despite the poor condition of the groyne, it was effective in stabilising this section of beach, with a healthy vegetated dune on both sides of the groyne.

Figure 43 – Groyne 11 looking south 25 June

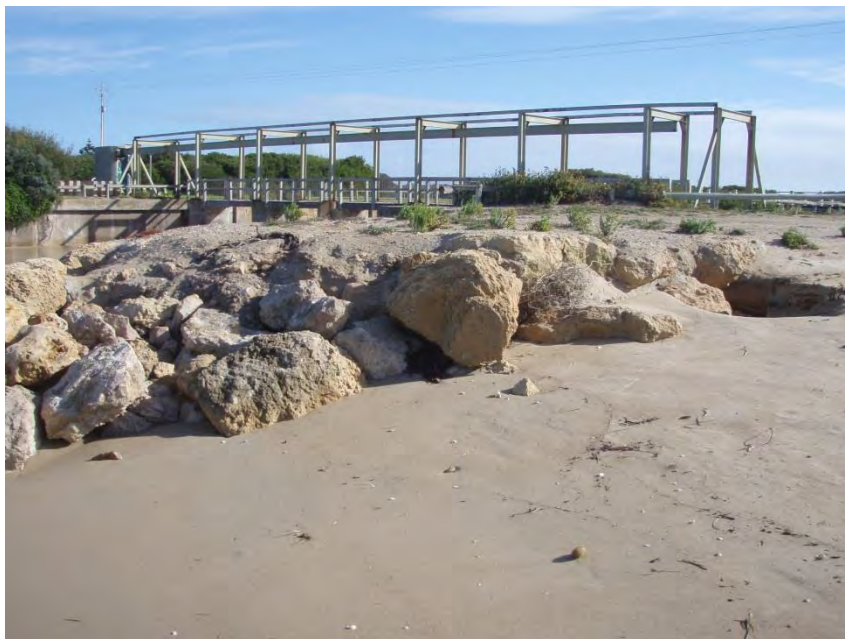
On the northern side of the Lake outlet a short rock groyne approximately 10 m long acts as a training wall (Figure 49). This groyne was in fair condition with a median armour diameter of 1000 mm. North of the groyne, the beach dune was in good condition.

Figure 49 – Short rock groyne at northern end of Lake George outlet – Lake George outlet structure in background

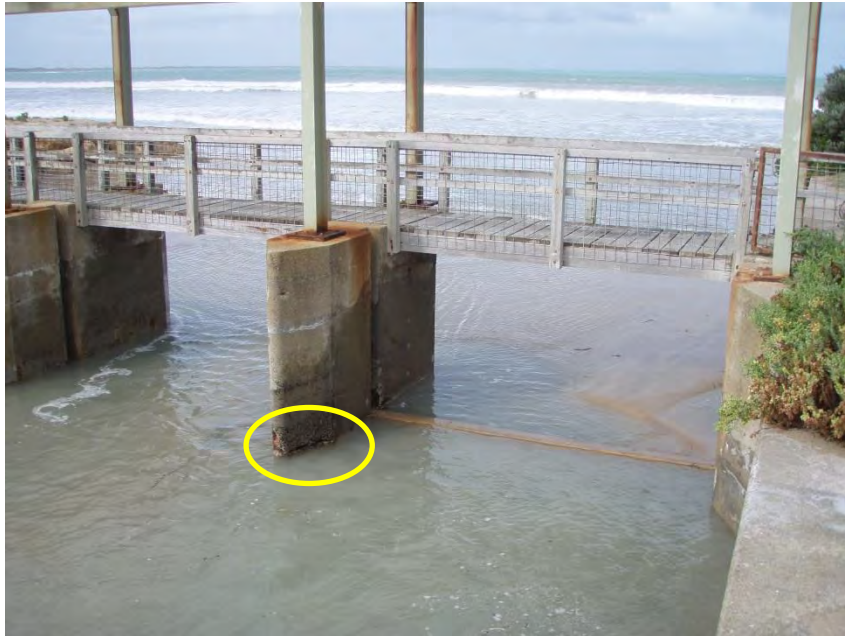
Figure 52 – Lake George outlet structure with corrosion of concrete reinforcement

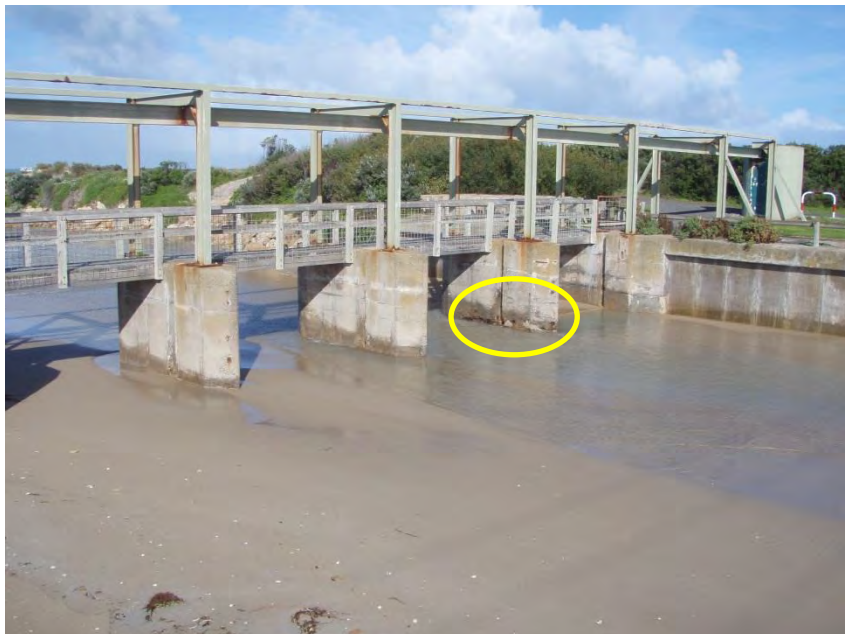
Figure 53 – Lake George outlet structure pier with corrosion of concrete reinforcement and concrete spalling
