WATTLE RANGE COUNCIL

Appendix 1 - Rivoli Bay

Assessment of Existing Coastal Structures

301015-03541 – 001

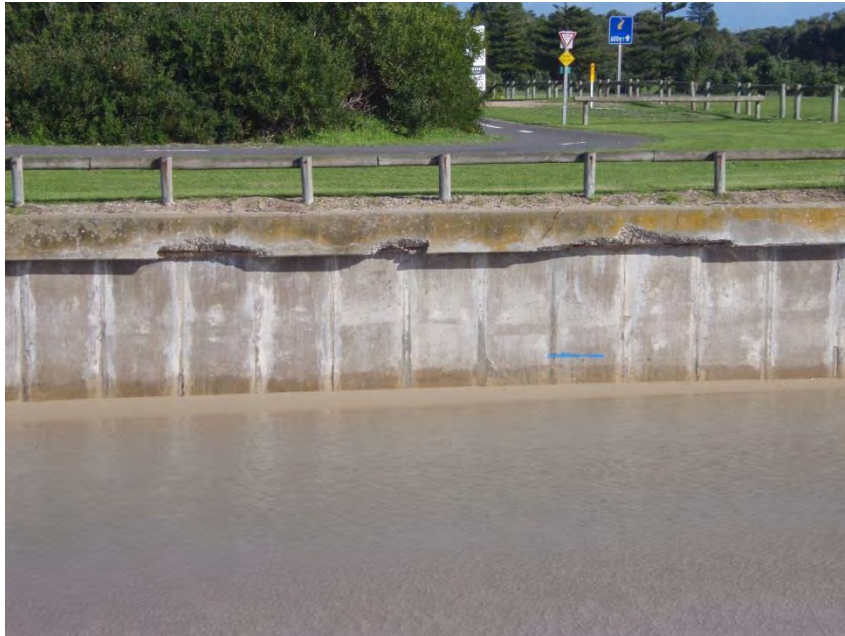
Figure 54 – Concrete spalling at capping beam along Lake George outlet channel upstream of outlet structure

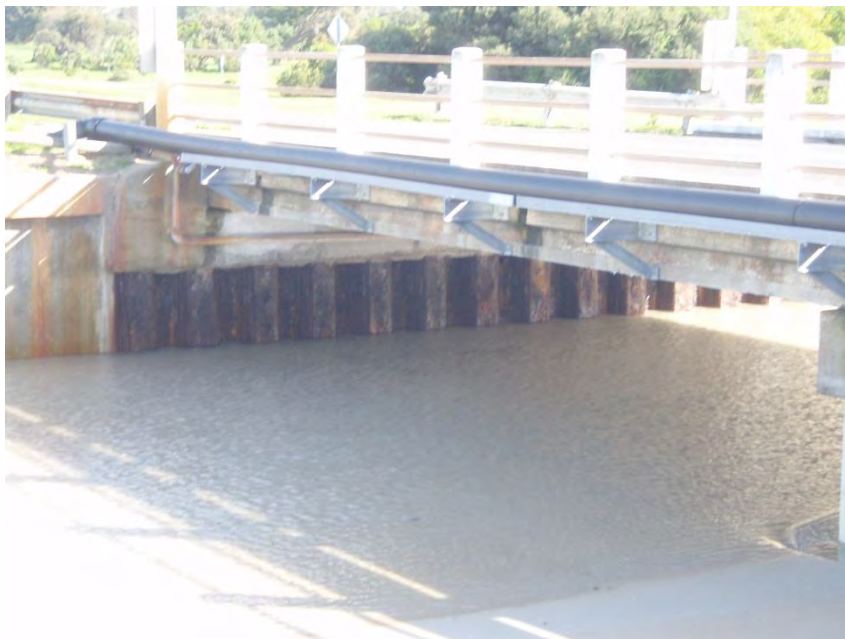
Figure 55 – Corrosion of sheet pile bridge abutment at road bridge upstream of Lake George outlet structure

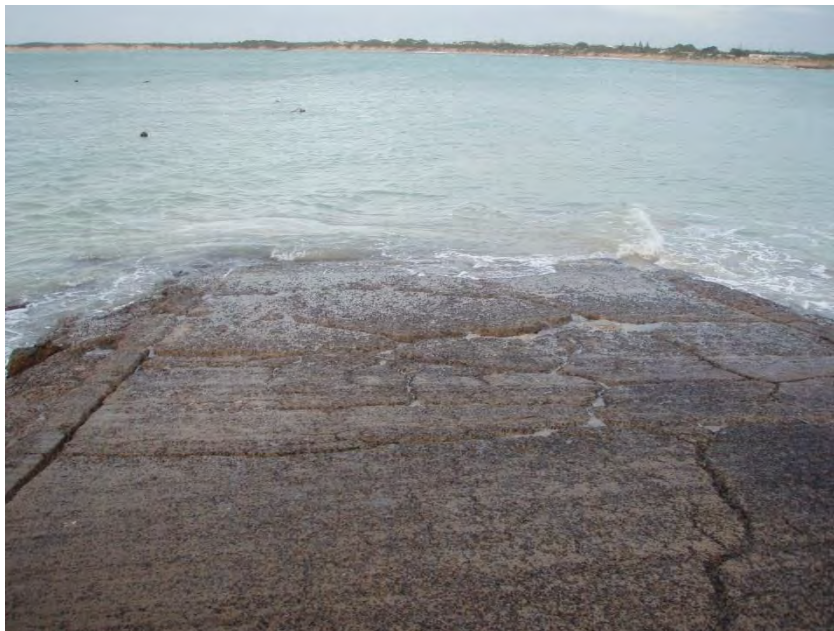
The concrete surface of the boat ramp had suffered some spalling and cracking (Figure 60) and waves were running up the surface of the boat ramp into the carpark on 24 June (Figure 61).

Figure 60 – Cracking and spalling of boat ramp surface, Southend

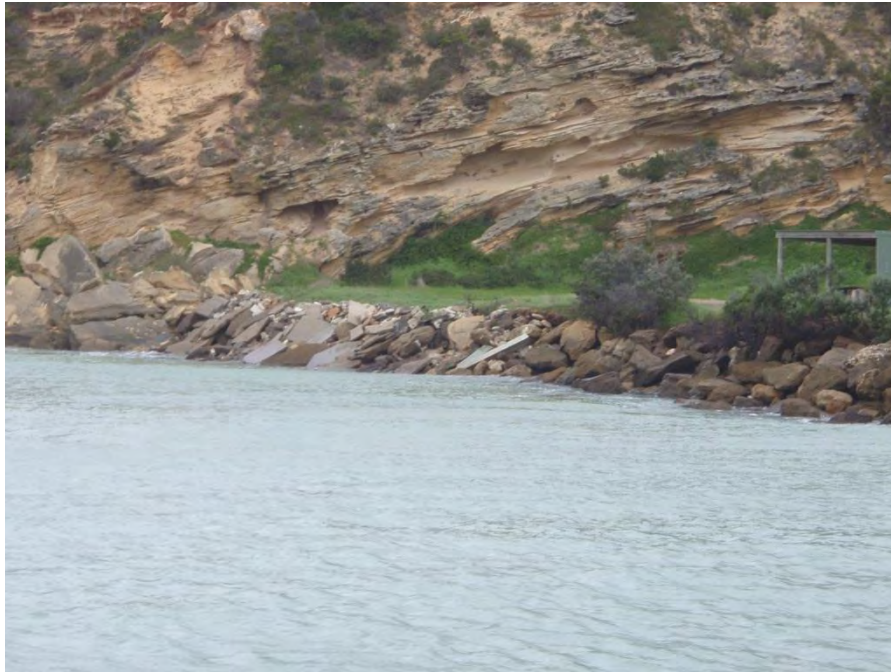
South of the boat ramp, a rock revetment comprising limestone armour of median diameter 1200 mm was subject to oblique wave attack – this revetment was at a slope of 1V:2H and was in poor condition, with the underlying fill material exposed and subject to erosion caused by wave overtopping (Figure 61 and Figure 62). At the southern end of the revetment, rock armour was replaced with ad hoc concrete and building rubble, as shown in Figure 63.

Figure 63 – Ad hoc rubble erosion protection at southern end of revetment near boat ramp

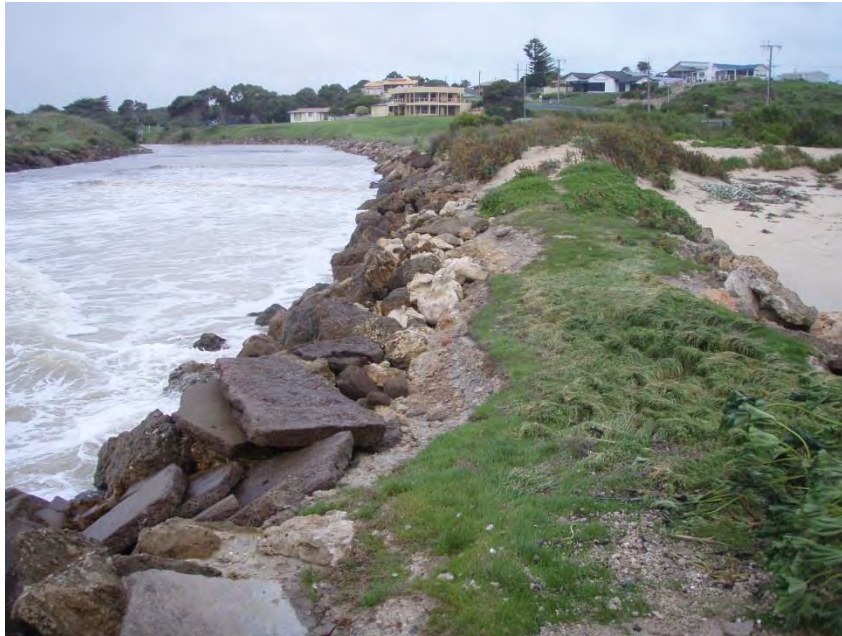
Figure 68 – Groyne at southern side of entrance to Lake Frome, looking inland. Note poor condition of clay capping and core on northern side, use of concrete rubble to repair erosion damage and groyne being covered by mobile dune sand

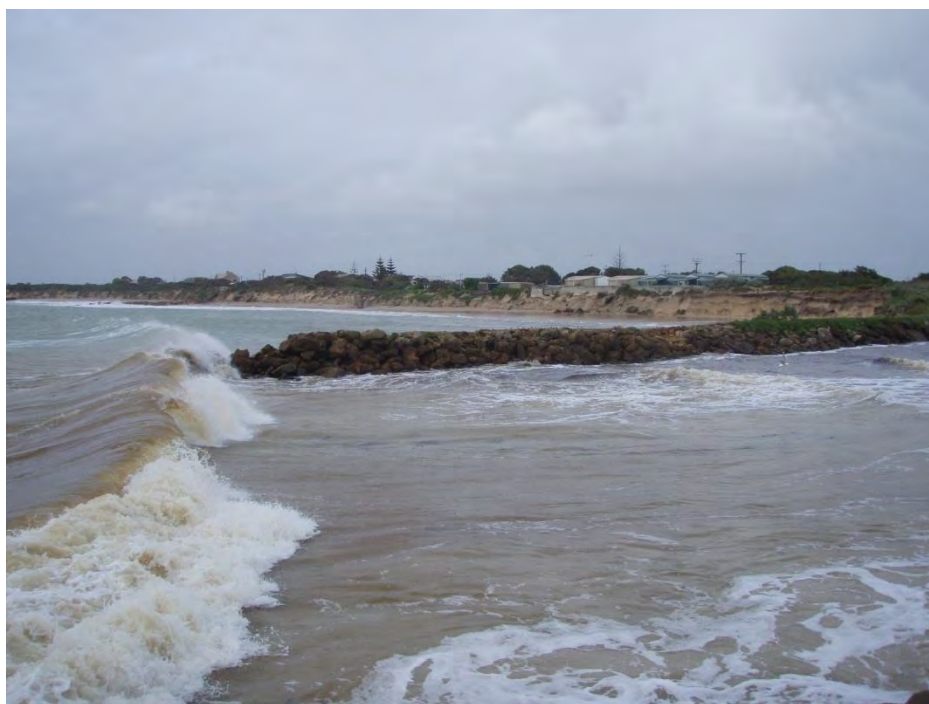
Figure 73 – Waves breaking at groyne on northern side of Lake Frome outlet

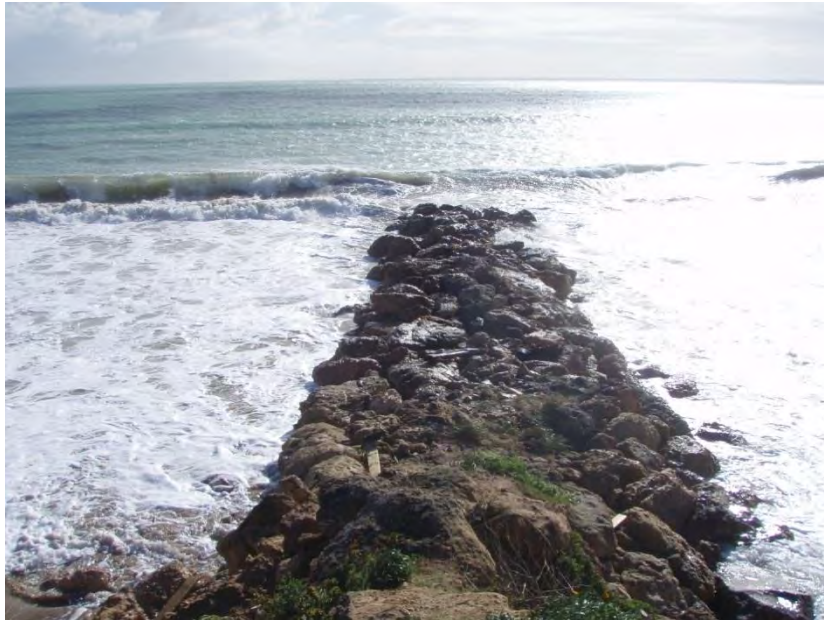
Figure 74 – Groyne 3 – note armour in good condition and interlocking between individual stones

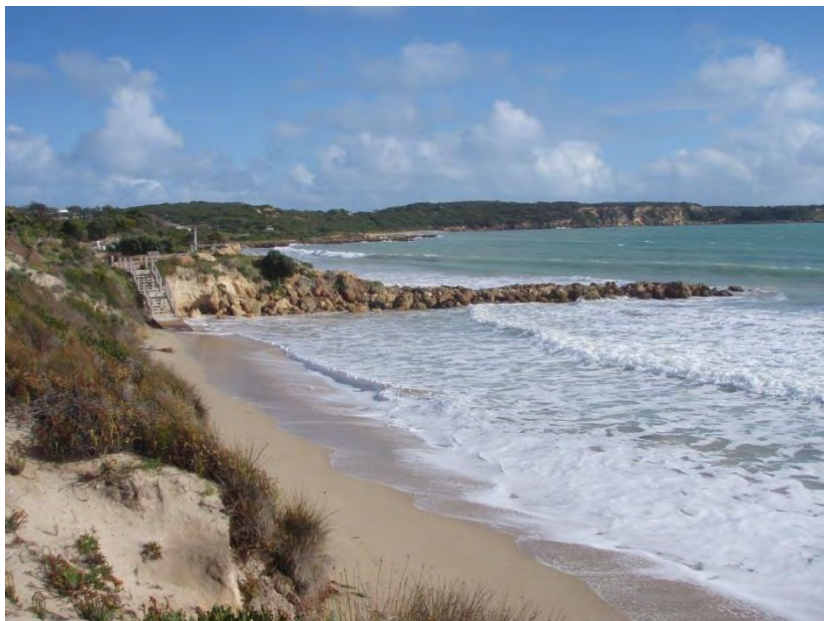
Figure 75 – View of Groyne 3 looking south. Note timber stairway and lookout at crest of groyne.

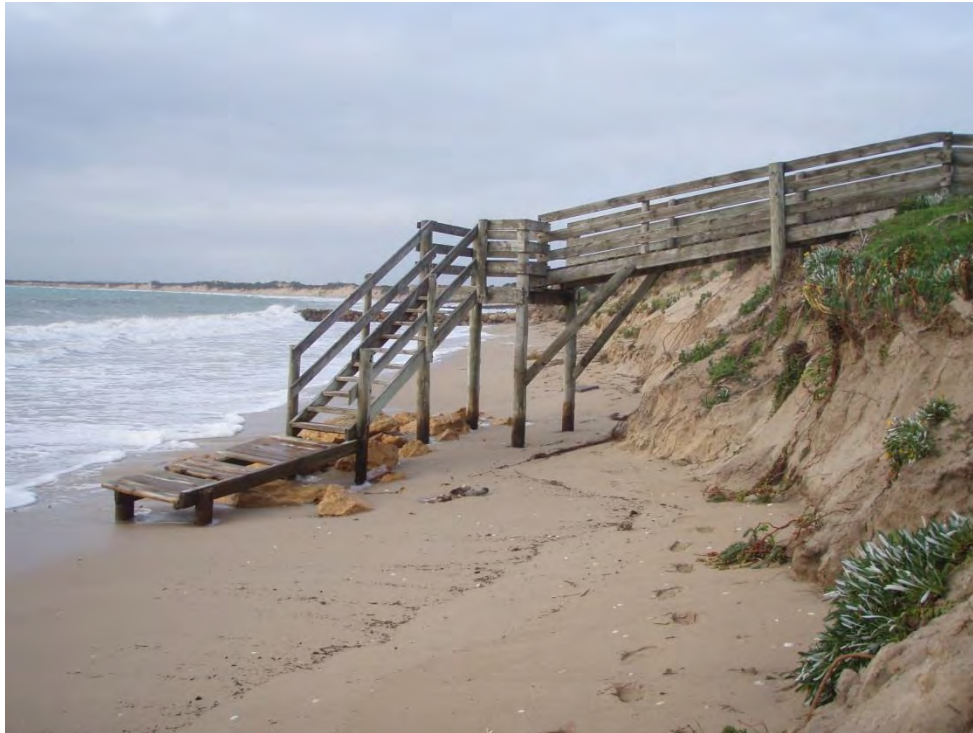
Figure 76 – Damaged pedestrian access onto beach south of Groyne 3

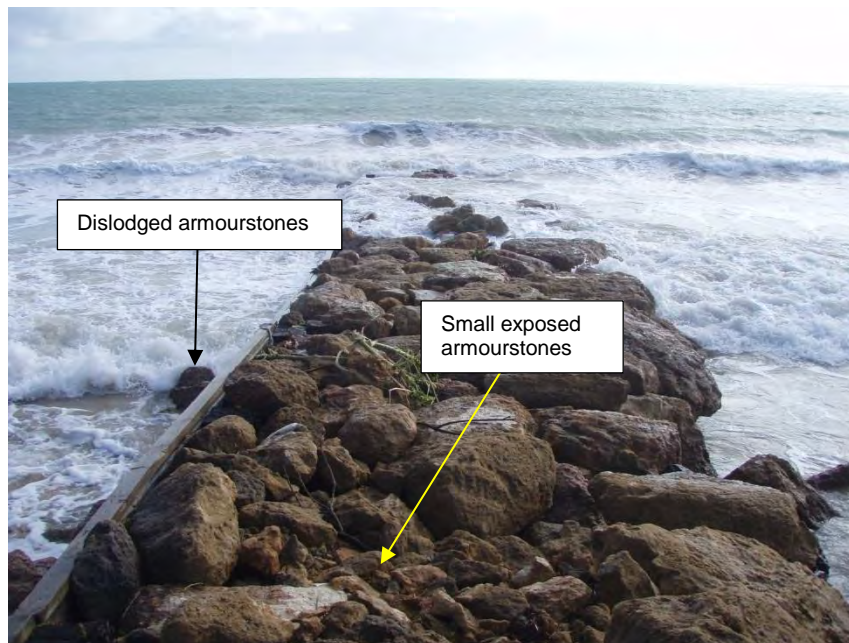
Figure 77 – Groyne 4 – note exposure of smaller armourstones, overtopping of the tip of the groyne and dislodgement of some smaller armourstones on the southern side of the groyne.

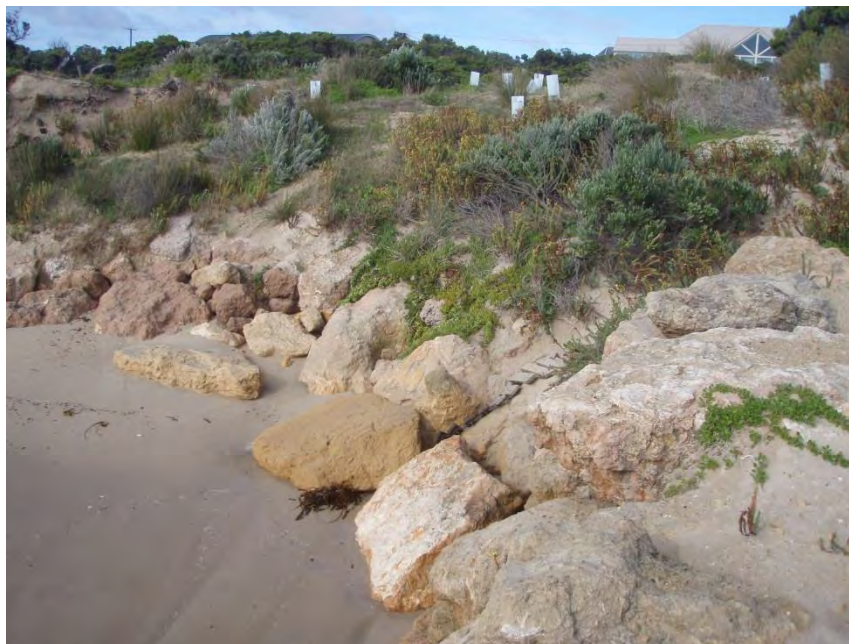
Figure 78 – Looking landward toward beach face. Note rock protection installed at toe of dune and lack of formal access onto the beach at this location.

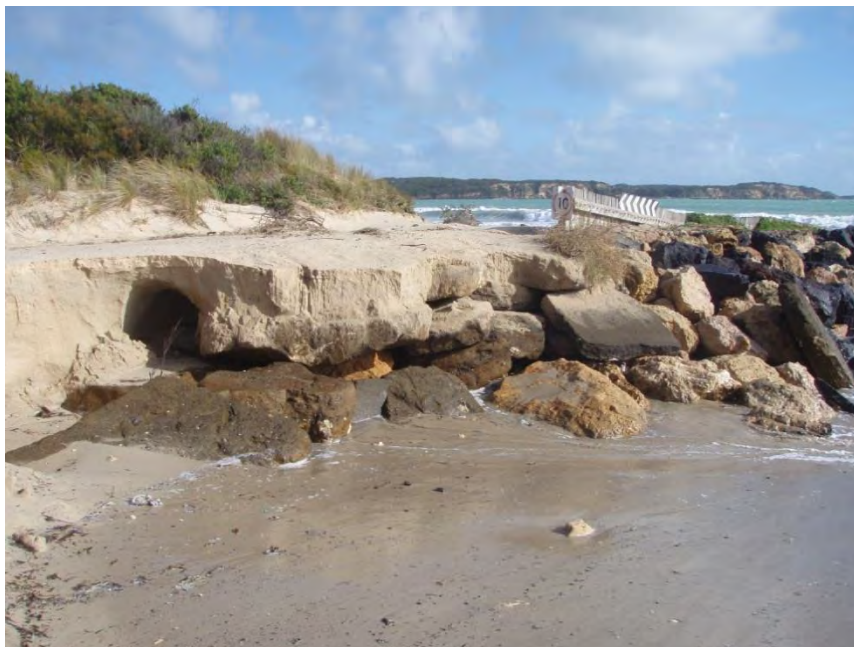
Figure 81 – Undermining of Groyne 5 at landward side

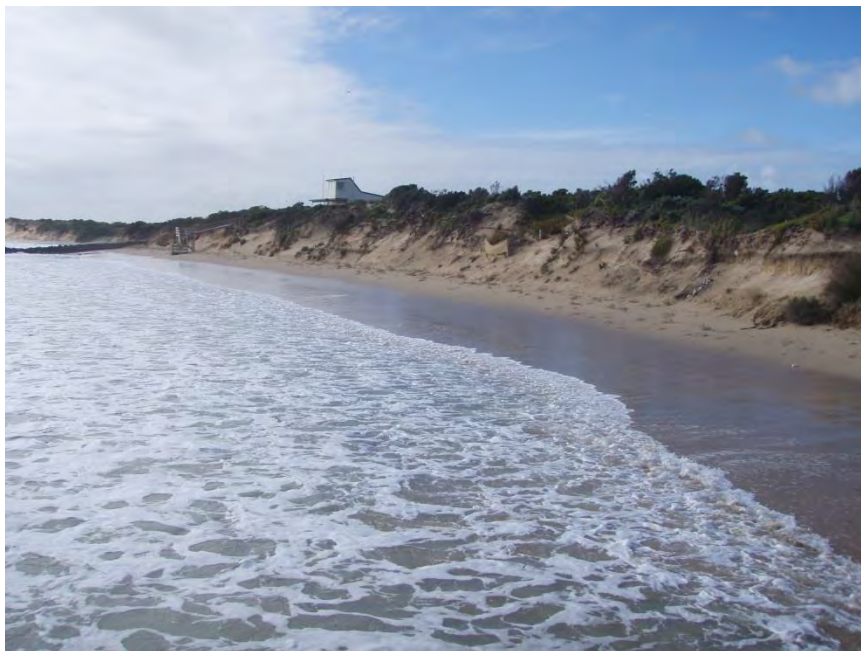
Immediately south of this groyne, a building within the Rivoli Bay Sailing Club area was close to the edge of the erosion escarpment (Figure 83).

Figure 83 – Building at Rivoli Bay Sailing Club close to dune escarpment
