Current Status and Management Options for Salmon Hole/Post Office Rock Beach

Report prepared for the Wattle Range Council

2018

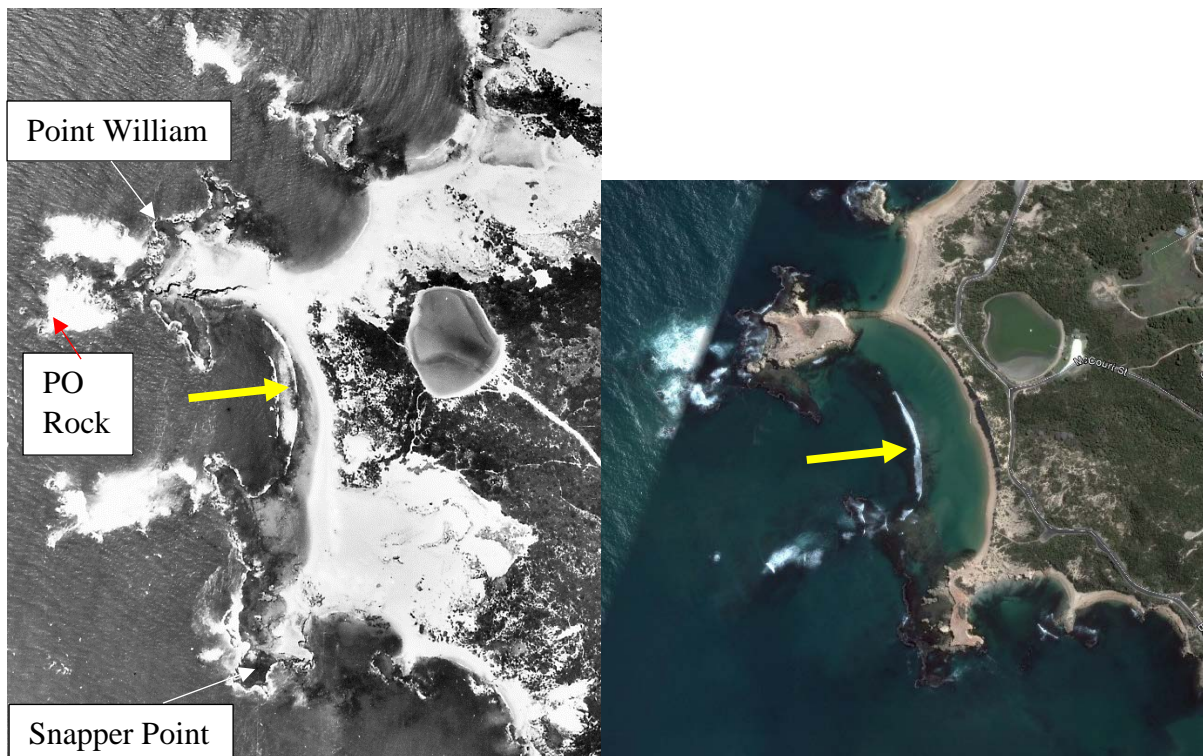
Figure 1: The Post Office Rock region, February, 1946 (left) and 19/4/2016 (right). Salmon Hole Beach lies between Point William and Snapper Point. The dune systems comprised vegetated and active transgressive dunefields in 1946 which by the late 1970's were largely stable and well vegetated. Note that the beach was attached to the reef (yellow arrow) in 1946, and was ~135m eastwards by 2016. Note the distance from the beach to The Pool of Siloam in 1946 versus 2016.

The shoreline retreated ~120 to 135 metres between 1946 and 2016. This is a mean maximum rate of shoreline retreat of ~1.93 metres per year. However, this underestimates the actual rate

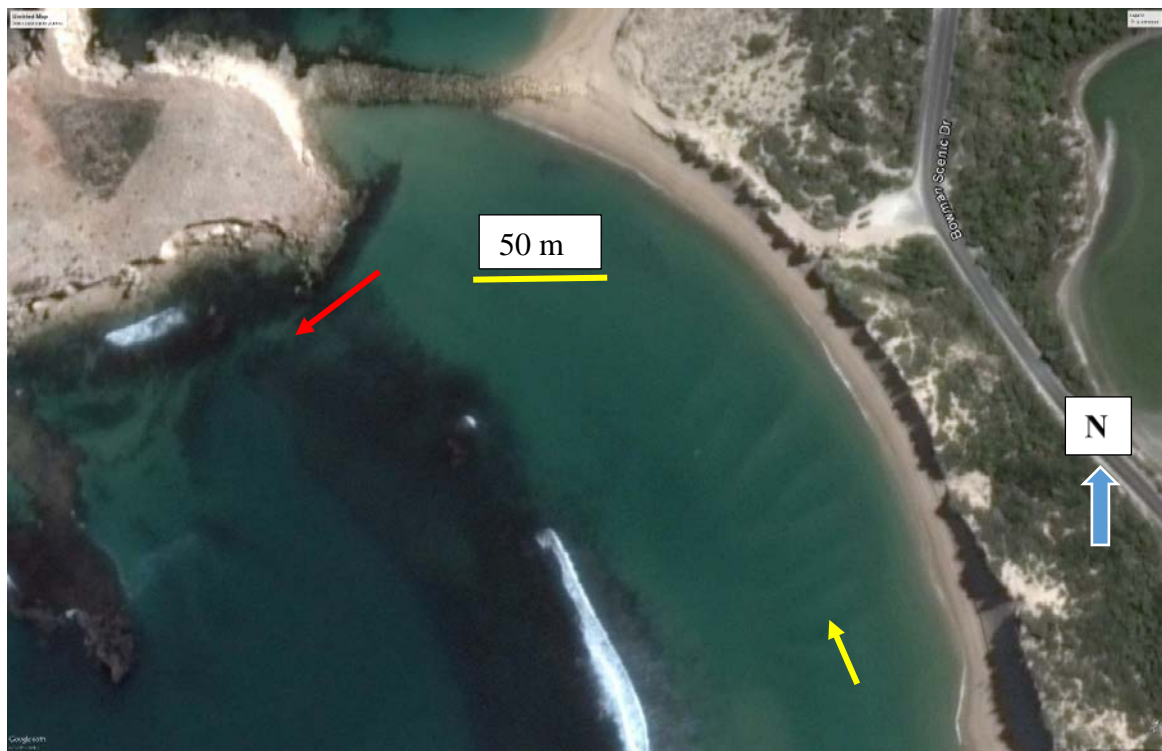
Figure 3: Google Earth image of the reef, surfzone ‘lagoon’, a suite of subaqueous transverse dunes in the lagoon indicated by the yellow arrow, and the reef/bedrock controlled rip channel (red arrow) at the northern end of the lagoon.

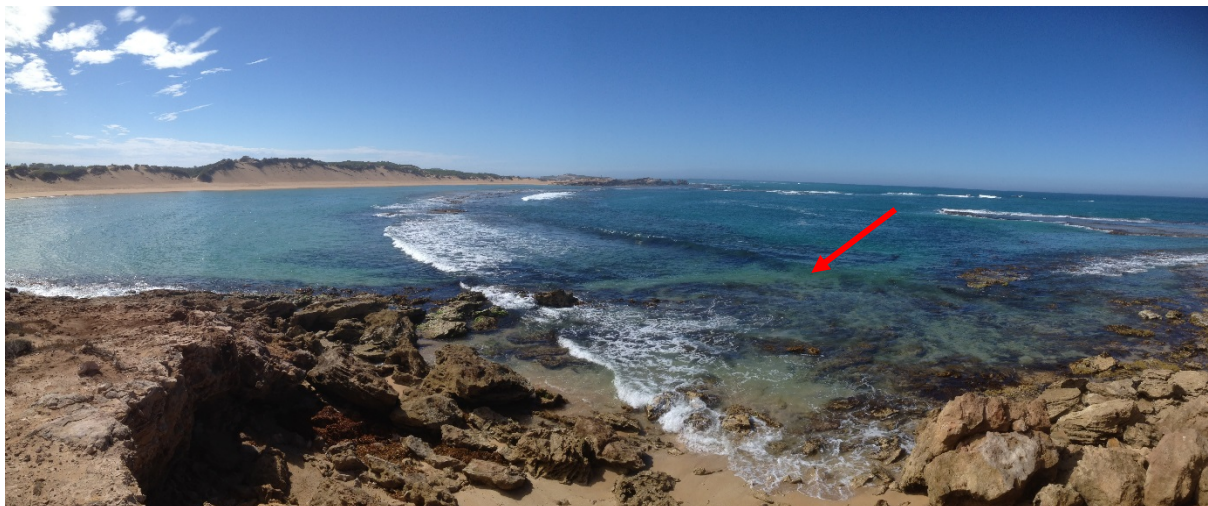
Figure 4: View of the reef and the reef/bedrock controlled rip channel (red arrow) at the northern end of the ‘lagoon’ during a low tide event, February, 2018.

The other major driver of sediment and water movement is a permanent rock arrested rip channel located at the northern end of the embayment adjacent to Point William/PO Rock. It is likely that sediment has always, and is still being transported offshore through this rip channel during moderate to strong wave events (Figures 3 and 4). The rip generating this channel is a hazard to swimmers and warning signs are recommended.

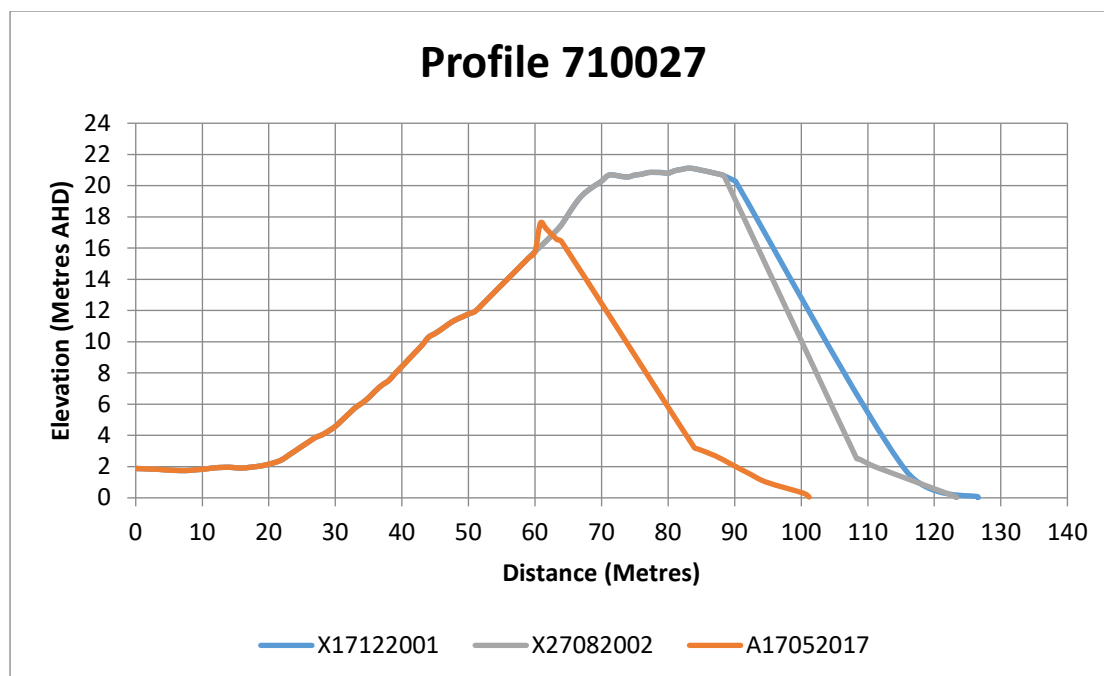
Figure 5: Plot of profile 710027 near the middle of the embayment showing changes between 2001 (blue), 2002 (grey), and 2017 (orange).

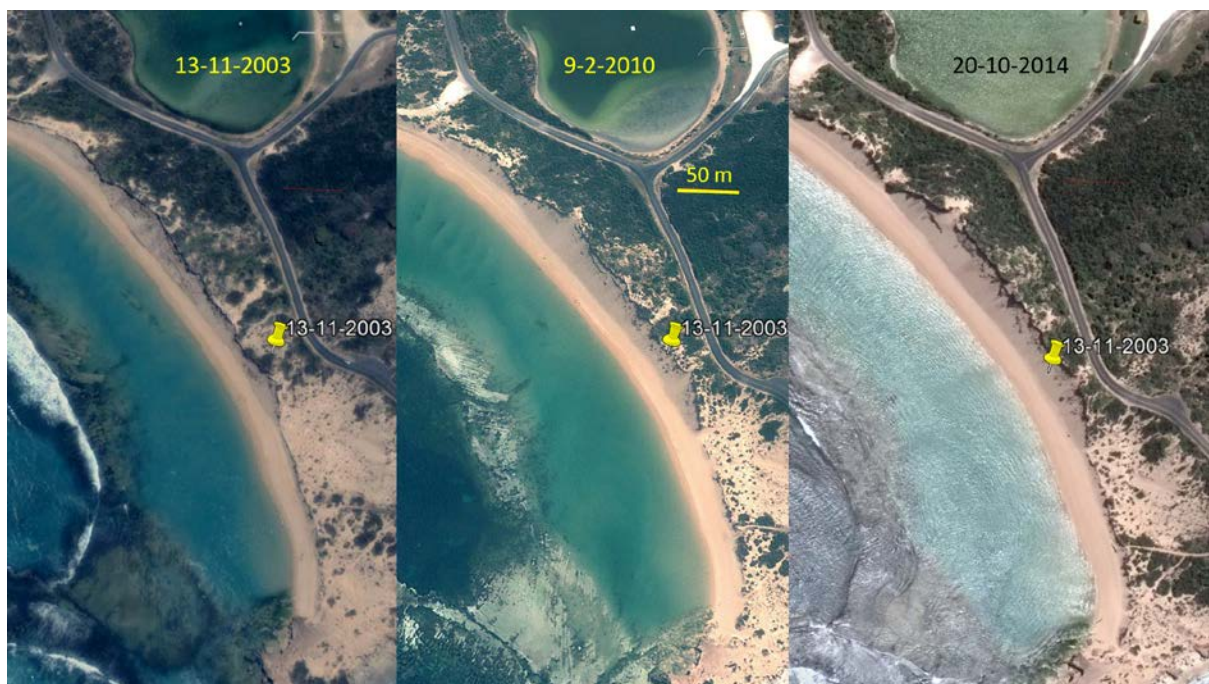
Figure 7. Google Earth images from 2003, 2010 and 2014 (left to right) illustrating the rate of erosion. The yellow pin located several metres landwards of the scarp crest in the November, 2003 image is located at the scarp crest by 2010, and half way down the scarp by 2014.

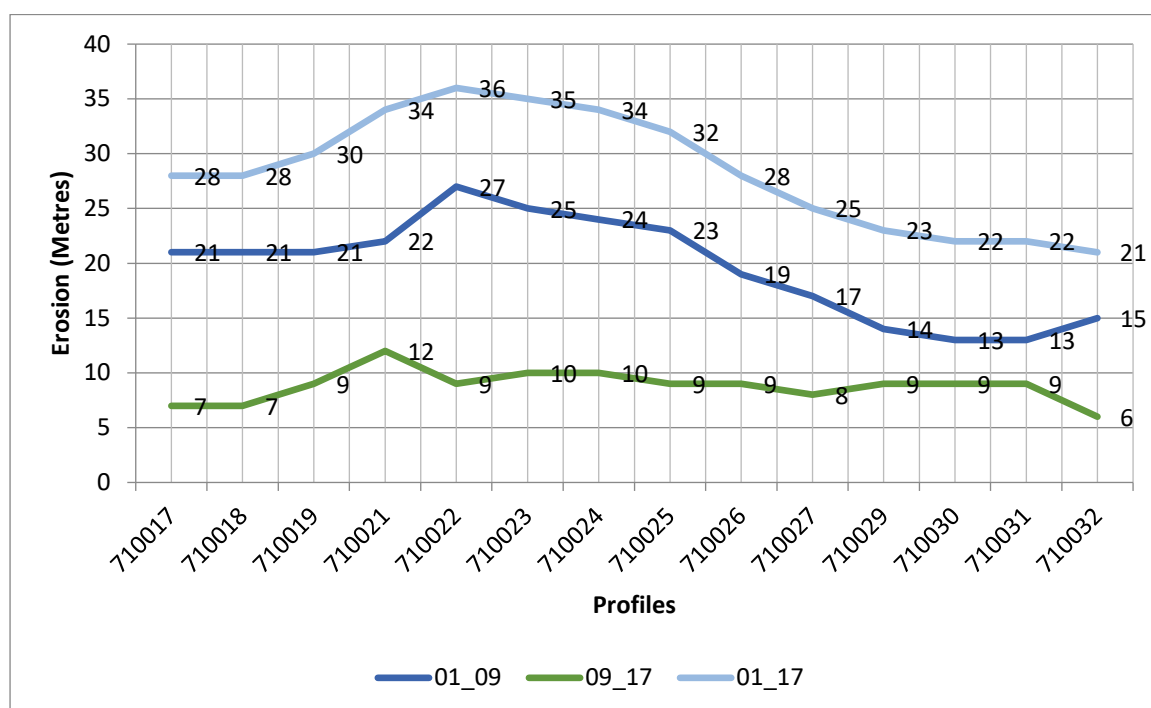
Figure 8. Graph showing erosion rates for profiles 17 (southern end) to 33 (northern end) for the periods 2001-2009, 2009-2017, and 2001-2017.

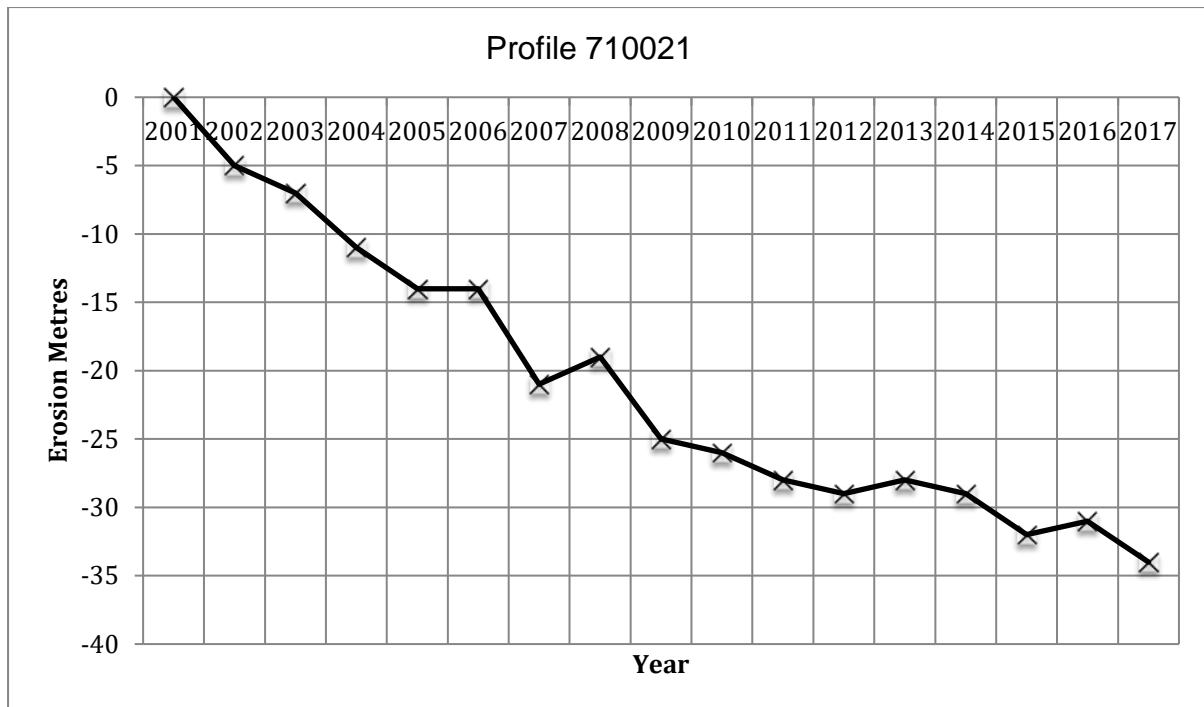
Figure 9. Cumulative erosion for Profile 710021, 2001 to 2017. The rate of erosion is declining since 2009.

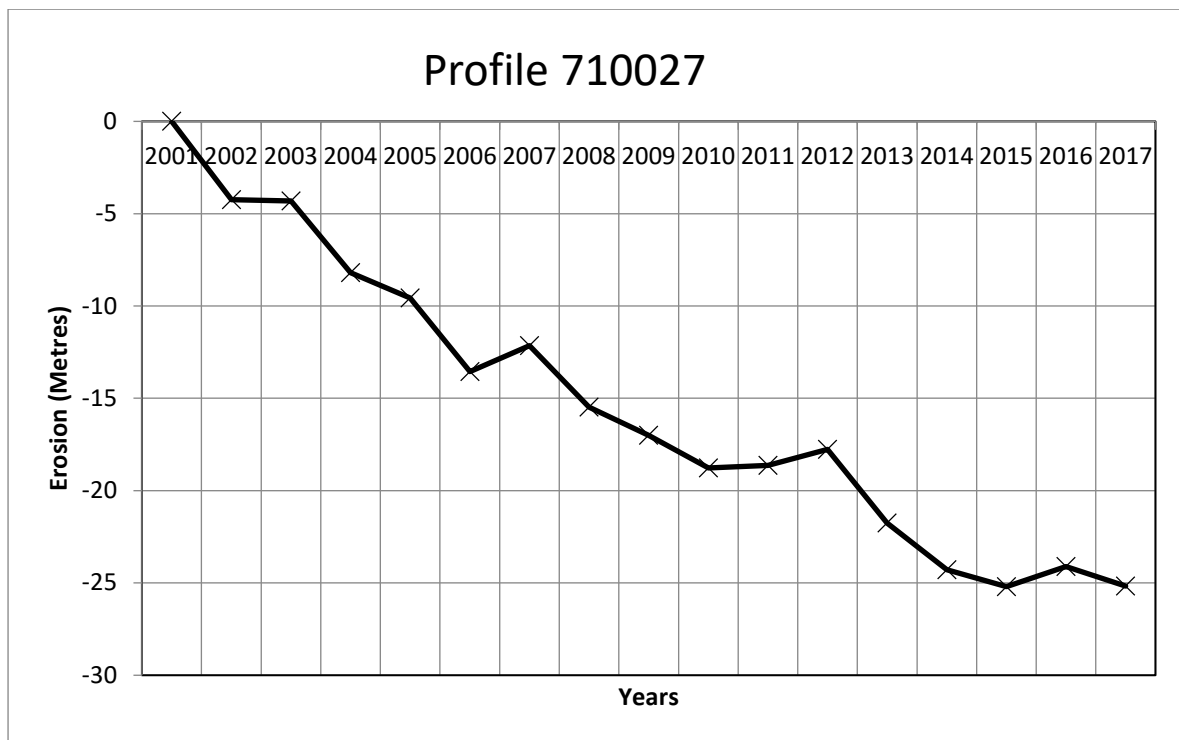
Figure 10. Cumulative erosion on Profile 710027, 2001 to 2017. The rate of erosion has slowed since 2009.

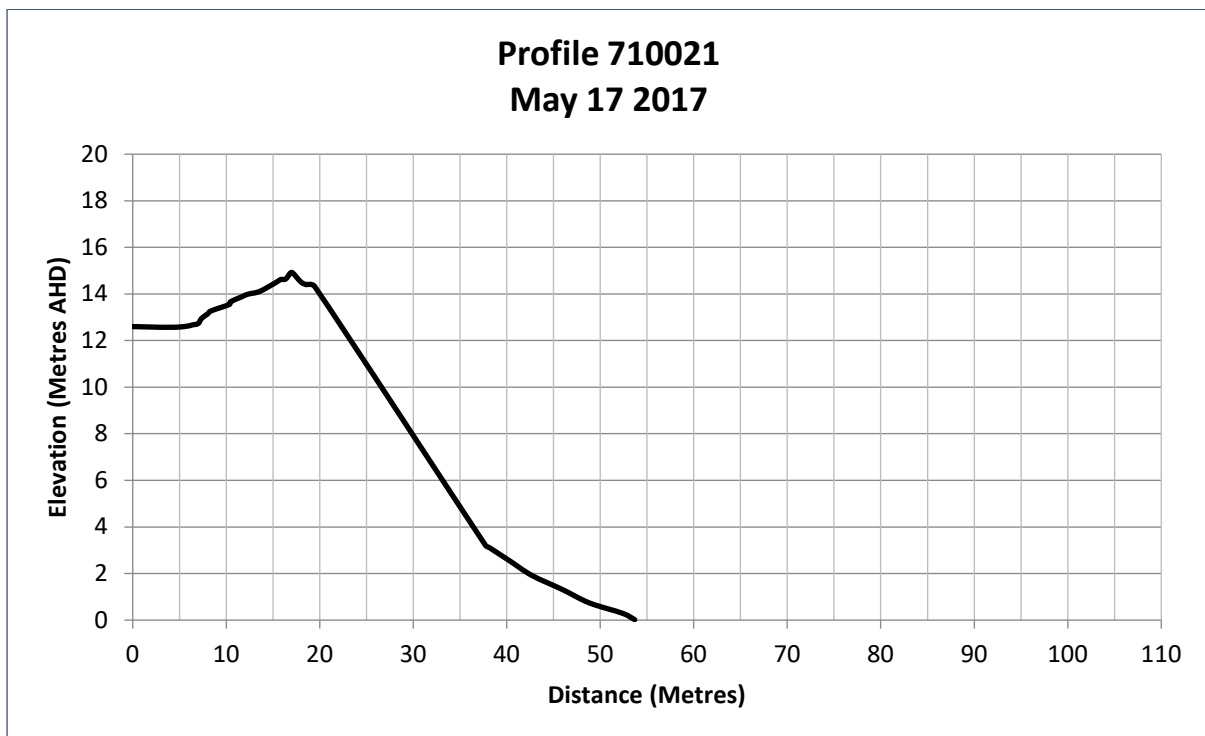
The road is most vulnerable to erosion at profile 710021 near the southern end of the embayment (Figure 6). A plot of the 2017 profile is shown in Figure 12. This survey shows that the top of the erosion scarp was 19.46 metres from the centreline of the road. The profile, which starts at the centreline, extends across 4.12 m of bitumen, and the verge extends to 6.36 metres distance. The scarp toe is at 37.71 metres.

Figure 12: Profile 710021. The middle of the coast road is located at zero metres in this figure.

The average annual volumetric loss estimated for Profile 710021 for the 2009 -17 period is 22.87 m³/m. The current dune volume (above 2 m AHD) to the middle of the road is ~ 171.5 m³/m. At the current rate of erosion the top of the erosion scarp will be close to the road verge (~7 m distance from zero in Figure 12) in 7.5 years (from May, 2017) or by mid-2024.

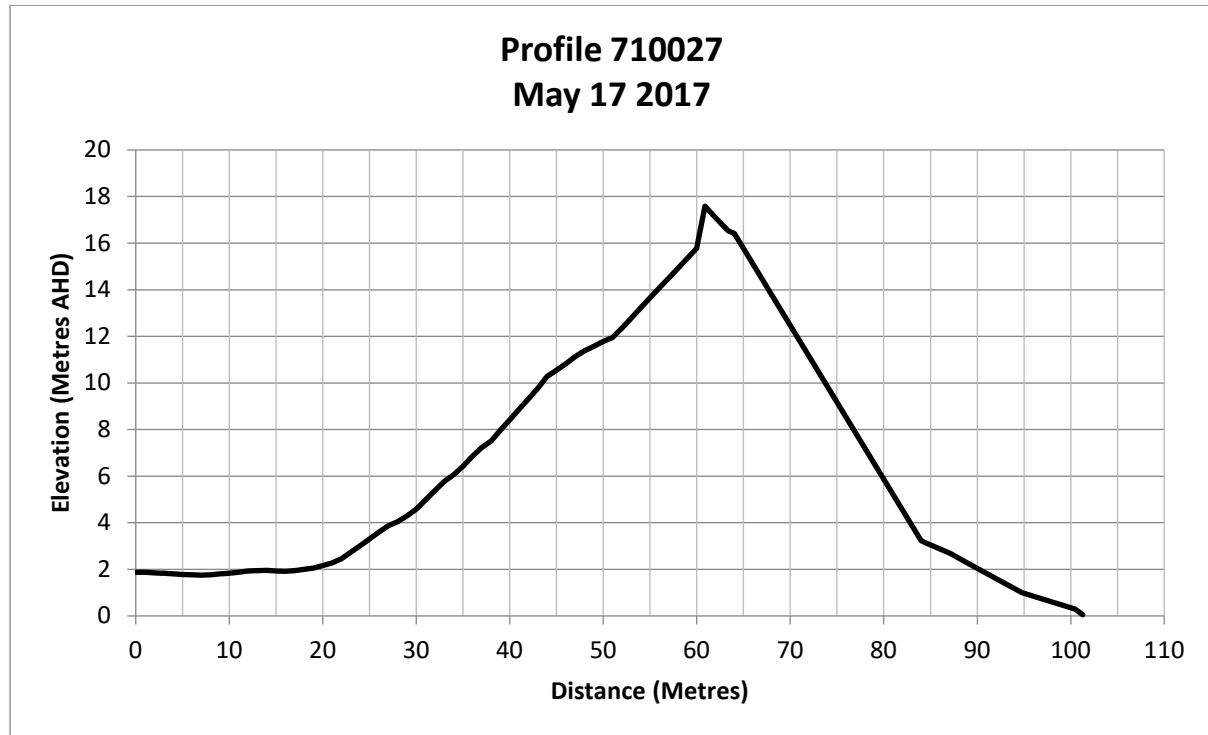
Figure 13: Profile 710027 located in the middle of the embayment.

The average annual volumetric loss for this portion of the embayment at profile 710027 is 15.62 m³/m/year for the 2009 to 2017 period. The current dune volume (above 2 m AHD) is ~ 474 m³/m. At the current erosion rate, the dune will be removed and the 2 m elevation point 20 metres seaward of the road will be reached in approximately 30 years (from May, 2017) or by 2048.

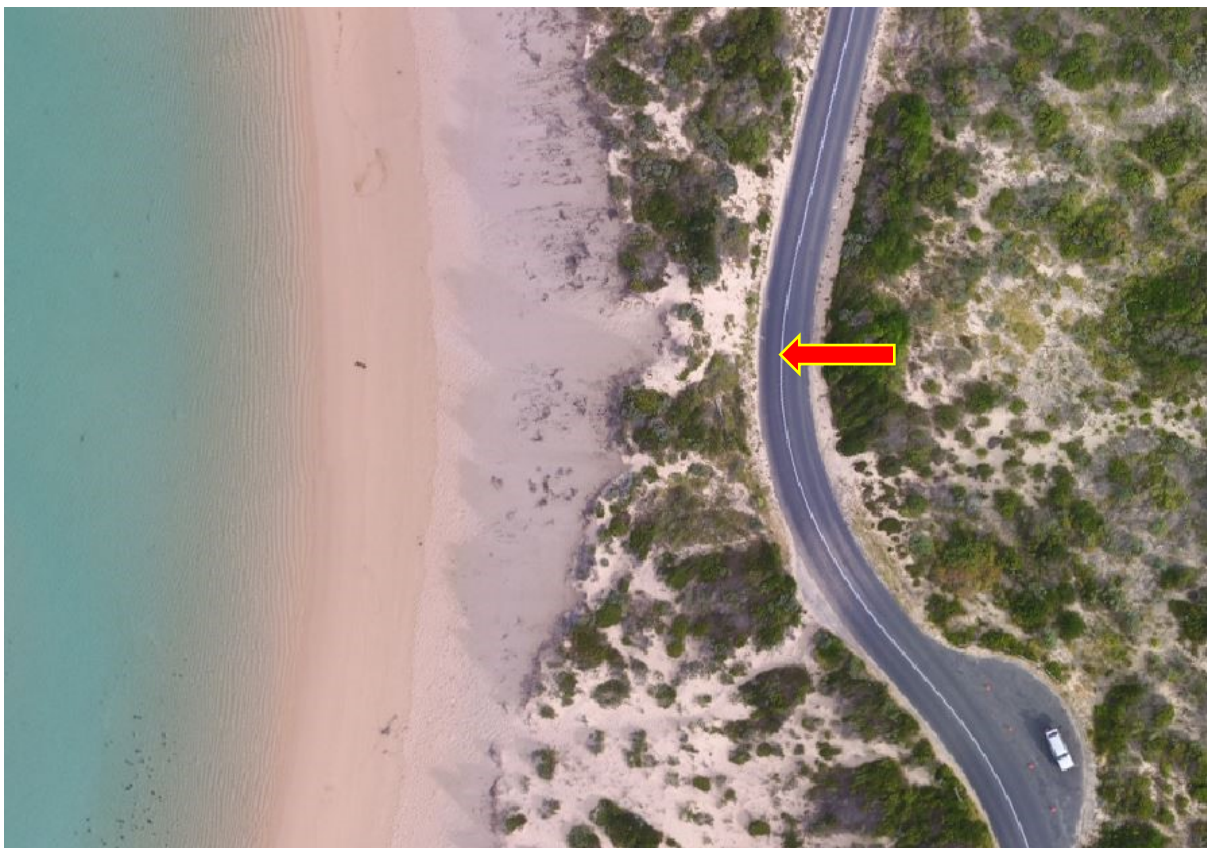
While the degree of erosion varies from year to year due to the impacts of storms in some years, the erosion rate along the embayment is generally slowing down as the Tables and Figures above indicate. The average erosion rate has decreased in the 2009 to 2017 period compared to the 2001 to 2009 period (Figure 8). During the period 2001 to 2009 the annual loss was 15,337 metres³, while for the period 2009 to 2017 it was 6603 metres³. This is obviously still a decent rate of erosion, but since the rate is decreasing, an option is to only deal with the sand transport issue on the dunes adjacent to the road in the area located around profiles 700021 and 22. In this location (Figure 14), sand is transported off the seaward

Figure 14. The currently most vulnerable section of the coast road (arrowed). The scarp crest is only ~14 m from the edge of the road. Brushing of the upper scarp will reduce sand transport onto the road. However, if dune erosion continues, it is likely that in the future the road will need to be closed north of the parking area (where the vehicle is parked in the photograph).

erosional dune scarp and deposited on the lee slope, road verge and road depending on the wind velocity at the time. The immediate management action here is to stabilize the eroding surface to the degree possible by laying overlapping brush (typically *Acacia* cuttings or other native plant cuttings) across the surface.

As the dune continues to retreat, this brushing may have to be repeated to reduce sand transport landwards. Once (or if) the dune scarp is relatively close to the road verge, the road will have to be closed. As noted above, the dune scarp will be near the road verge by 2024. The stability of the dune will be need to be assessed before this time to see if it is stable enough to adequately support the road.

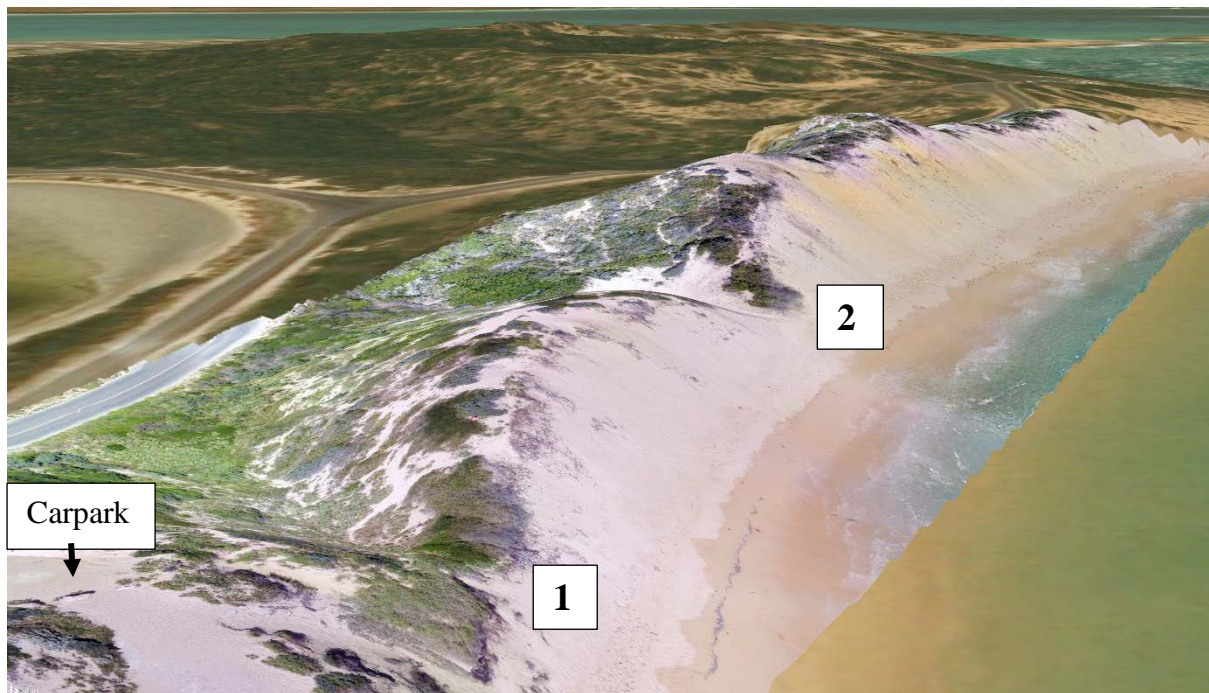
There are two topographic lows in the current dune system (Figure 15). One, here termed the gully, is located immediately adjacent to (just south) of the carpark situated at the northern end of the embayment. Two, there is a blowout in the central-northern portion of the dune system opposite the Pool of Siloam (Figure 15).

The greatest immediate threat to inundation and erosion of the coast road and the Pool of Siloam and environs is if either or both of these are cut through, inundated or overtopped by storm waves. Such an event could produce a significant overwash channel down through these lows, across the eastern portion of the dune system and onto the road and into the Pool of Siloam. This could cut the dune into two or potentially three segments depending if one or both occurred respectively.

Figure 15: DEM produced from a February, 2018 UAV drone flight and overlaid on a Google Earth image showing the dune system and the two topographic low areas. 1 – Gully; 2 – Blowout.

Option 4 involves adding sand to both of these to reduce this possibility and extend the time within which no flooding of the eastern dunes, road and Pool occurs.

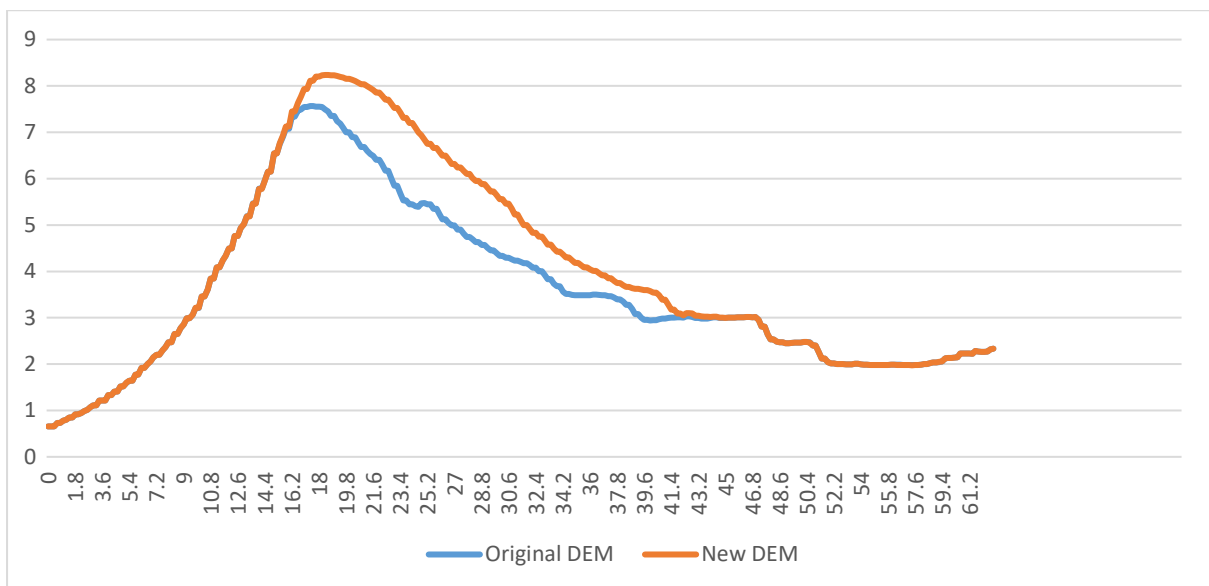
The gully lies ~23 m landwards of the present dune scarp, the crest of which is at an elevation of 7.5 m. Figure 16 illustrates the present topography extending up through the lowest portions of the dune system and gully and over the scarp crest to the beach.

Figure 16: Present topography (blue) of the dune fronting the gully section (at profile 710032) and the nourishment profile (orange).

The current dune profile at the Gully has an approximate volume of $93 \text{ m}^3/\text{m}$ (above 2 m AHD), and at an estimated rate of erosion of 7.4 m^3 per year the dune will be gone within ~10 years if the current erosion rate continues. Superimposed on the present 2018 topographic profile shown in Figure 16 is a post-nourishment profile. This latter profile is a minimum volume required to raise the crest level and primarily to extend the crest region landwards, thereby reducing the chances of waves eventually breaking through and into the gully. The total estimated volume required to achieve this nourishment is 192 m^3 . The nourishment profile shown in Figure 16 contains another $21 \text{ m}^3/\text{m}$. This extra sediment will only add a little less than an extra 3 years life to the dune. The nourishment profile indicated does not therefore add much life to the dune, but is provided as an indication of how much minimum sediment volume would need to be added *each 3 years* post-2019 to prevent overwash occurring.

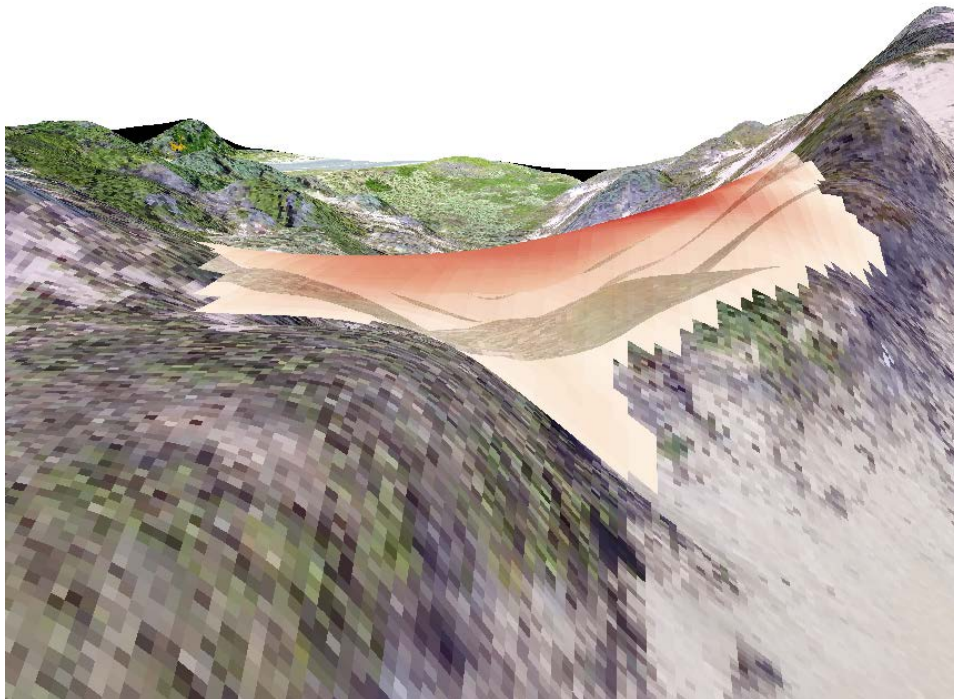
Figure 17: The gully location with nourishment sand overlaid on a February, 2018, Digital Elevation Model of the dune produced from a UAV drone flight.

Figure 17 illustrates the nourishment sand overlaid on a recent (February, 2018, Digital Elevation Model (DEM) of the dune produced from a UAV drone flight. In the case of the gully, the placement of the sand could be achieved relatively easily with minimal impact by vehicles on the vegetation, by simply tipping sand into the gully from the edge of the carpark margin. Nonetheless, vegetation would be impacted where the nourishment fill is placed and native vegetation impacts will have to be considered.

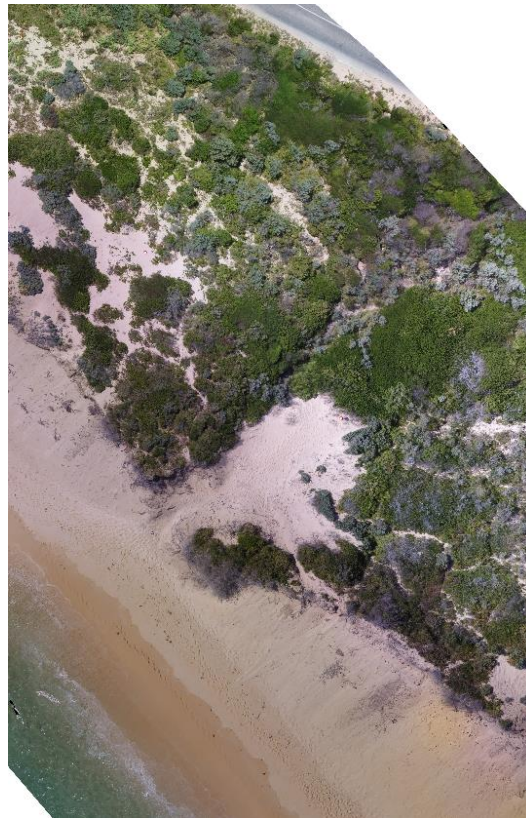
Figure 18 illustrates the blowout and landwards, low elevation, partially tracked strip extending eastwards to the road and Lake. The blowout entrance is currently only 3m above mean sea level.

The blowout comprises a throat (entrance) region (6 to 10m distance landwards in Figure 19), deflation surface (10m to 23m distance in Figure 18), and depositional lobe extending from ~23m to 45m landwards (Figure 19). The throat or entrance region rises to ~3.5 m above AHD, an elevation which could be presently reached by storm waves acting on top of a 1 metre setup in water level at high tide. The profile shown in Figure 19 traverses across the blowout and then across the lowest topography towards the Pool. However, a low swale continues seawards up the side of the depositional lobe. This provides a path of least resistance should waves reach into the blowout and wash down into the low topography.

Figure 18: Aerial photograph of the blowout and environs produced from a UAV drone survey on the 24th January, 2018.

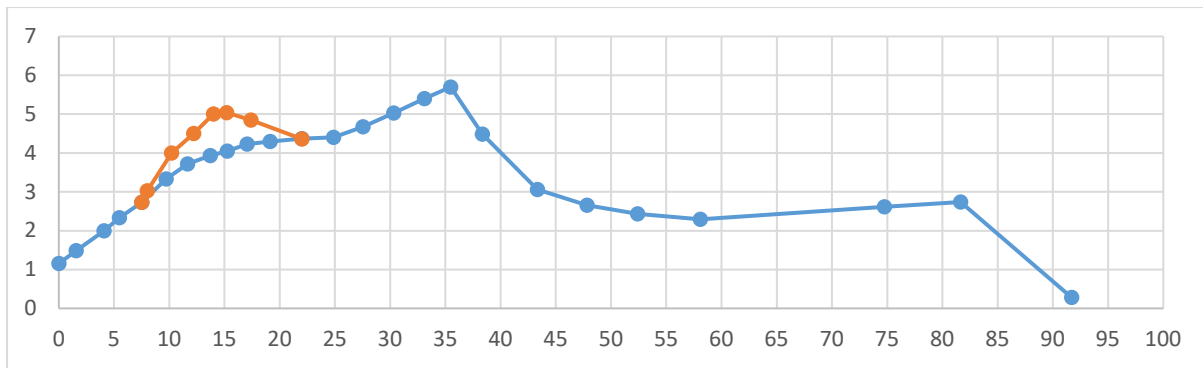
This profile shown in Figure 19 is therefore the maximum volume present and comprises ~90 m³/m in its current form (above 2 m AHD). The nourishment volume comprises 83 m³ and the profile (Figure 19) contains ~11 m³/m and primarily raises the height of the dune to prevent inundation into the blowout and overwash/inundation down the lower, northern side of the depositional lobe. This is also a minimum nourishment volume, and clearly a much greater volume placed in this location would improve the medium term “stability” of this location.

Figure 19: Present blowout profile (blue) and proposed nourishment profile (orange). Currently high tides reach to ~2.5 to 3 m AHD.

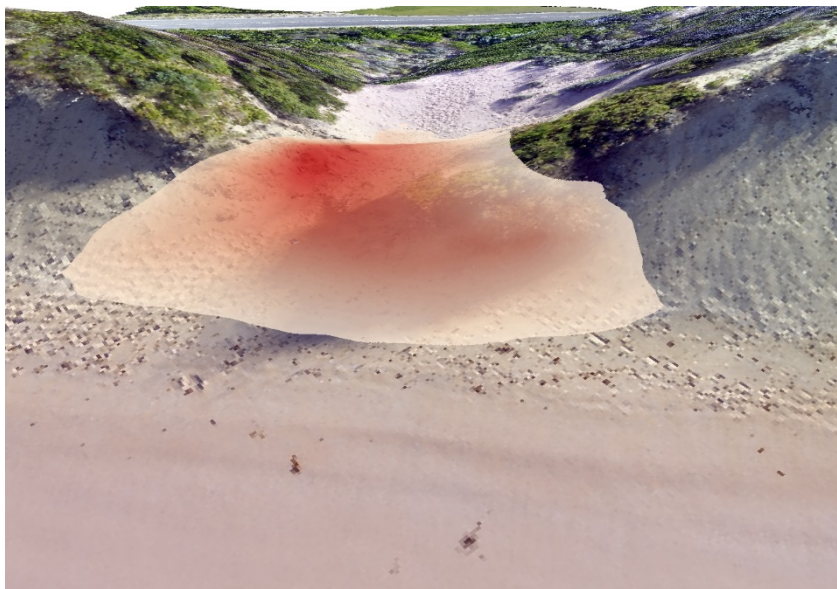
Figure 20: Drone DEM of the blowout with overlaid proposed nourishment sand.

There is a significantly greater difficulty providing nourishment sand to this site. It may be possible at a very low tide and low wave energy day to get a tracked vehicle along the beach and dump sand into the blowout entrance. This option is not without considerable risk. The other option is to create a track across the native vegetation from the coast road to the blowout and then deliver sand to the entrance via that route. This option will have impacts on native vegetation. However, if waves break through into the blowout and then down across the dune system and into the Pool, the native vegetation will be severely impacted and likely killed, so a short term track, later rehabilitated, is likely a lesser impact option.
