WATTLE RANGE COUNCIL

Rivoli Bay Study

301015-03541 – 001

26 Oct 2015

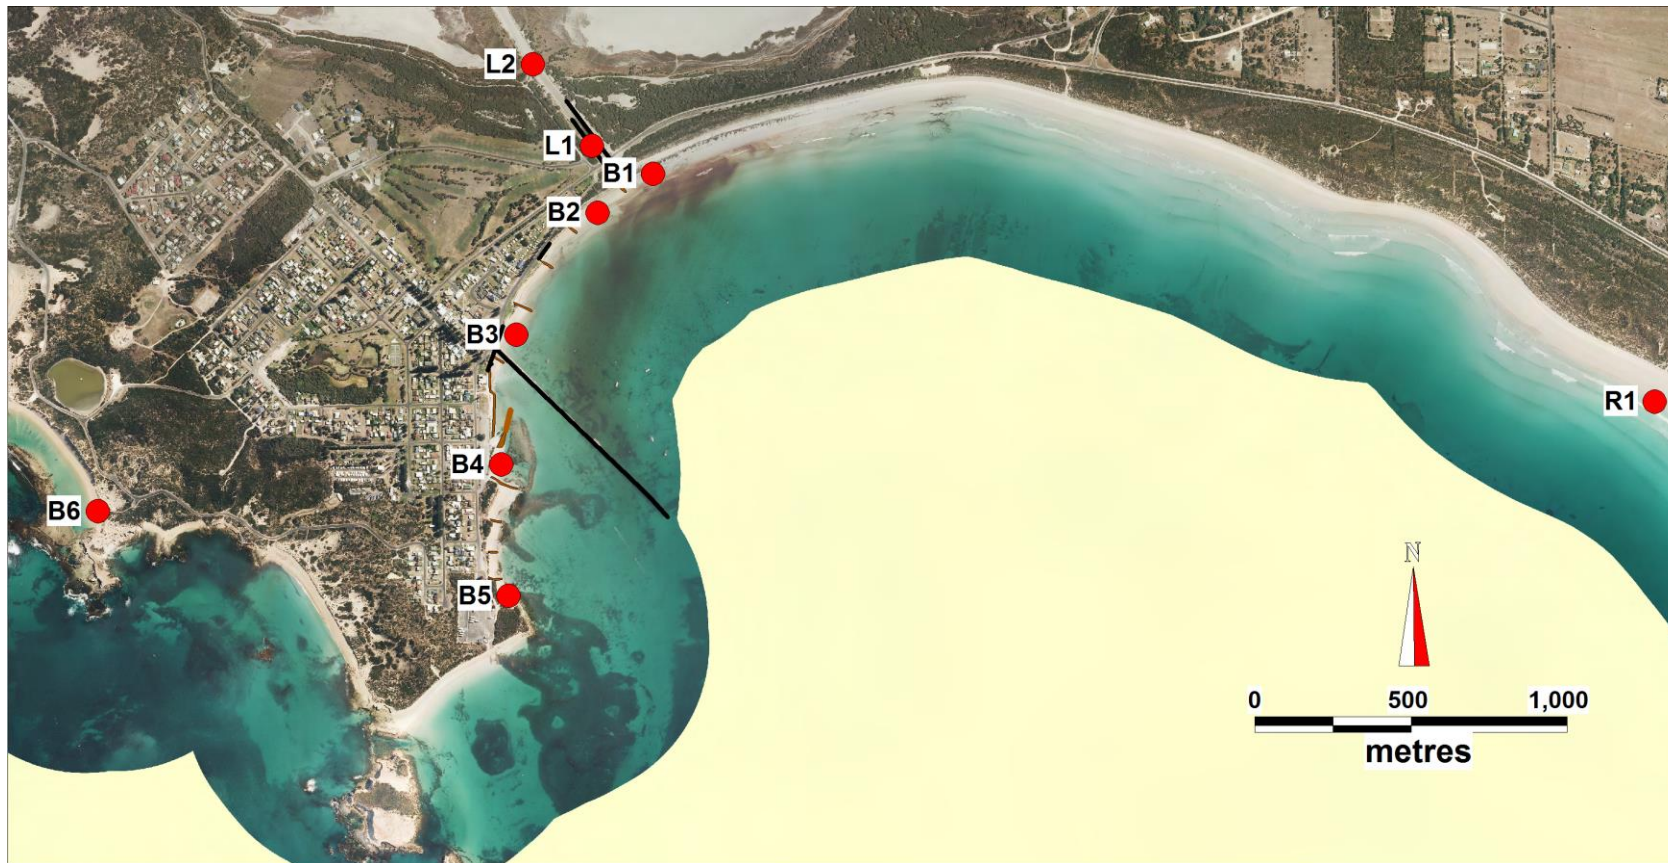
Figure 8 – Beachport sediment sampling locations

- Sample R1 near the centre of Rivoli Bay was also very similar in composition to the sand found along the Beachport foreshore;
- Sample B5 was finer than the sand at the other locations west of Lake George, possibly as a result of this location being more sheltered than other locations along the beach, allowing finer sediment to settle on the beach rather than being carried downdrift by wave-driven currents;

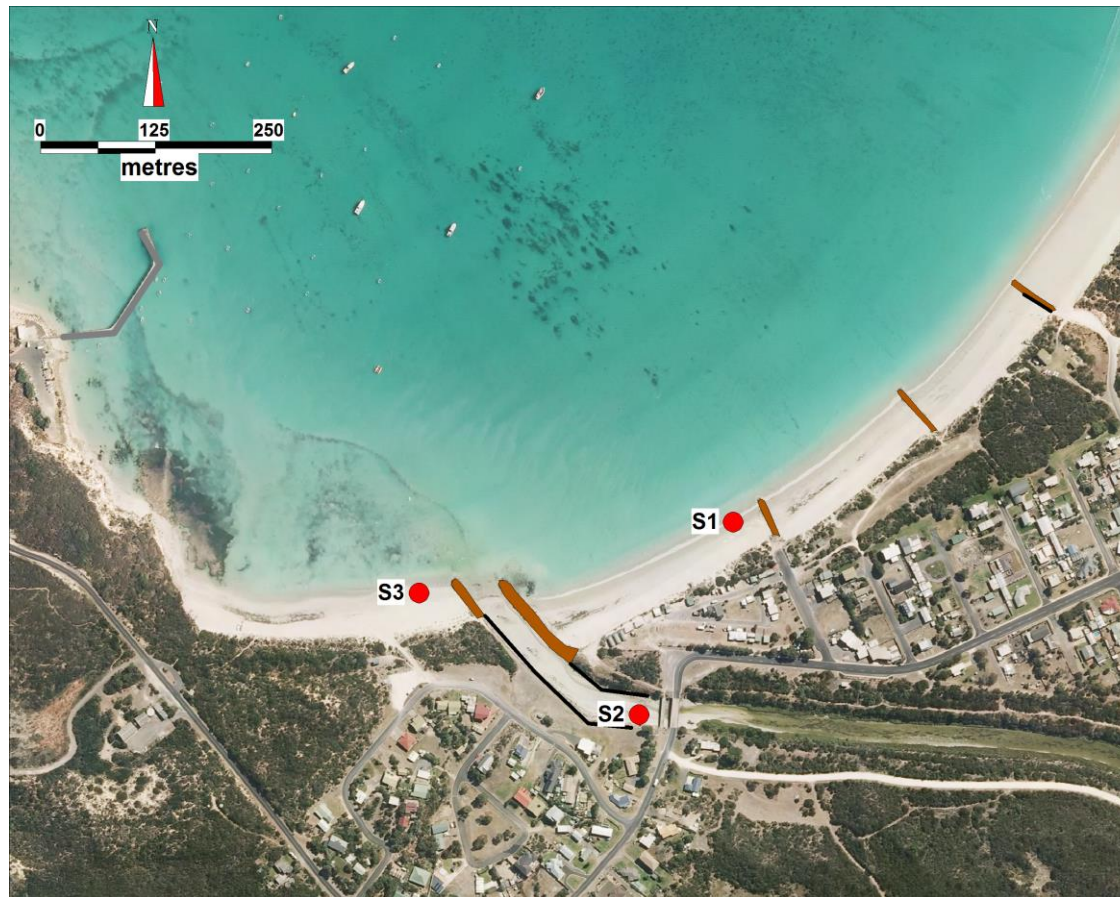
Figure 9 – Southend sediment sampling locations

- Sample S3 was coarser than Sample S1 and S2 and very similar to the sand in Beachport and at the centre of Rivoli Bay, indicating that the finer fraction was being drawn into the Lake and being more actively transported by the erosion process occurring at this location.

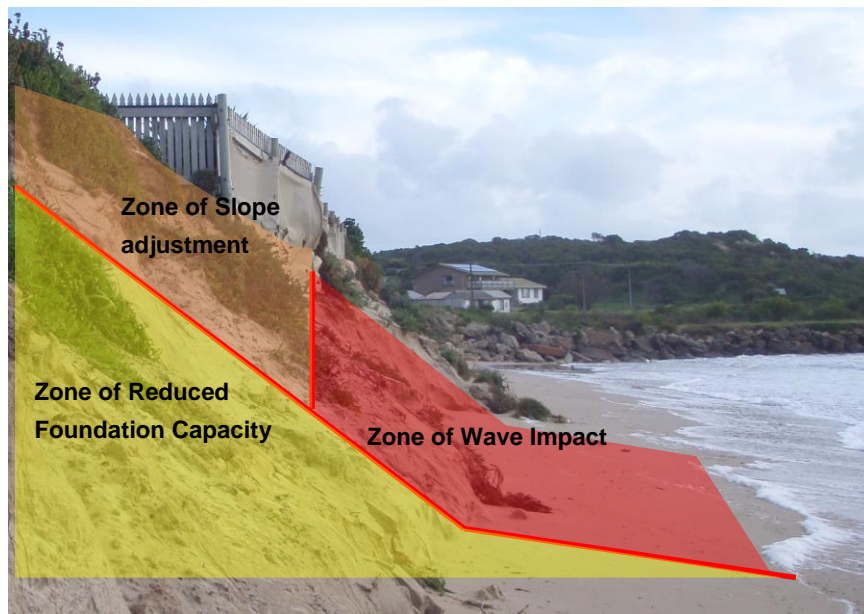
Figure 13 – Example of the application of the dune erosion hazard zones at Southend (June 2014)

An illustrative example of how the dune erosion hazard zones would apply is provided in Figure 13, for an area where there was a steep erosion escarpment where infrastructure was considered to be at risk at Southend following the June 2014 storms, immediately east of the outlet to Lake Frome.

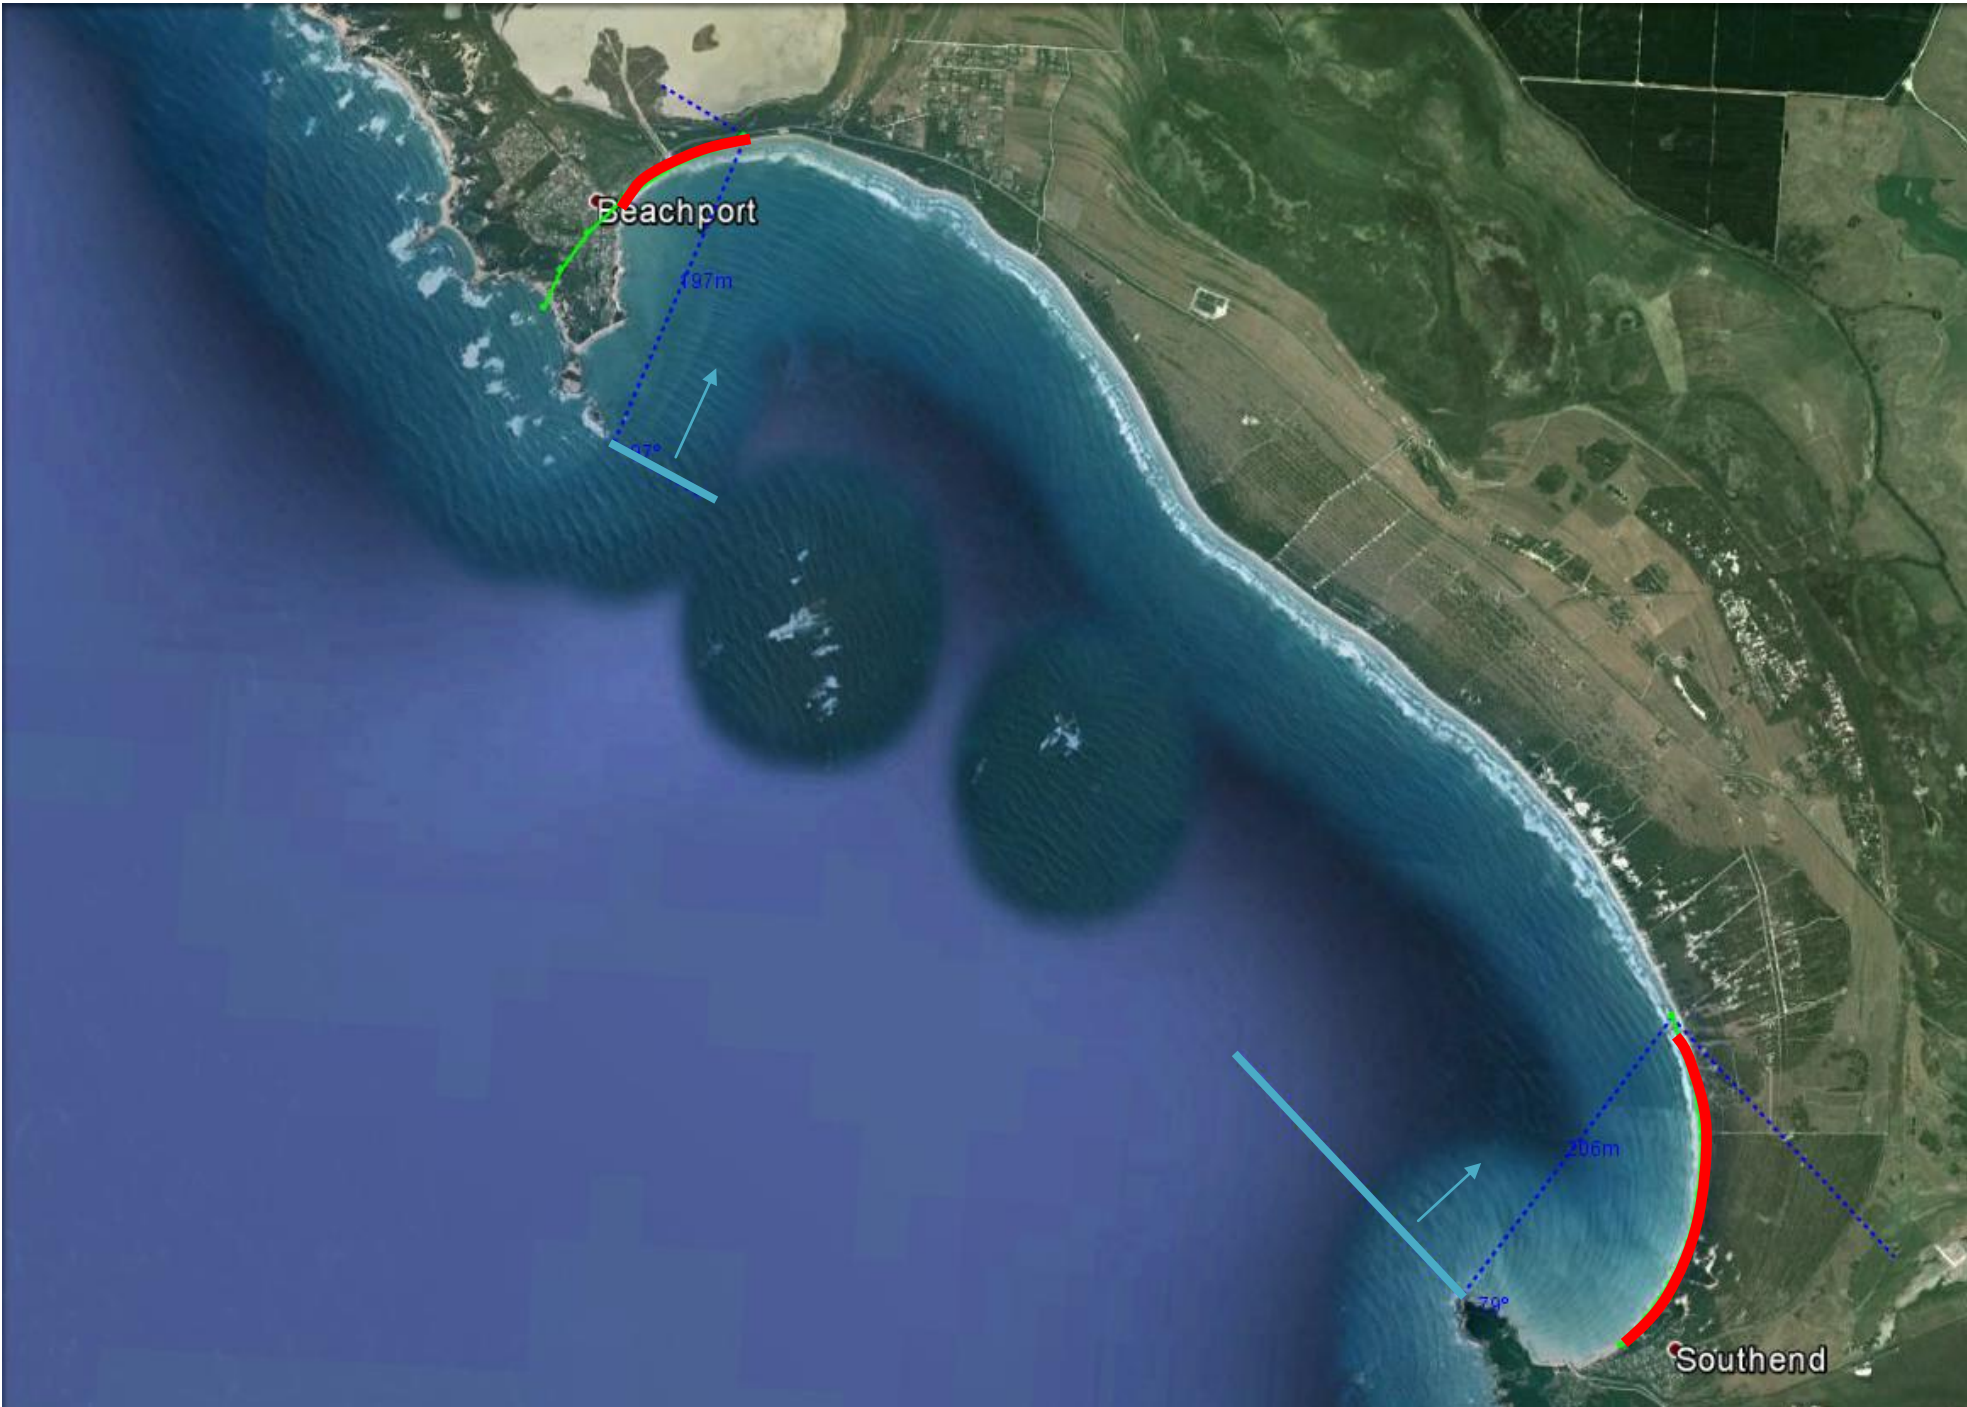
Figure 14 – MEP-BAY calculated shoreline alignment (shown in red) with indicated wave angles, Beachport and Southend

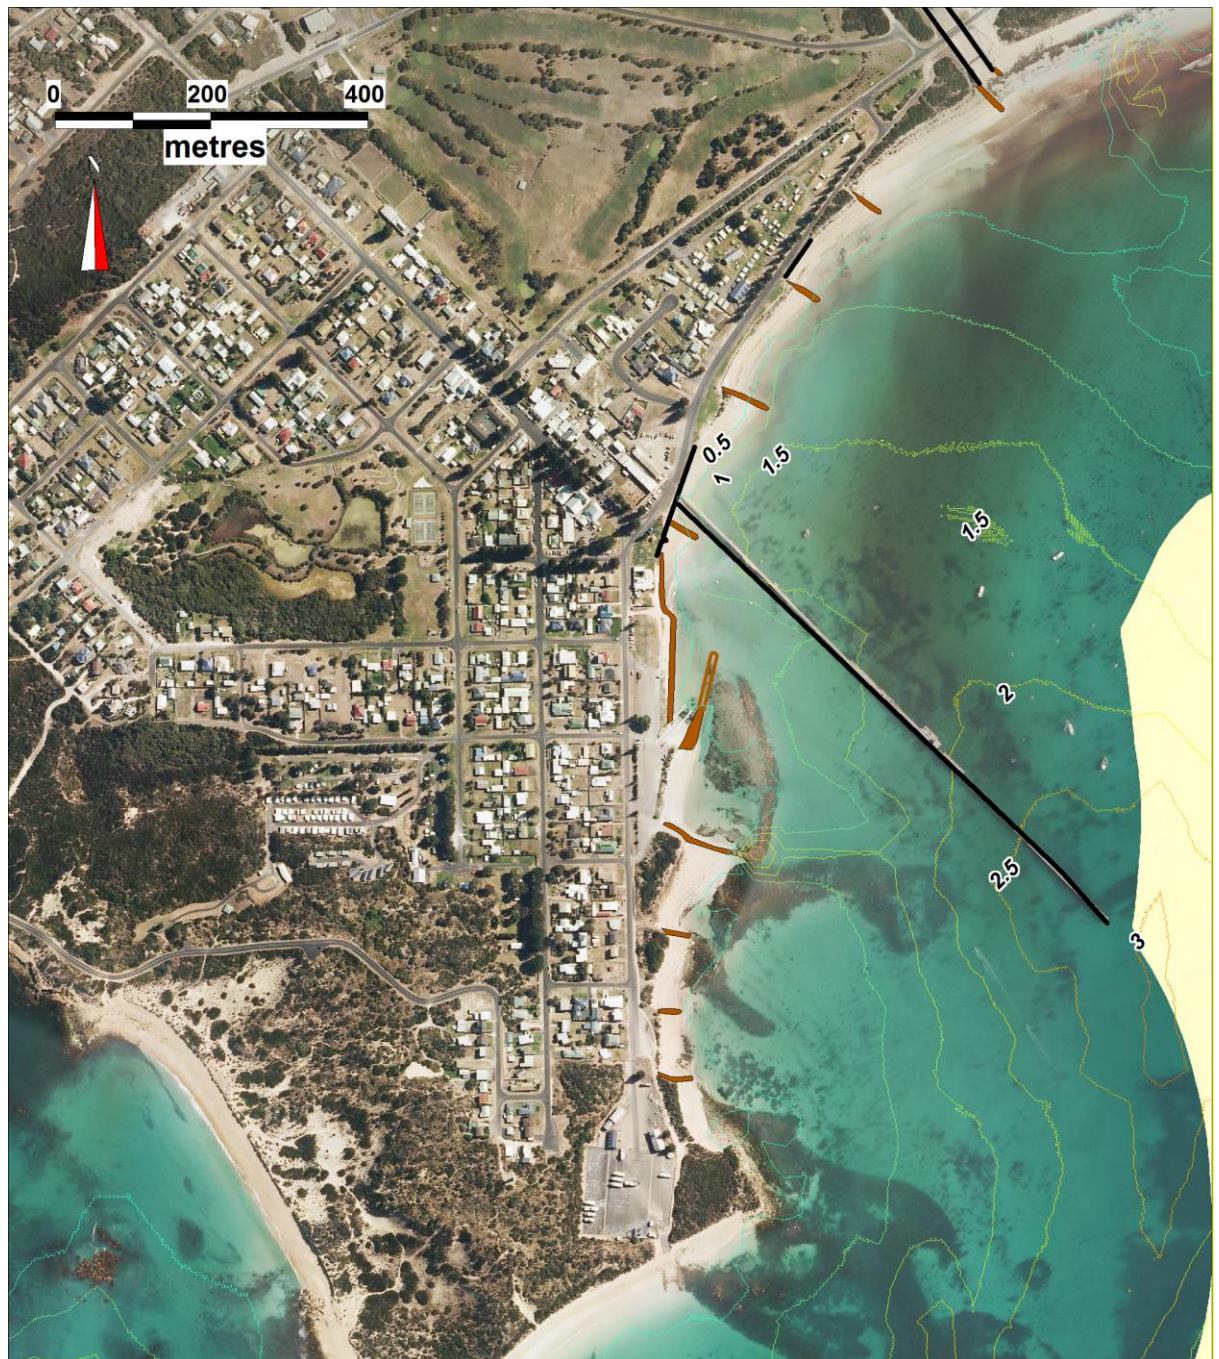
Figure 15 - SWAN calculated change in nearshore wave angle at Beachport should offshore wave angle change by 5°

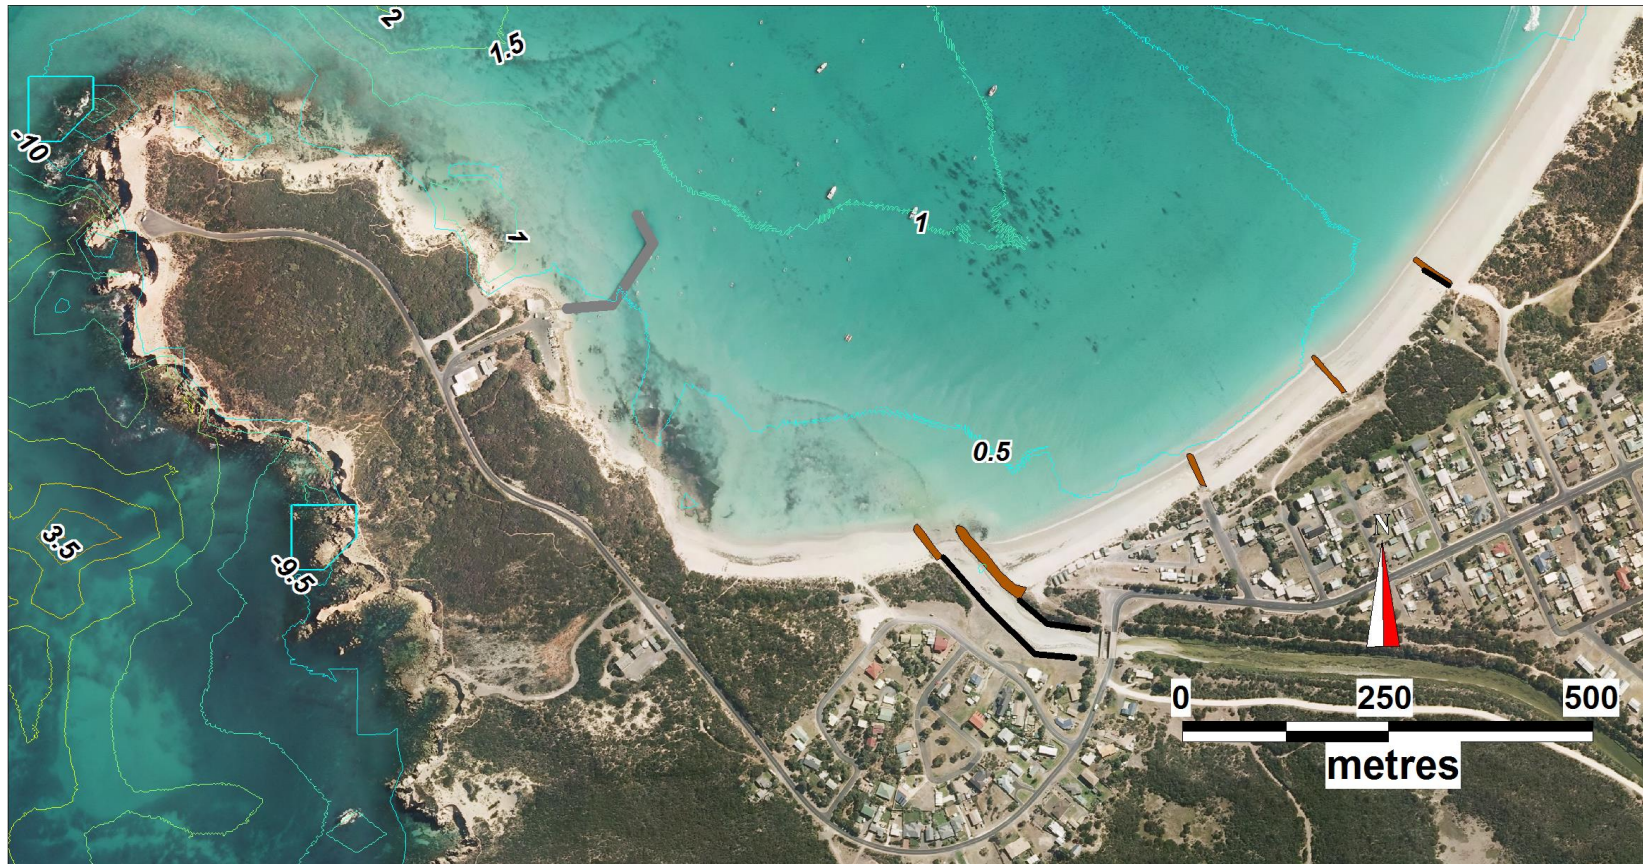
Figure 16 - SWAN calculated change in nearshore wave angle at Southend should offshore wave angle change by 5°

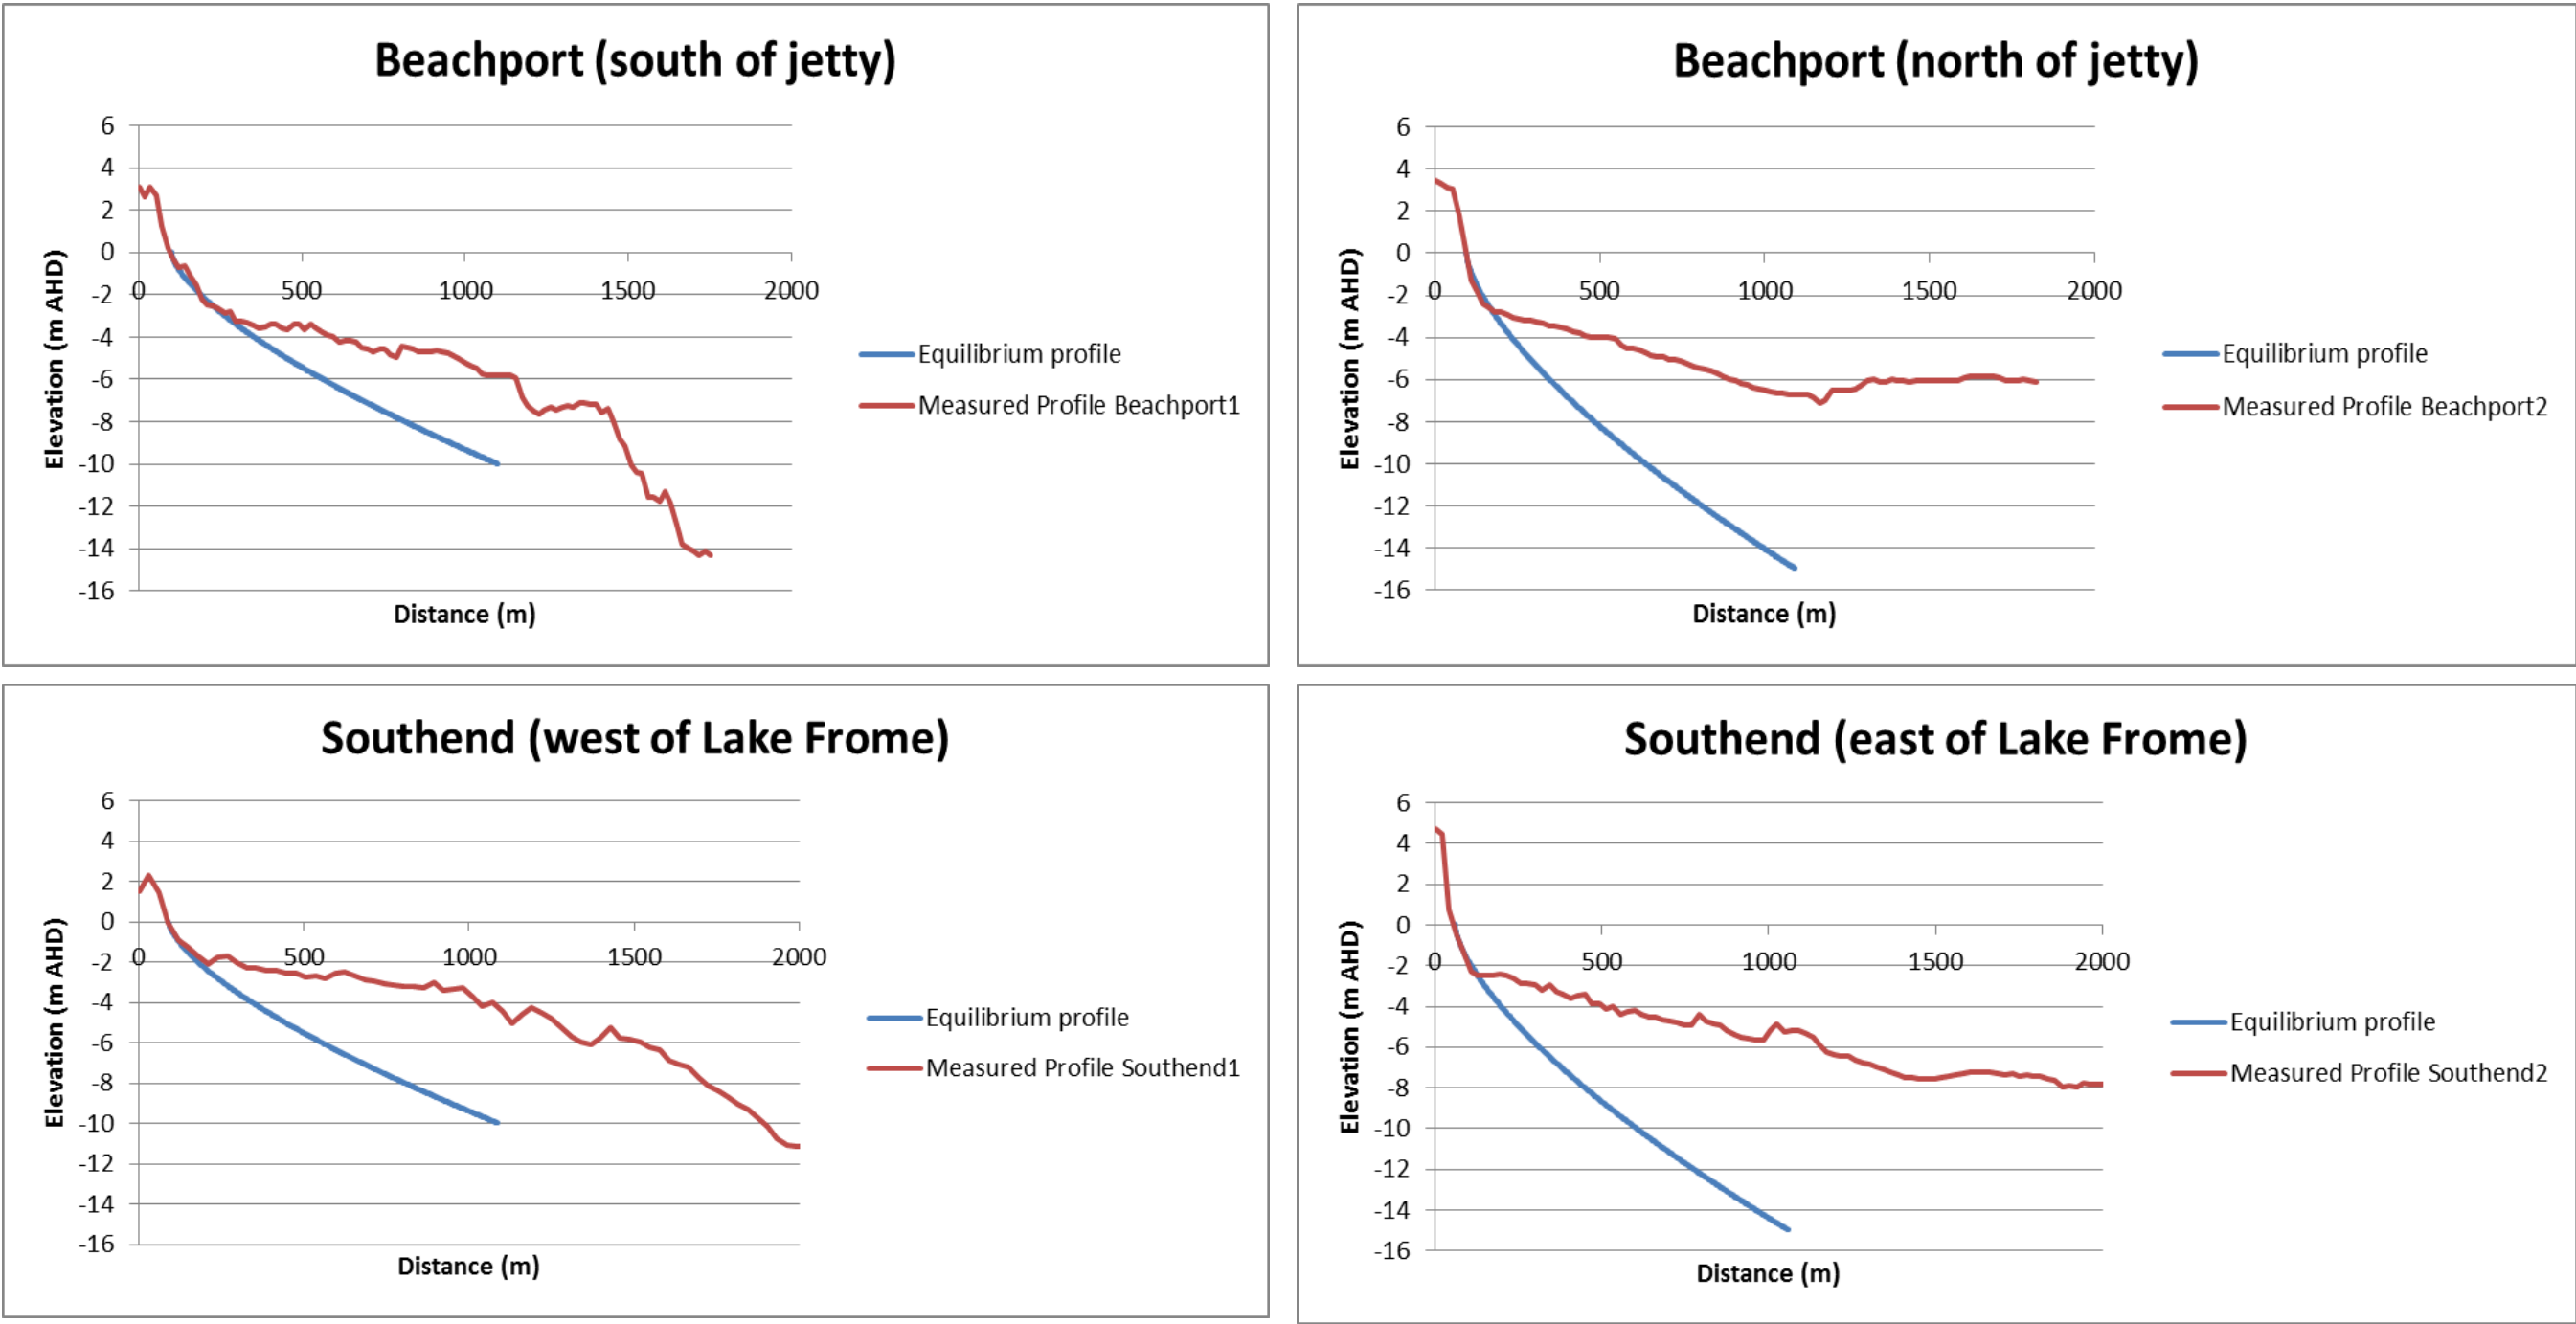
Figure 20 – Measured vs. equilibrium beach profiles at Beachport and Southend. Note the presence of significant quantities of nearshore sand, indicating continuing onshore transport over geological time scales.

As the application of the Bruun Rule is limited to the portion of the profile in equilibrium, the Bruun Rule cannot be applied to the beach at Southend or Beachport as the beach does not conform with the assumptions of the Bruun Rule. It should be noted that the dominant mechanism of sediment transport into the Beachport area is longshore sediment transport which would be expected to continue under sea level rise and that the Bruun Rule schematises the beach response to sea level rise purely as a cross-shore process. In addition, the beaches are stabilised by a series of groynes and seawalls in some locations, so long term recession in Rivoli Bay due to sea level rise is unlikely to occur. It should be noted, however, that recession has been observed along parts of the Beachport and Southend foreshores, with the Coastal Protection Board observing a general erosive trend along the Southend foreshore heading north around the bay for 1 – 2 km. Areas that have suffered long term recession include those areas downdrift of the groynes at the outlet to Lake Frome, the areas in front of the Beachport jetty which have suffered due to the impact of reflections from the vertical seawall, and areas where the bathymetric profile has deepened due to loss of seagrasses.

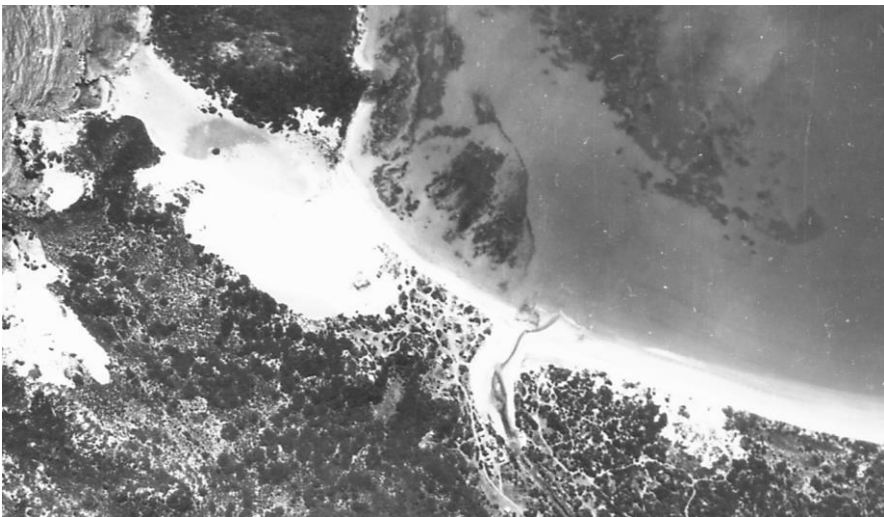
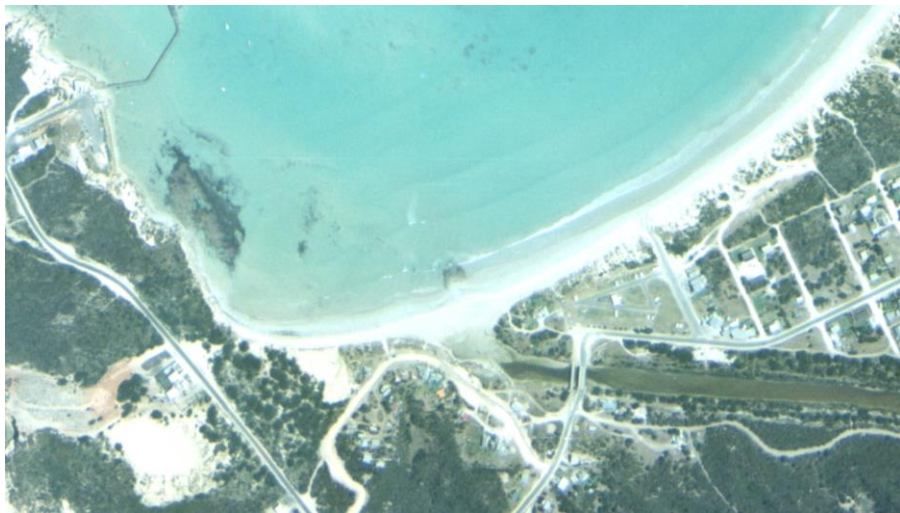
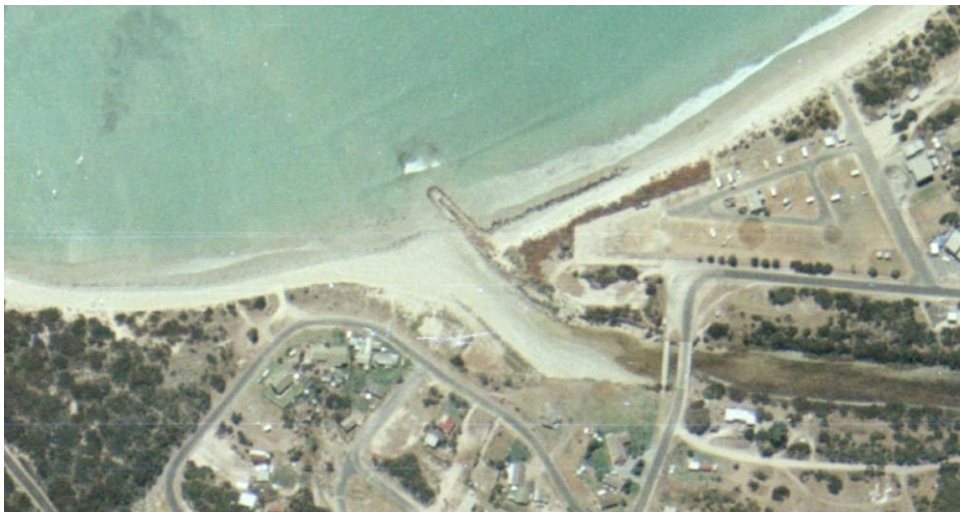
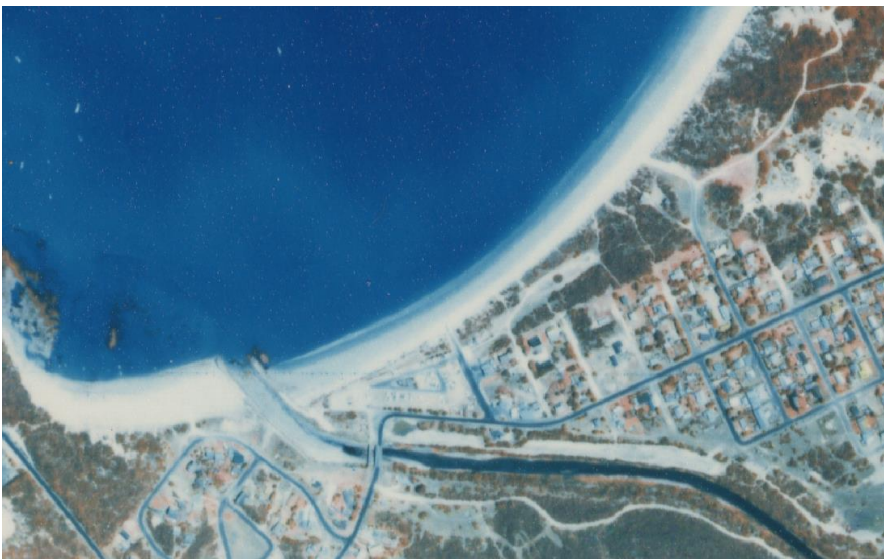
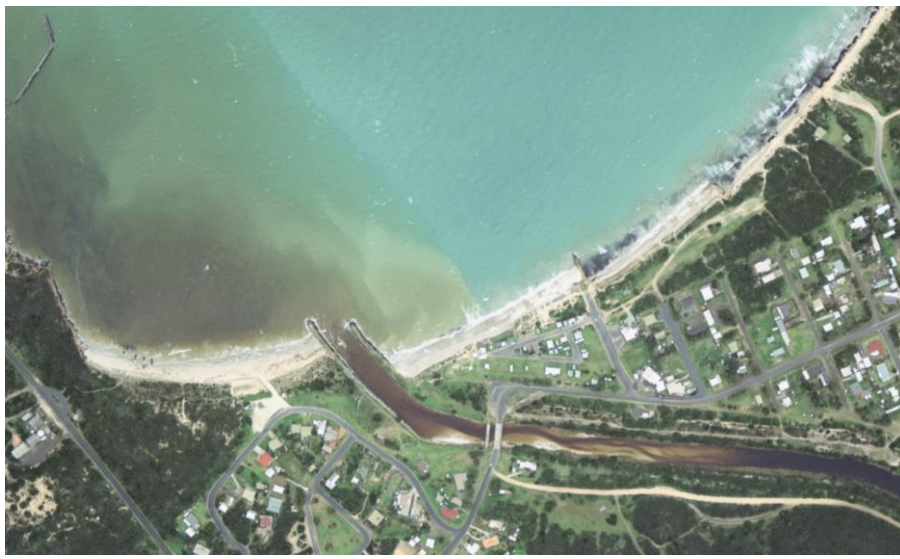
Historical aerial photography of Southend is shown in Figure 33.

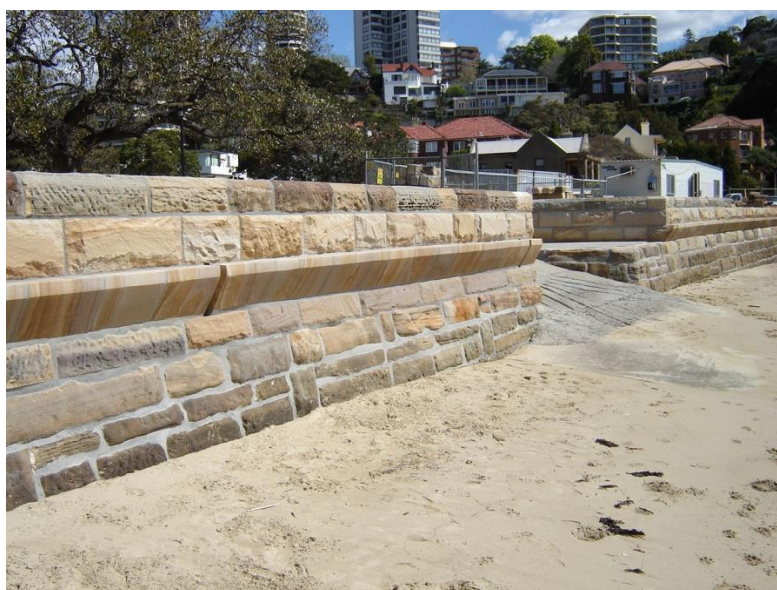
Figure 41 – Rigid near-vertical sandstone gravity wall.

The crest level for this site is up to approximately 4.0 m AHD. Therefore the structure for this site could be up to 4 to 6 m high with consideration to the design scour level of -2 m.

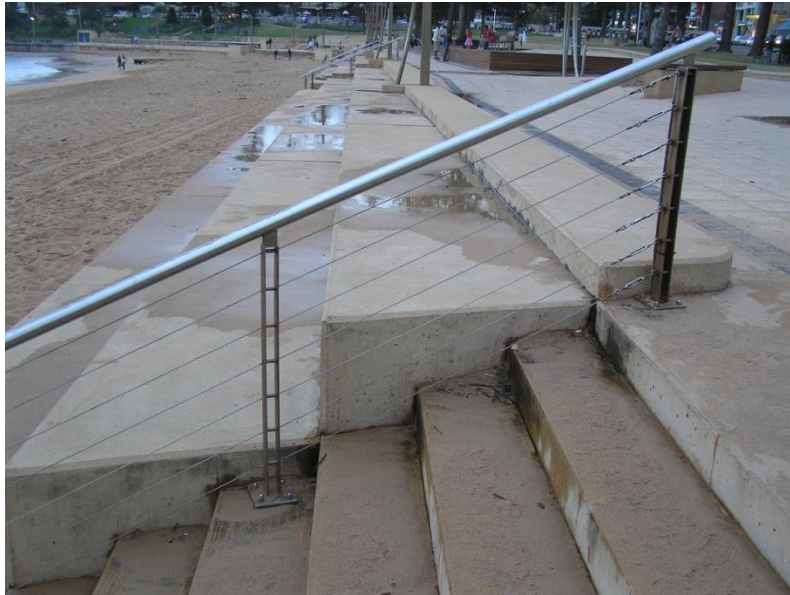
Figure 42 –Rigid stepped concrete gravity wall.

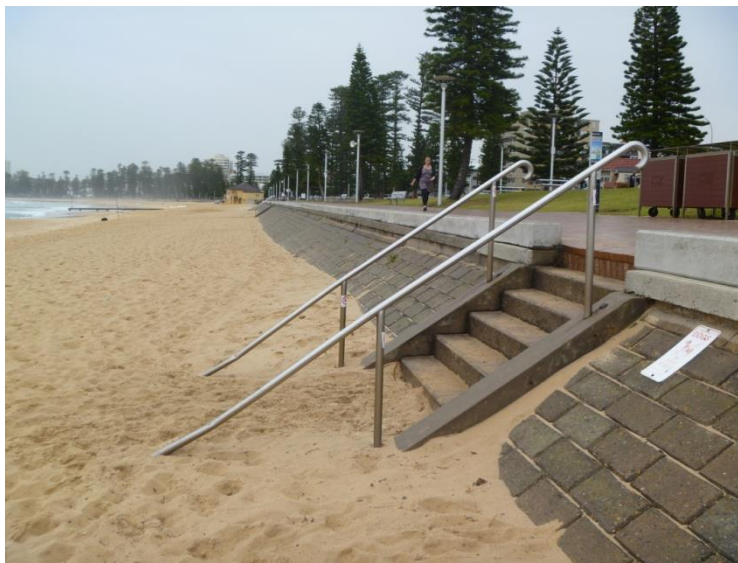
Figure 43 –Promenade and rigid sloping revetment with access stairs.

Rigid sloping revetments with a wave return wall can be considered for the site. However, a semi-rigid sloping pattern-placed unit revetment is likely to be more suitable because it can dissipate wave energy and can tolerate some movement or displacement without total collapse.

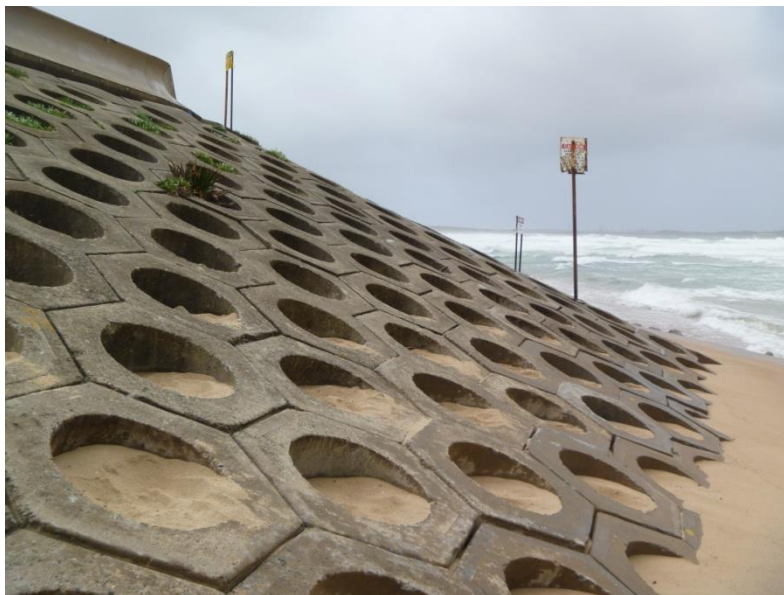
Figure 44 –Example of Seabee seawall.

Sloping pattern-placed unit revetments with a wave return wall can be considered for the site.

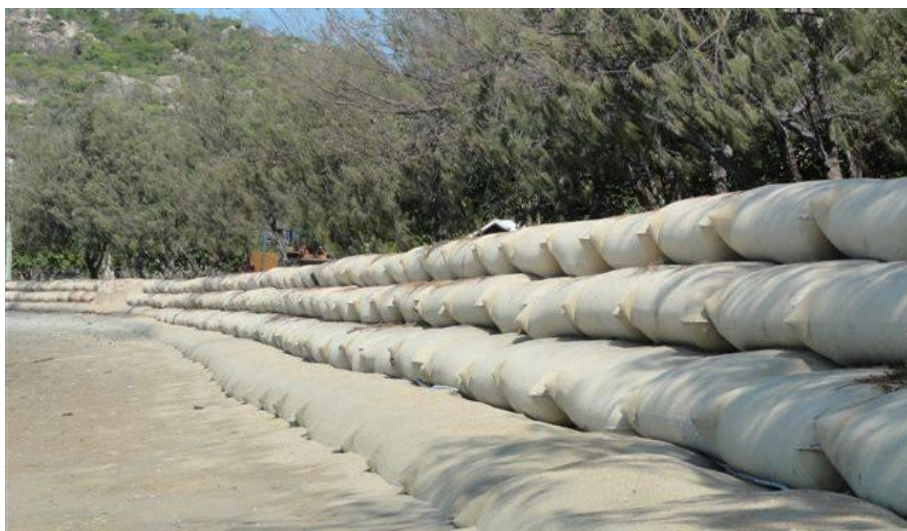
Figure 45 – Sandbag gravity seawall (source: Geofabrics Australasia)

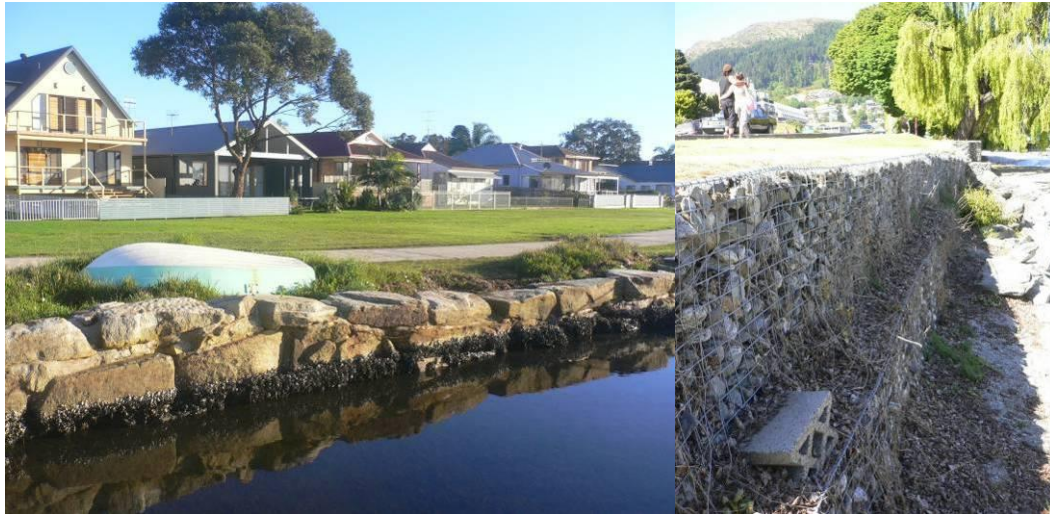
Figure 46 – Left: Rock boulder gravity seawall; Right: Gabion gravity seawall

Flexible near-vertical rock gravity structures can be considered for this site.

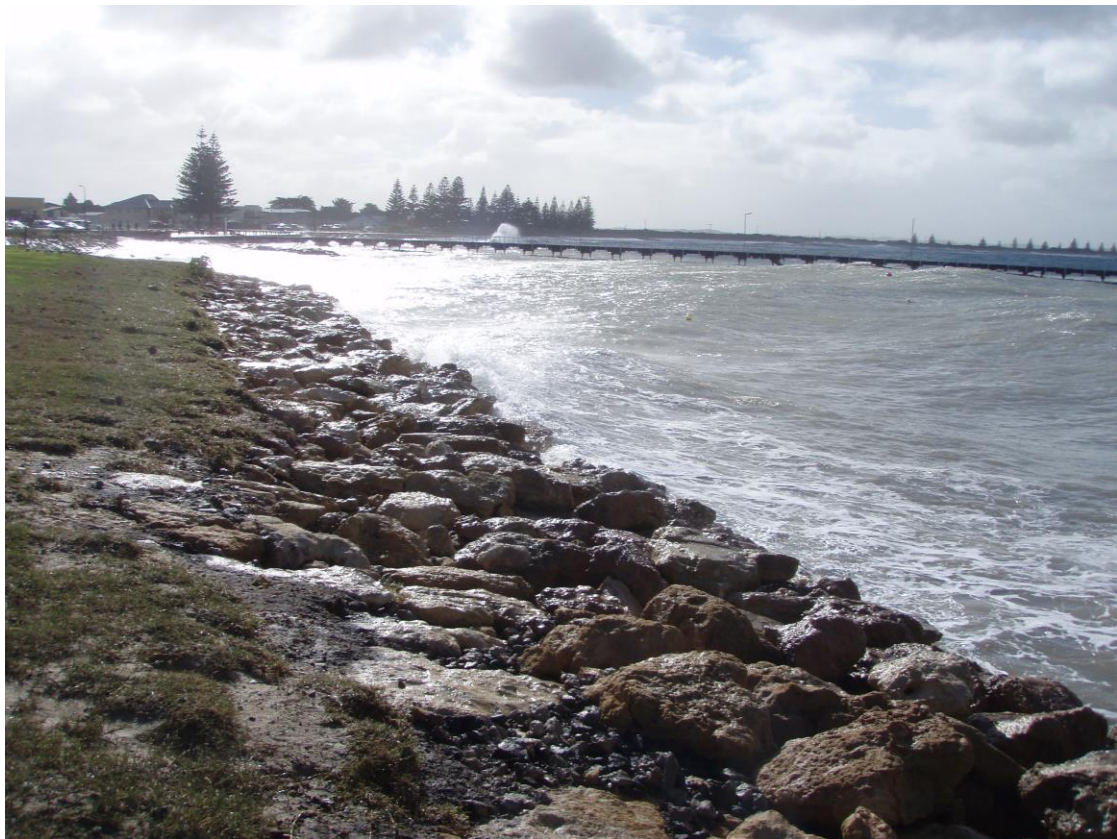
Figure 47 – Existing rock revetment south of Beachport jetty

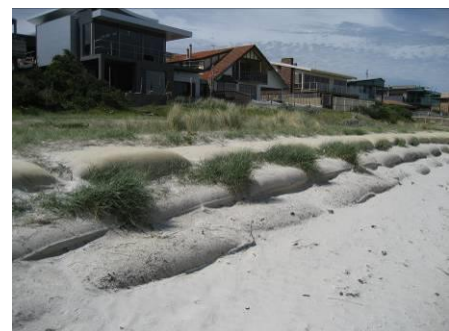
Figure 48 – Sandbag revetment (source: Geofabrics Australasia)

Sloping sandbag revetments are being used increasingly on beachfronts. Sandbags are mainly for wave climates with significant wave height of less than 2.5 m and therefore would not be suitable for this site except if used as emergency protection works.

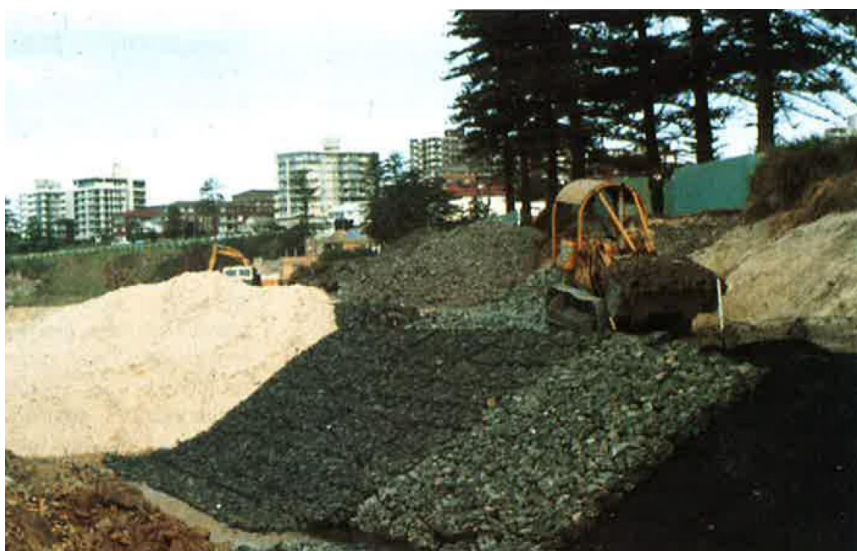
Figure 49 – Left: Sloping Reno-mattress revetment under construction (Source: NSW Gov., 1990).

Reno mattress systems units are not recommended for the ocean coast as the coatings and casings for the units could easily be damaged and lead to catastrophic failure.

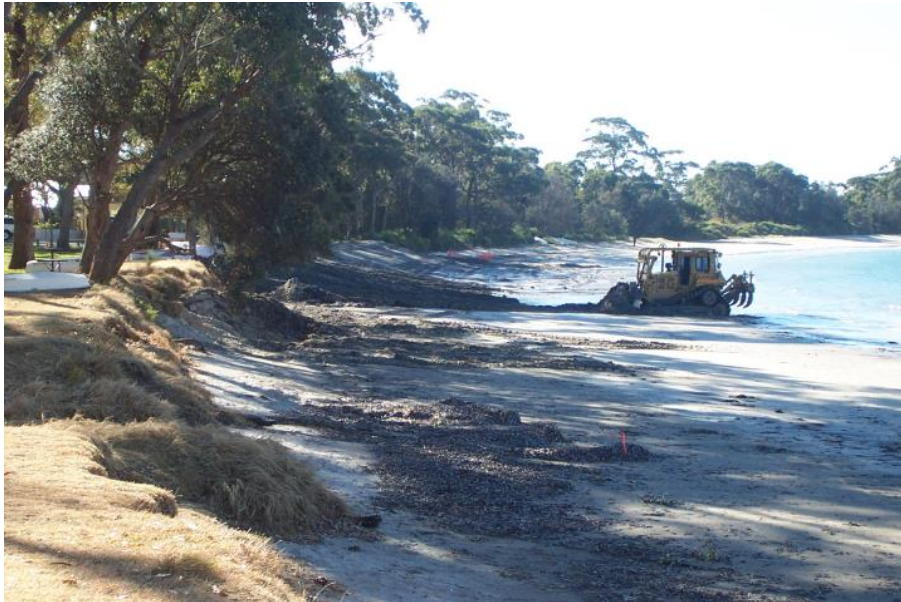
Figure 51 – Example of beach scraping of sand against eroded dune escarpment
