Southend adaptation strategy

Report prepared for Wattle Range Council

27 March 2018

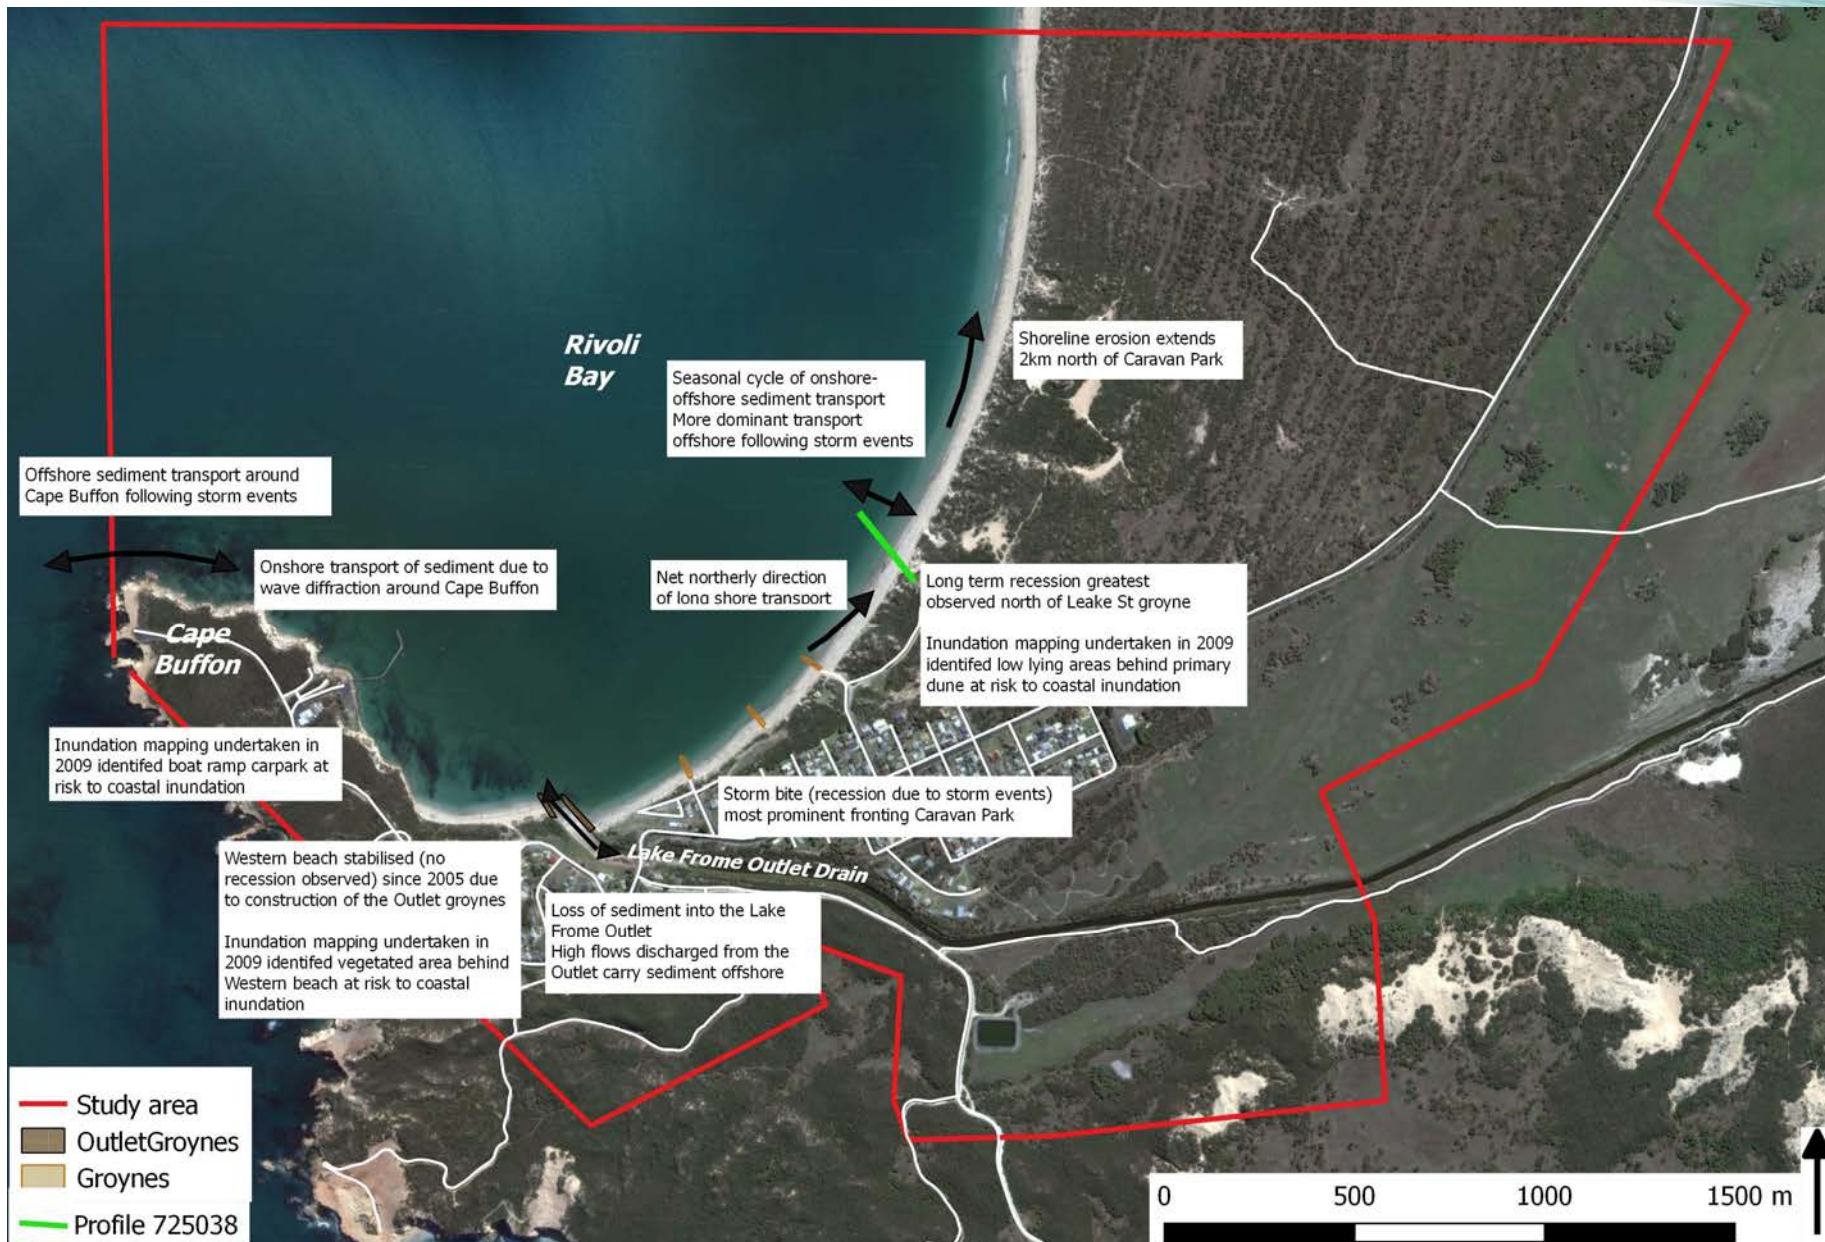
Figure 3: Overview of coastal processes and coastal management issues

- The zone of erosion extends 2kms east from the Caravan Park (Fotheringham, 1984). This is further supported in the review of the cross-shore profiles with recession observed in all profiles north of the groynes over the recorded periods. The greatest rate of recession observed is at profile 725038 (location shown in Figure 3) of 20m over a 15 year period (2002 – 2017).

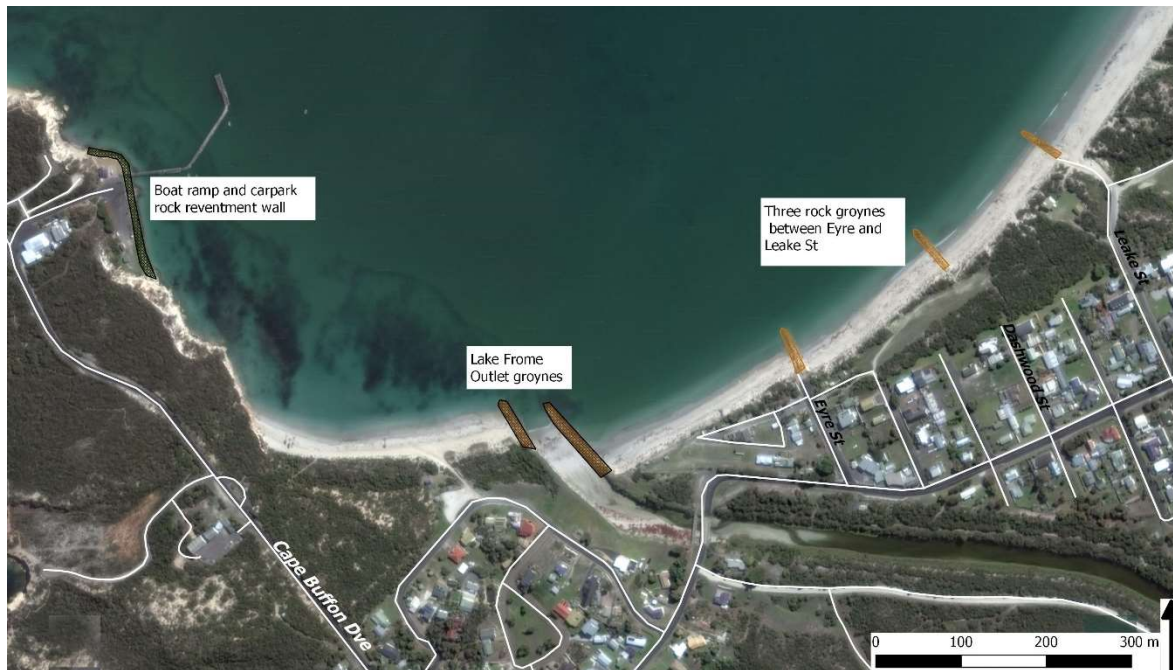
Figure 4: Coastal protection structure location map

- Boat ramp carpark rock revetment wall
- Lake Frome Outlet groynes
- Three rock groynes between Eyre St and Leake St

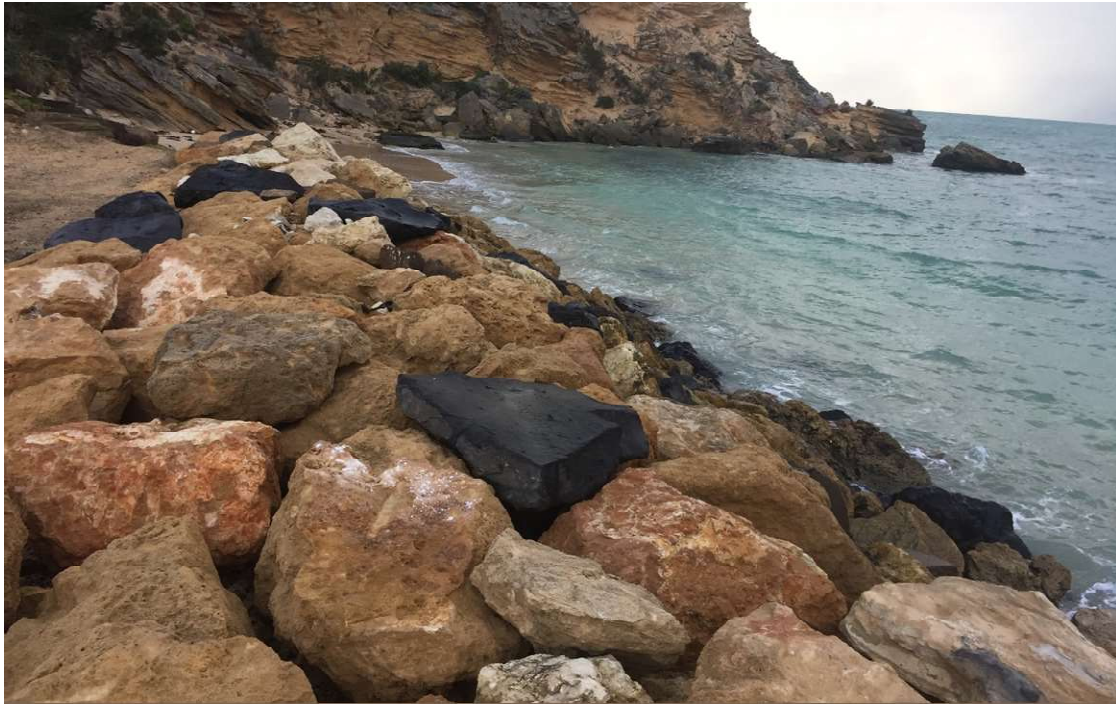
Figure 5: Northern revetment (directly north of jetty)

The revetment wall immediately surrounding the jetty is in good condition, and appears to include a mix of basalt and limestone armour rock (Figure 5). The revetment north of the boat ramp is subject to direct wave attack diffracted around Cape Buffon, whilst the eastern facing wall is subject to oblique waves (Worley Parsons, 2015). The revetment is overtopped during storm events, with evidence of dislodged small armour stones and gravel thrown into the carpark.

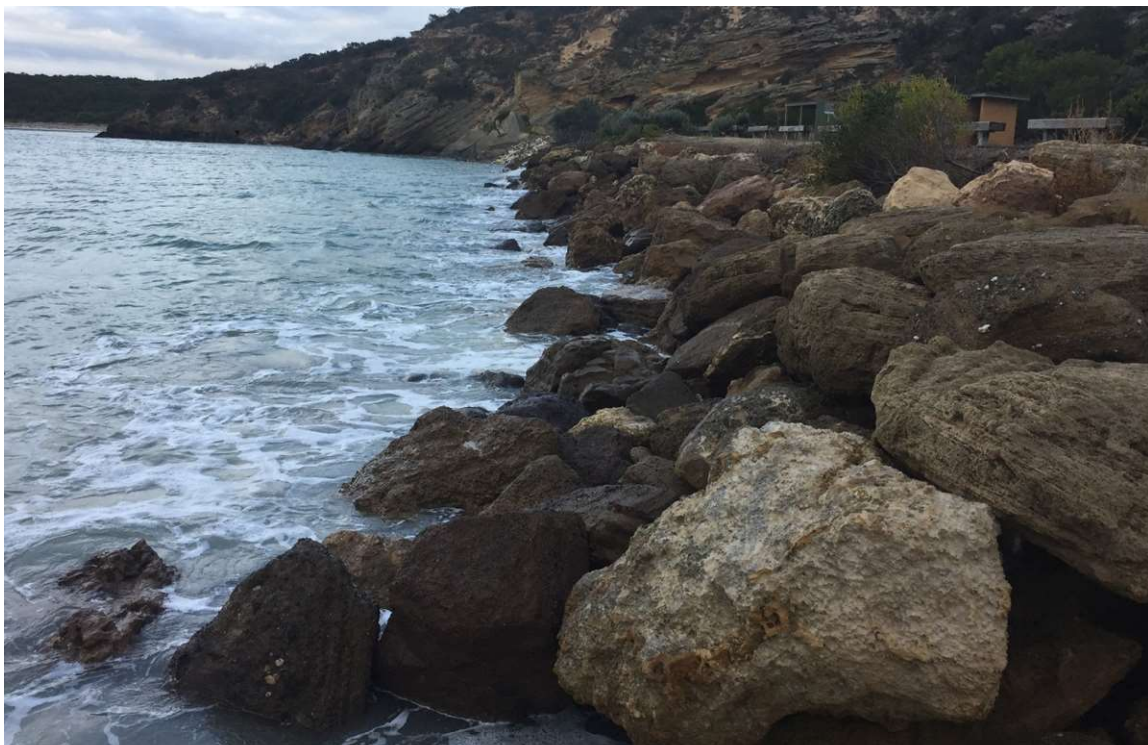
Figure 6: Southern revetment (directly south of boat ramp)

The revetment south of the boat ramp is constructed of limestone and is in poor condition (Figure 6), with the underlying fill material exposed and subject to erosion from wave overtopping. At the southern end of the revetment, rock armour has been replaced in an ad-hoc fashion with concrete and building rubble (Figure 7).

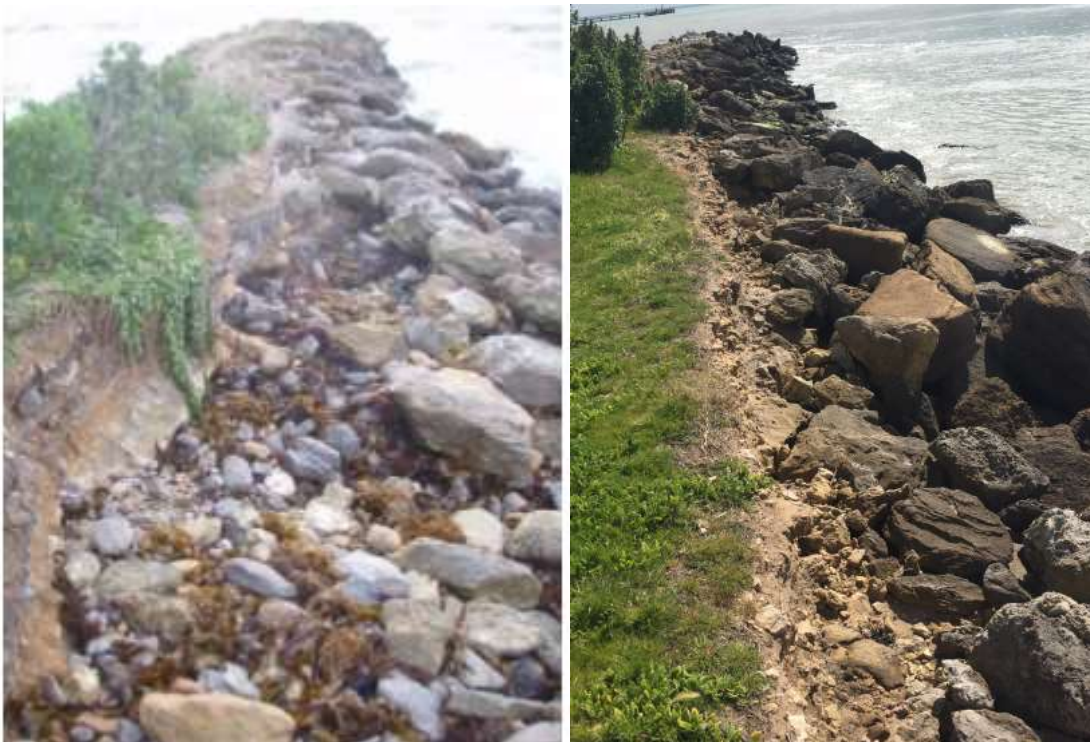
- Damaged and slumping rock armour observed at both the eastern and western groynes;
- The primary rock armour is limestone, with large areas of exposed core rock at both groynes;
- Exposed clay cap at both groynes, the 2015 inspection reported the clay core and capping of the eastern groyne was severely eroded especially on the more exposed northern side of the groyne (Figure 8), remedial works (additional rock placement) was evident in the 2017 site inspection (Figure 8);
- Ad-hoc repairs to groynes with concrete and building rubble has been carried out (Figure 9).

Figure 8: Left - Severe damage reported in 2015, eastern side of eastern Outlet groyne (Source: Worley Parsons, 2015) Right – remedial works as observed during 2017 inspection

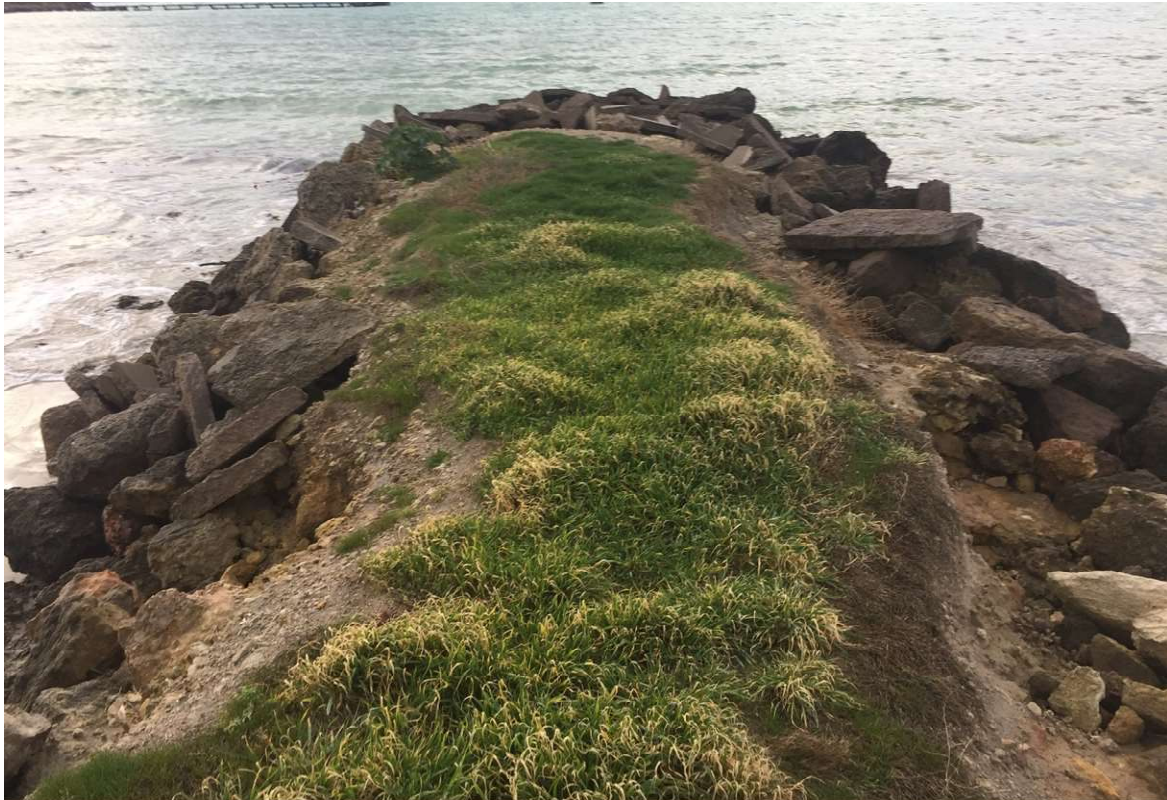
Figure 9: Western Outlet groyne. Note poor condition of clay capping and core, use of concrete rubble to repair damage

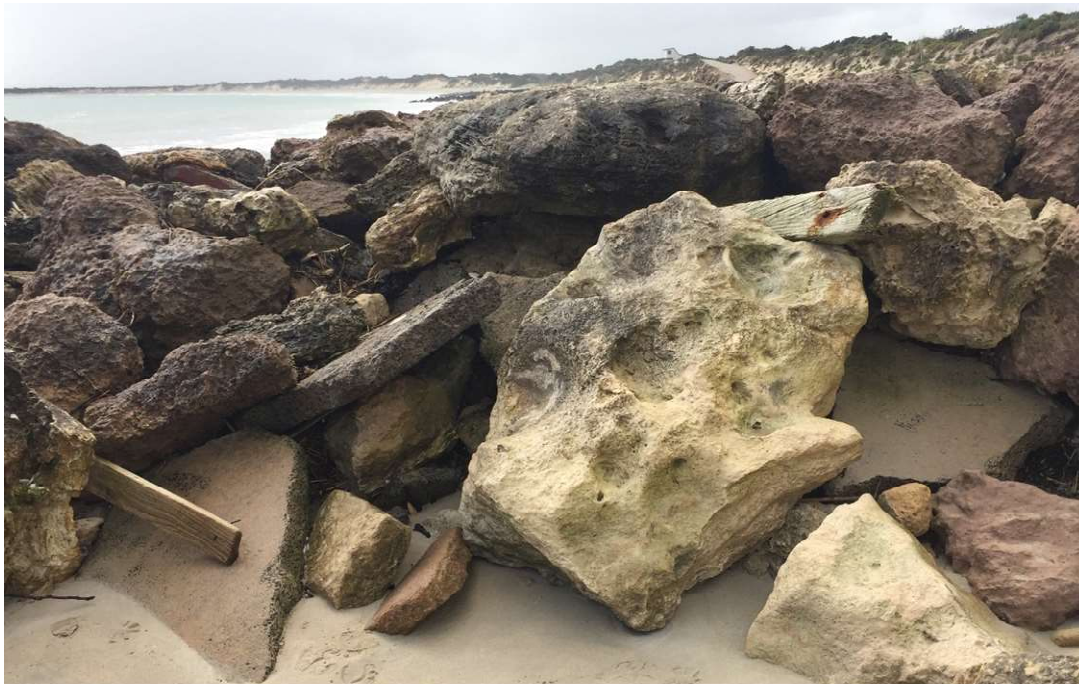
- Eyre St groyne is in reasonable condition, constructed of a mix of limestone and basalt armour, generally good interlocking between armour on the northern side and head of the groyne. Dislodged armour, exposed core armour and repairs with concrete rubble are evident on the southern side (Figure 10).

Figure 10: Dislodged armour, concrete rubble – southern side of Eyre St groyne

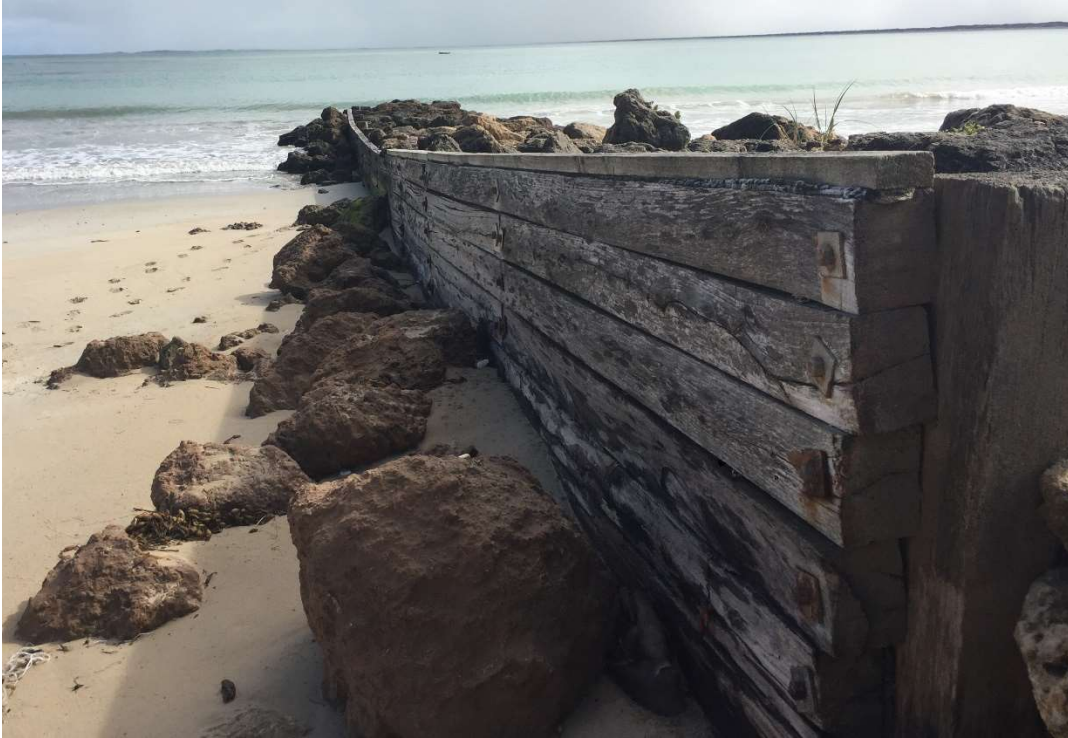
- Dashwood St groyne is constructed of limestone primary armour, and bounded on the southern side by a vertical timber face. The groyne is in good condition, although smaller armour stones are exposed and some dislodged and deposited on the southern side of the groyne (Figure 11).

Figure 11: Dashwood St groyne, dislodged armour on southern side

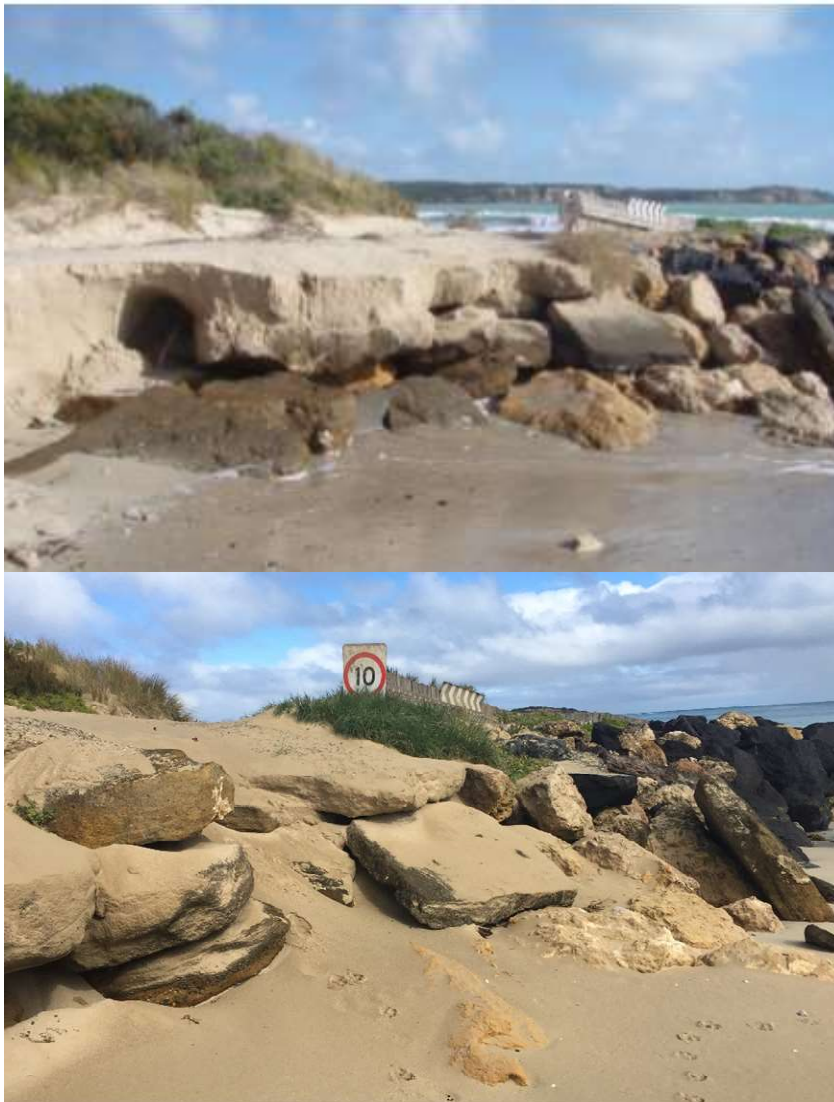
- Leake St groyne is constructed of basalt rock armour, bounded on the southern side by a timber wall. The groyne is in fair condition, and remedial works appear to have been undertaken since the 2015 condition assessment report undertaken by Worley Parsons. Limestone rock armour has been placed on the landward end of the northern side of the groyne where severe erosion and undermining was previously observed (Figure 12).

Figure 12: Remedial works at the landward end of northern side of Leake St groyne. (Top photo source Worley Parson, 2015).

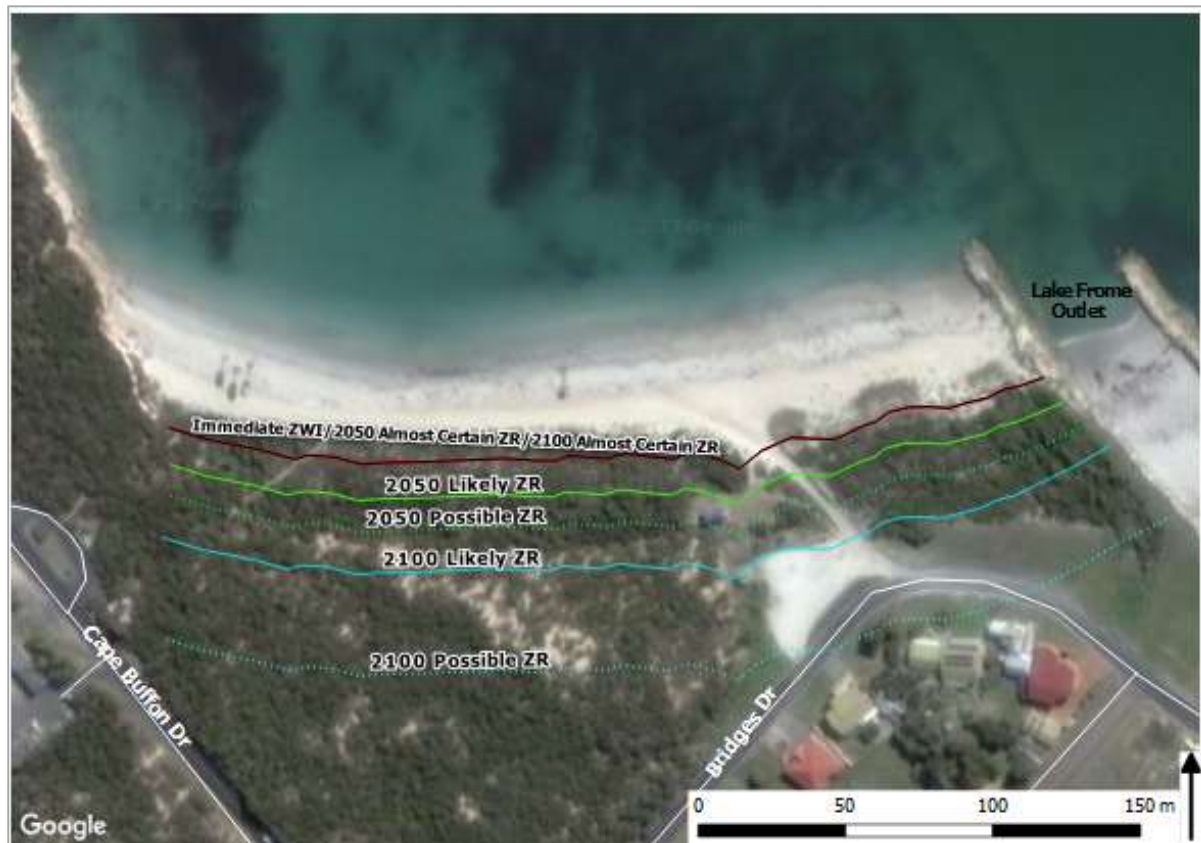
Figure 14: Coastal erosion hazard lines: Section 1

The immediate ZWI hazard line was positioned based on the potential storm erosion (S1), relative to the Horizontal Setback Datum (HSD). The future hazard lines for the 2050 and 2100 scenarios were estimated by taking the immediate ZWI hazard line (S1 component) and adding the underlying long-term recession (S2) and recession due to sea level rise (S3).

(Note: Coastal hazard Lines Immediate ZWI, 2050 Almost Certain ZR and 2100 Almost Certain are located in the same position)

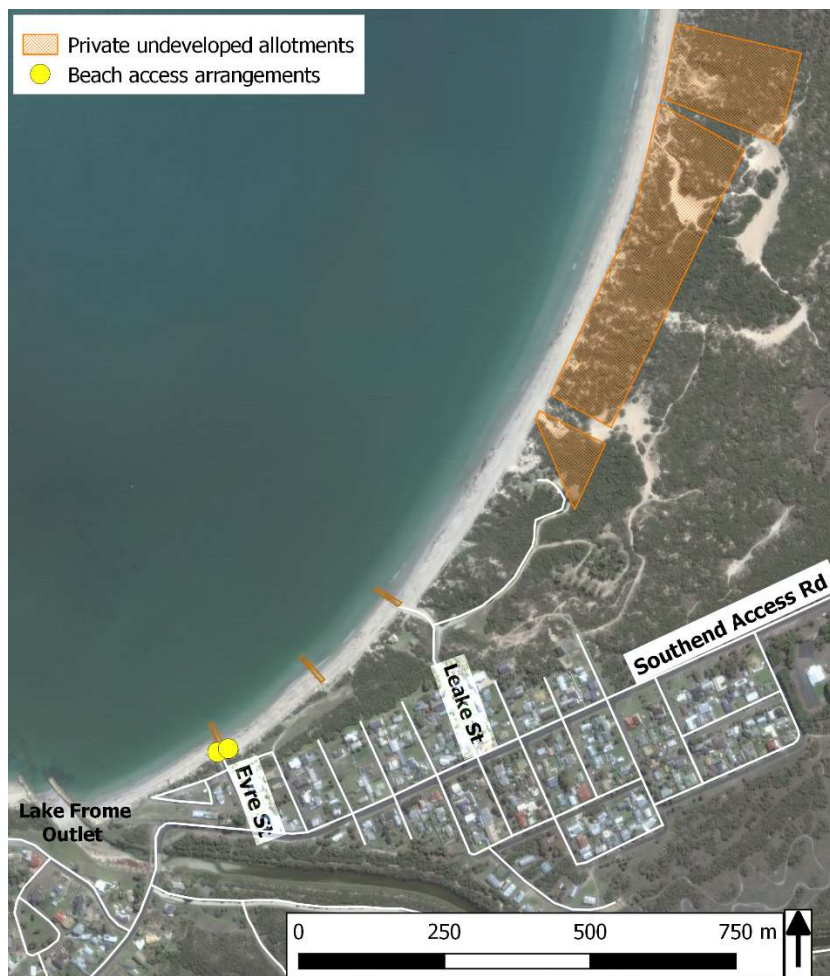
Figure 17: Assets at risk to coastal erosion or inundation (2017 Scenario)

- Immediate risks are identified for the two beach access arrangements either side of the Eyre St groyne due to storm damage.
- Three of the privately sold allotments within the coastal conservation areas north of Leake St are at risk to short term erosion due to storm events (as shown in Figure 17), and the shoreward boundary of the parcels of land are currently exposed to wave action. The allotments are also at risk to coastal inundation. Given the path of egress is likely to allow the water to quickly dissipate, the inundation risk is considered to be very low, and the primary risk for these lots is related to erosion (medium risk).

- The low-lying land subdivided for sale between Southend Access Rd and the Lake Frome drain is currently at risk to inundation via flows from the drain. Without the boundary extents for the allotments it is difficult to determine the magnitude of the inundation risks, Council will need to provide boundary extents for the parcels of land for sale to confirm risks.

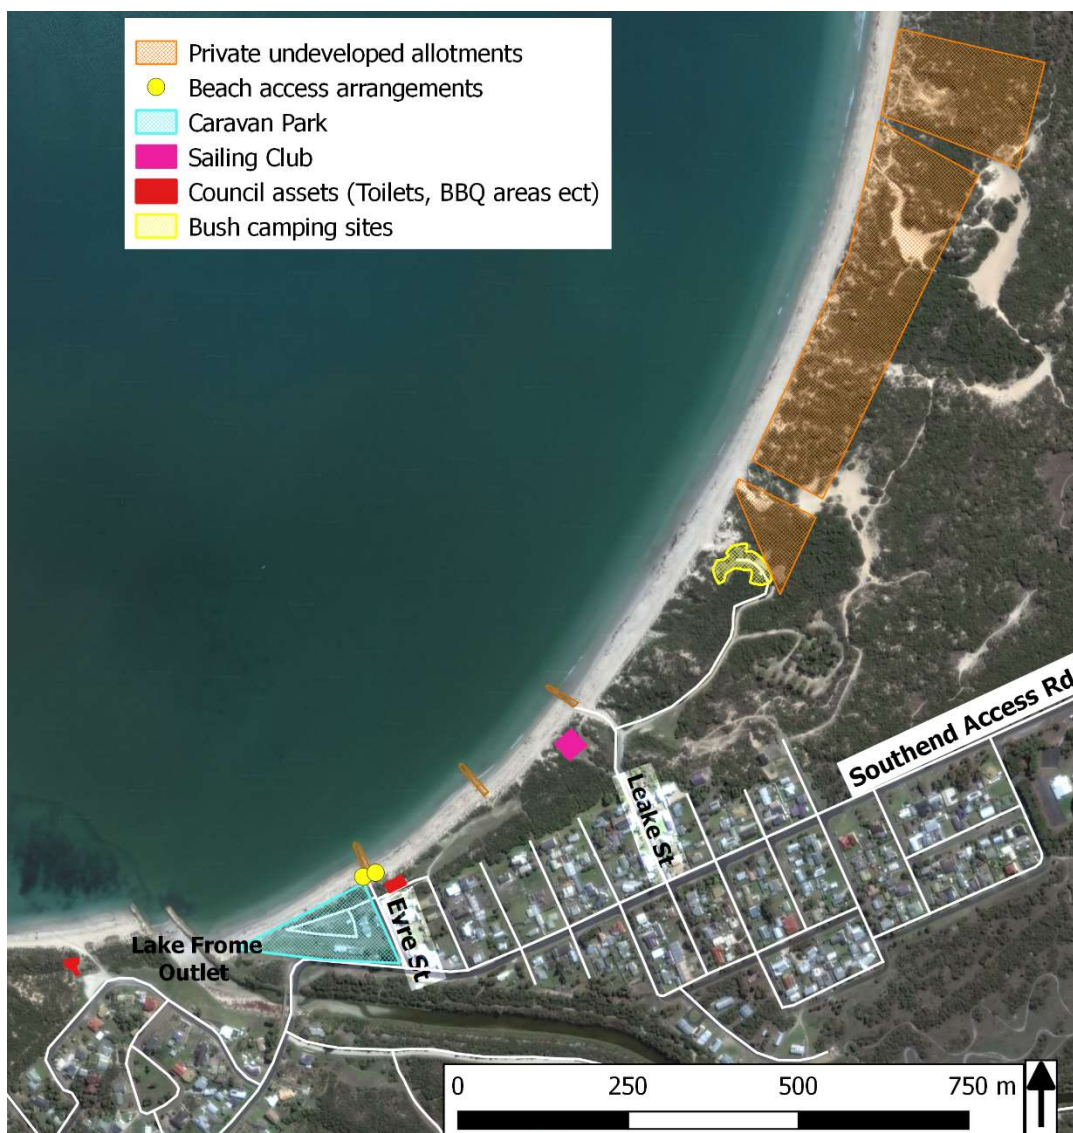
Figure 18: Assets at risk to coastal erosion or inundation (2050 Scenario)

The following assets would be at risk to coastal erosion for the 2050 scenario, if a “Do Nothing” approach was taken, location of assets at risk as shown in Figure 18:

- The foreshore reserve at Eyre St and related structures (toilet and shower blocks);
- The Caravan Park and related structures (amenities block, office and power facilities);
- The Southend Sailing Club;
- The bush camping sites north of Leake St; and
- The coastal reserve at Western Beach including the BBQ, shelter and boardwalk
