Wattle Range Council

# BEACHPORT BOAT RAMP

REVIEW OF MAINTENANCE REQUIREMENTS

Job No. WPH161346

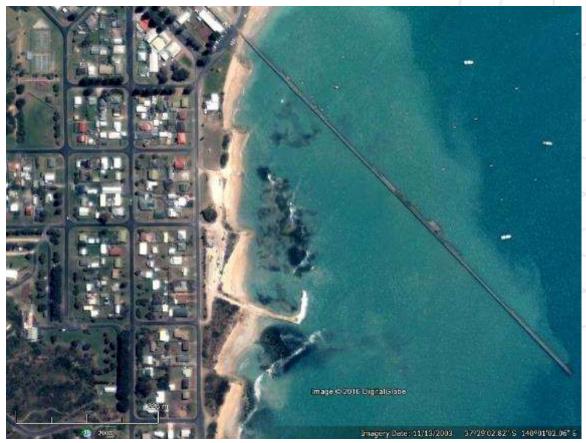
Figure 1.1 – Aerial view of the original beach ramp, taken while the 'trial' geotextile breakwater (Groyne 5) is under construction. (Source: Google Earth, November 2003)

A new boat ramp facility was constructed in 2004 and improved the functionality and operability of the boat ramp considerably. The development was not without controversy though, and led to significant divisions between the townspeople due to the broader changes to the adjacent beaches. Specifically, the challenge of trying to maintain deep water for small boats to access the boat ramp facility was at odds with beach users who previously swam from the beach at the end of Corigliano Street (Beach 6), and those who used the beach between the 'Harbourmaster's Residence' and the jetty. Figure 1.1 below shows an aerial view of the Beachport foreshore prior to construction of the 2004 boat ramp.

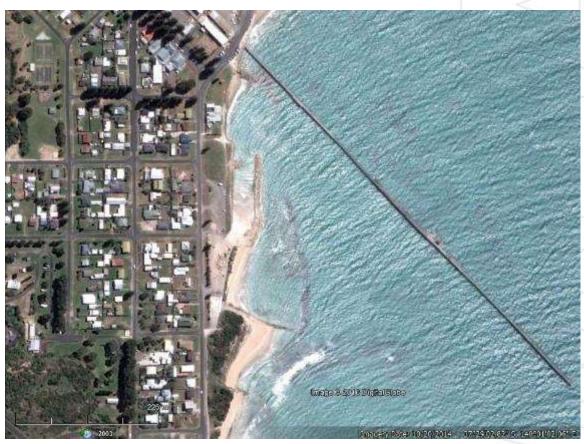
Figure 1.2 – Aerial view of the '2004 boat ramp' under construction in late 2003, with extended breakwater. (Source: Google Earth, November 2003)

Further major changes were made to the boat ramp facility in late 2013 / early 2014 to form a larger marina basin by extending the protective groyne by approximately 100m in length to the North (parallel to the rock revetment armouring the shore). Figure 1.2 below shows the breakwater extension under construction.

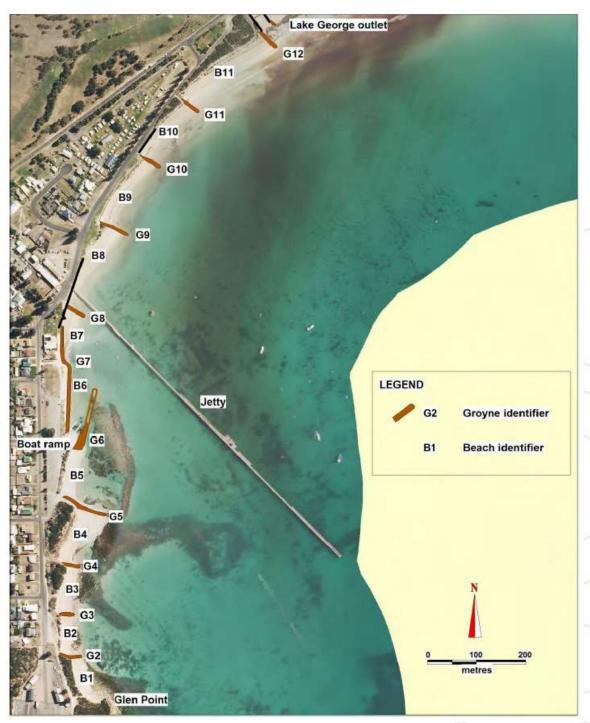
Figure 2.1 – Groyne and beach identifiers along the Beachport foreshore, as used by WRC (Source: Worley Parsons 2015 report).

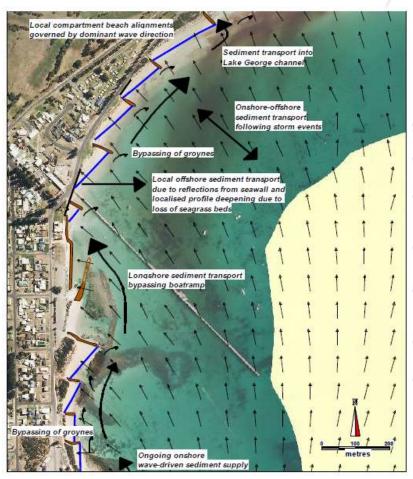
The prevailing action for sediment transport along the Beachport foreshore is longshore drift due to wave action, clearly outlined below in the summary figure from the Worley Parsons Rivoli Bay report (refer Figure 3.1). However, longshore transport along the coast to the North is not the only coastal process that causes sedimentation, especially at the boat ramp location where a number of other secondary effects combine to exacerbate the problem.

Figure 3.1 – Summary of the main sediment transport mechanisms that occur along the Beachport foreshore (Source: Worley Parsons 2015 report).

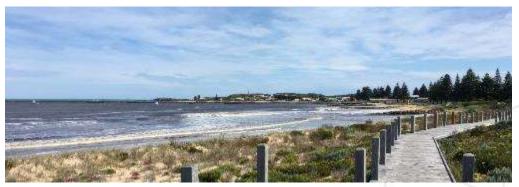
Photograph 3.1 – View to the South from the Lake George outlet drain showing dark coloured fresh water draining from inland. It can be clearly seen that there is a current taking the 'dirty' water to the South via the anti-clockwise currents setup in Rivoli Bay at the time. (Source: Author, October 2016)

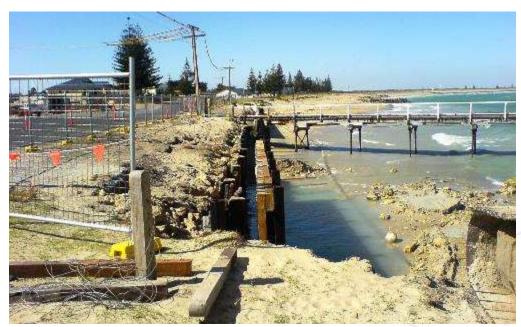
Photograph 3.2 – View to the North of the renewal / replacement of the vertical seawall adjacent to the jetty. (Source: Author, November 2006)

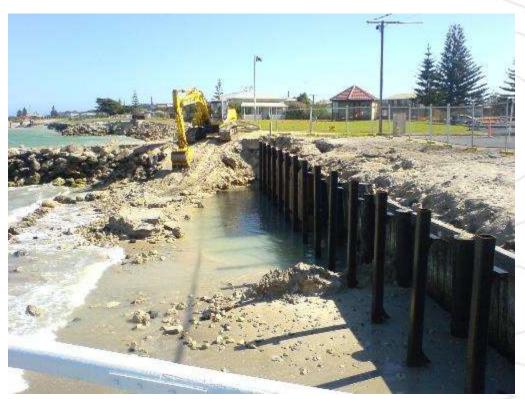
Photograph 3.3 – View to the South (from the Jetty) of the vertical seawall construction. (Source: Author, November 2006)

This seawall reconstruction was necessary to address the advanced deterioration of the original timber seawall (left in place behind the newer wall). The reflected wave that forms as waves drive into the seawall creates a perfect condition for mobilising sediment, and right at a bad location in terms of offering fresh sediment to the mouth of the new, extended boat ramp basin. Refer to Figure 3.4 for a view of a large reflected wave forming at the seawall location adjacent to the jetty (note very large swell conditions).

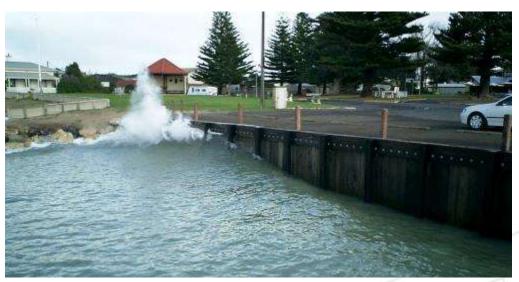
Photograph 3.4 – View of a reflected wave forming at the timber seawall adjacent to the jetty during large swell conditions, Beach 8 (Source: Author, May 2007)

- 8) Construct an additional groyne on the northern side of the jetty
  - Seawall at jetty under far more direct wave attack than historically
  - Reflective wave conditions cause scour and put sand in suspension

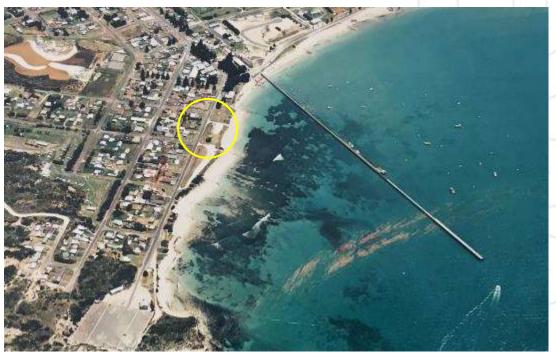
Figure 3.2 – Aerial photo of the Beachport foreshore with the original beach ramp. (Source: Barbara Cameron, Circa early to mid-1980's, summer)

The original beach ramp consisted of a basic concrete slab on the beach approximately half way between Corigliano Street and Blacketer Street on Beach 6. It served more as a vehicle access to and across the beach rather than a boat ramp, generally effective only in reducing the number of vehicles that would get bogged in soft sand by providing a more competent footing down to the firmer beach within the tidal range. An aerial view of the Beachport foreshore with the basic beach ramp access is shown below in Figure 3.2. The previous ramp location is within the marked yellow circle.

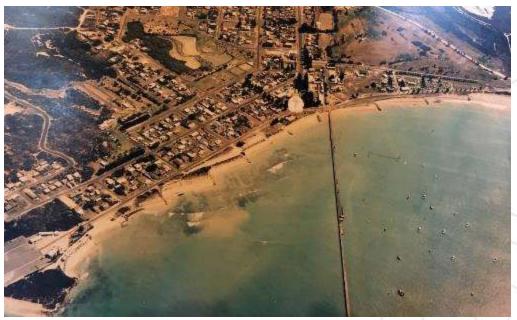
Figure 3.3 – Aerial photo of the Beachport foreshore with the original beach ramp. (Source: Author, Circa early 1990's, summer)

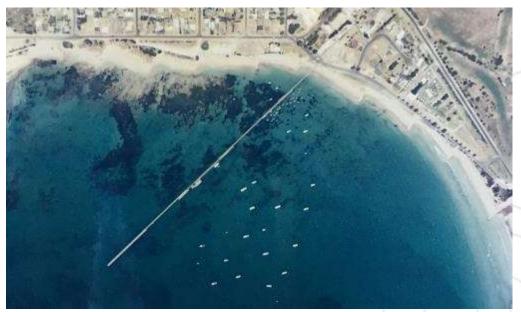
Figure 3.4 – Aerial photo of the Beachport foreshore with the original beach ramp. (Source: Author, Circa mid to late 1990's, summer)

The commercial fishermen (mainly crayfish, or Southern Rock Lobster) typically used the beach ramp only at the beginning and end of the crayfishing season, leaving there dinghies tied to the jetty through the summer fishing months. This meant that the ramp was generally only used by recreational fishermen. Figure 3.3, above, is an aerial photograph taken at least 5 – 10 years after the photograph from Figure 3.2, and it can be seen that relatively little change has occurred to the various beach compartments. Similarly, Figure 3.4 below is from just prior to construction of the trial breakwater and 3-lane boat ramp and very little change is evident along the beach compartments.

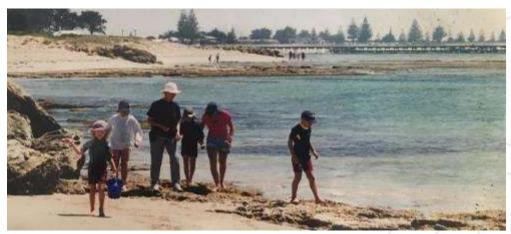
Photograph 3.5 – Photograph of beachgoers, view to the North, Beachport foreshore and former beach ramp location beyond. (Source: Barbara Cameron, Circa early to mid-1990's, summer)

Photograph 3.5 below shows a view of the beach where the former beach ramp was located, with the reef structures visible at low tide. The ramp itself is not visible in this photograph as it is obstructed by the Blacketer St rock groyne (Groyne 6). It can be seen that continuous access along the Beachport foreshore was only interrupted by the original groynes themselves, and these were easily walked around at low tides.

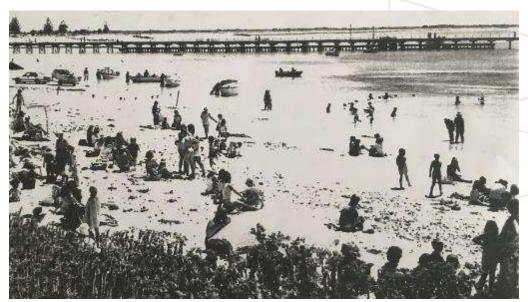
Photograph 3.6 – Photograph of beachgoers at the current boat ramp location, view to the North-East, Beachport foreshore and former beach ramp in the background. (Source: Barbara Cameron, 1988, summer)

Photograph 3.6 below shows beach users set up at the current boat ramp location, with the former beach ramp in operation in the background. Note that this mixed use would be considered a significant safety risk for the design of any modern boat ramp facility, where it is highly desirable to separate pedestrians and other beach users from vehicle traffic.

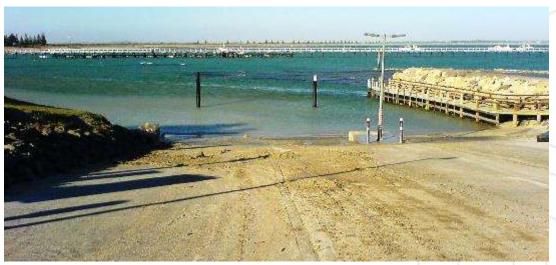
Photograph 3.7 – View to the North-East of the previous 2004 Boat Ramp arrangement. (Source: Author, November 2006)

A new boat ramp facility was constructed in 2004 and improved the functionality and operability of the boat ramp considerably. The development was not without controversy, and led to significant divisions between the townspeople due to the broader changes to the adjacent beaches. Specifically, the challenge of trying to maintain deep water for small boats to access the boat ramp facility was at odds with beach users who previously swam from the beach at the end of Corigliano Street, and those who used the beach between the 'Harbourmaster's Residence' and the jetty (Beach 7). The new structure also prevented beachgoers from walking uninterrupted between the jetty beaches and Glenn Point, and took away some of the better protected deep water swimming from the foreshore area. The arrangement (minus the pontoons, removed at the time for maintenance) is shown below in Photograph 3.7.

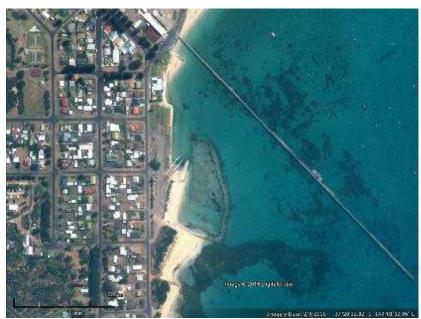
Figure 3.5 – Aerial view of the previous (post 2004) boat ramp, taken during summer months with the facility operational (a number of boat trailers are visible in the carpark). (Source: Google Earth, February 2010)

This project immediately followed the construction of a new 'trial' breakwater built with sand filled geotextile bags approximately 100m from the beach. At this time, the groyne at the end of Blacketer Street (Groyne 6) was also amended significantly and reoriented towards the NNE to provide protection to the boat ramp from the prevailing South-Easterly winds that occur for much of the summer period. An aerial view of the entire development is shown below in Figure 3.5.

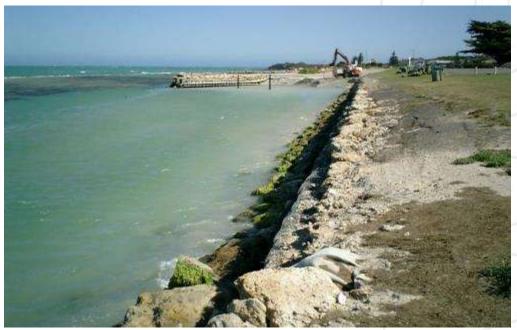
Photograph 3.8 – View to the South of the previous Boat Ramp arrangement showing initial gabion basket revetment wall with additional rock protection. (Source: Author, November 2006)

This revetment wall was originally constructed using rock filled gabion baskets, but additional rock protection was necessary to stabilise the wall after deterioration.

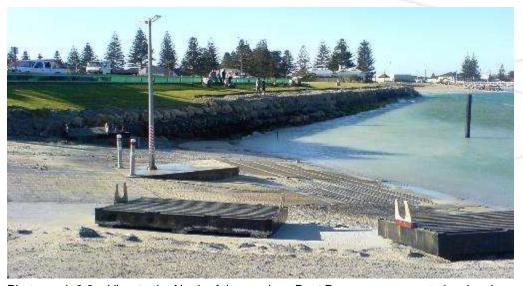
Photograph 3.9 – View to the North of the previous Boat Ramp arrangement showing the relatively steep armoured revetment wall. (Source: Author, November 2006)

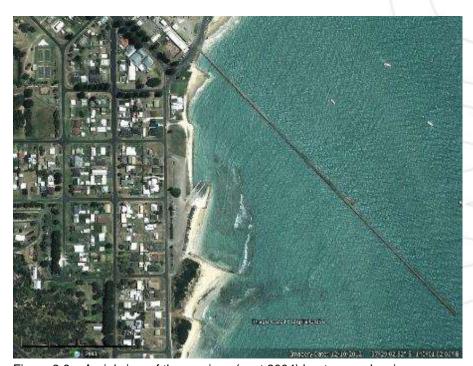
The rock groyne protection for the 2004 boat ramp was approximately equal in length to the floating pontoons, extending only about 30m out from shore. Waves refracting and diffracting around the end of the submerged geotextile breakwater outflanked the end of the protective groyne, introducing relatively large amounts of wave energy into the marina basin during heavier swell conditions. These conditions allowed considerable sediment to be driven directly into the boat ramp area, including sediment load carried in by currents and settling into the quieter water at the toe of the ramp. The wave pattern described is easily visible in the 2012 aerial photograph below in Figure 3.6.

Figure 3.6 – Aerial view of the previous (post 2004) boat ramp showing waves transforming around the geotextile bag breakwater. (Source: Google Earth, October 2012)

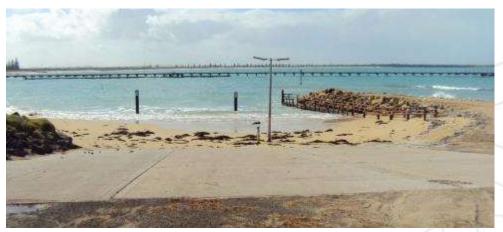
Photographs 3.10 and 3.11 below show extensive sand build up at the boat ramp after winter storms. During times like this, only small dinghies could be launched across the sand, similar to the arrangement with the previous beach ramp, but with less water depth available due to shoaling.

Photograph 3.10 – View to North-East of the previous Boat Ramp during winter months showing the large build-up of sand on the beach. Note that the ramp is entirely ineffective and floating pontoons have been removed. (Source: Author, August 2010)

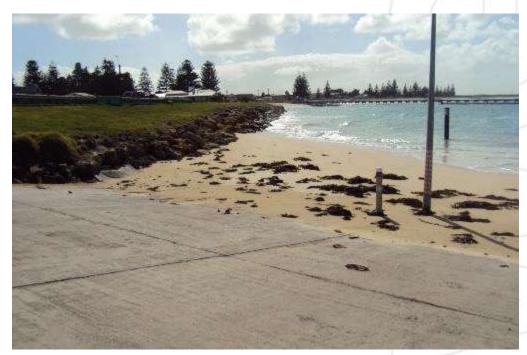
Photograph 3.11 – Another view to the North of the previous Boat Ramp during winter months showing the large build-up of sand on the beach. (Source: Author, August 2010)

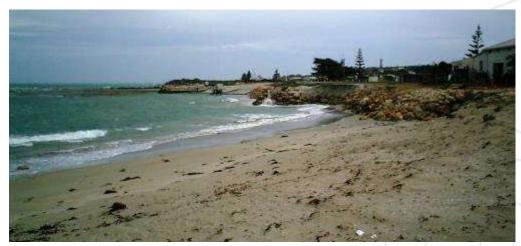
Photograph 3.12 – View to South of Boat Ramp and Rock Revetment Structure (Source: Author, December 2006)

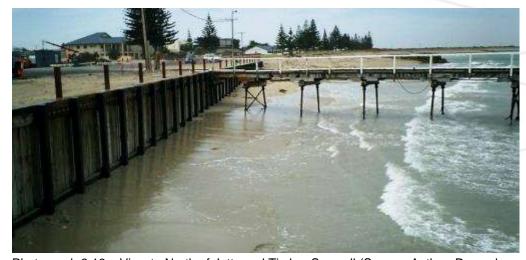
Photograph 3.13 – View to North of Jetty and Timber Seawall (Source: Author, December 2006)

The vertical seawall adjacent to the jetty is also considered to be an important feature of the overall system, particularly due to the increased wave energy because of reflective waves forming at the seawall with increased force due to the greater water depths (see Photograph 3.13 below). This reflected wave energy is particularly effective at mobilising sediment into the water column, which is potentially transported back towards the boat ramp area when anti-clockwise currents exist in the Beachport end of Rivoli Bay.

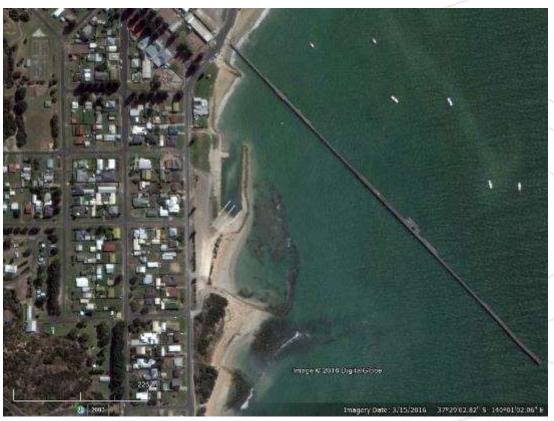
Figure 4.1 – Aerial view of the current boat ramp and marina basin arrangement. The central sand bar can be seen in the middle of the basin (Source: Google Earth, March 2016)

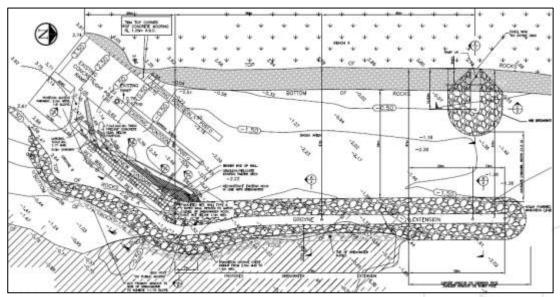
Figure 4.2 – Part engineering plan for Beachport Boat Ramp – Breakwater Extension (Source: Magryn & Associates, September 2013)

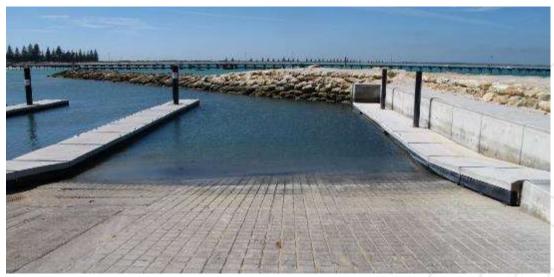
Photograph 5.1 – Boat ramp and concrete retaining wall. The additional set of floating pontoons creates a 4<sup>th</sup> lane for vehicle access. (Source: Author, March 2017)

When not adversely affected by sedimentation, the new boat ramp arrangement with the extended breakwater is a high quality facility offering great conditions for launching and retrieving vessels in almost any weather for tourists and local residents alike. The ramp itself has only minor changes, most notably the vertical concrete wall on the outer (east) side, and an additional set of pontoons to create a 4<sup>th</sup> working ramp. The traffic of boats in busy periods seems to continually grow year by year, and the additional ramp seems to have helped somewhat with congestion (refer Photograph 5.1 below).

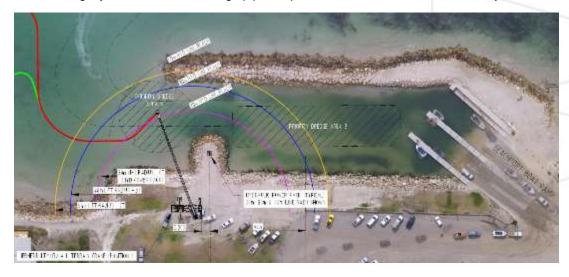
Figure 5.1 – Part of WGA set out drawing showing trial dredge, refer Appendix C for further details. (Source: WGA, March 2017)

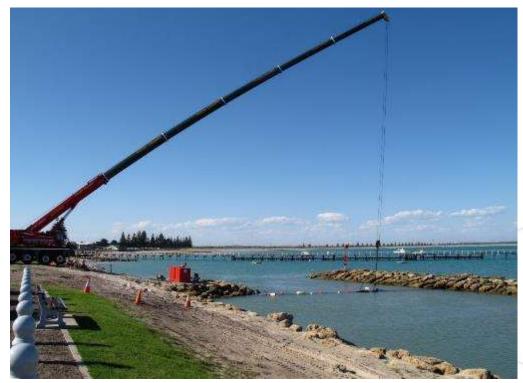
Photograph 5.2 – View to North-East showing dredge trial underway (Source: Author, March 2017)

The weather during the trial was close to perfect. Moderate temperatures, light winds and relatively low swell (other than day 2 where some difficulties were encountered with handling the dredge disposal pipe). Photographs 5.2 to 5.5 show the dredge trial from a number of different viewpoints.

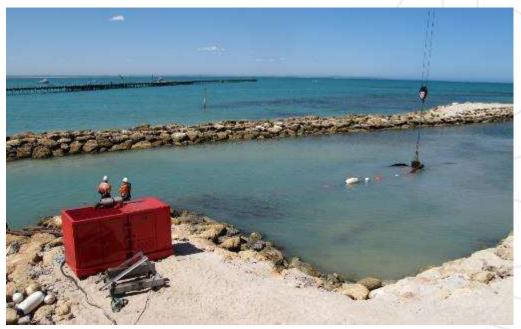
Photograph 5.3 - View to South-East showing dredge trial underway (Source: Author, March 2017)

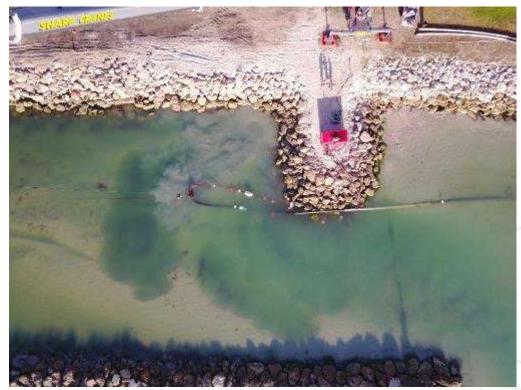
Photograph 5.4 – Drone view of dredge trial underway (Source: Maritime Constructions, March 2017)

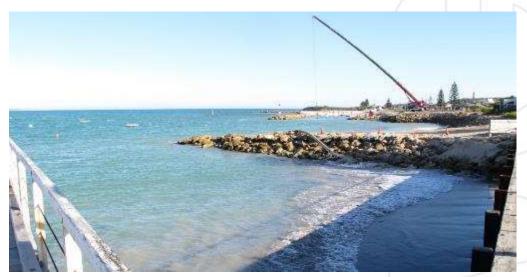
Photograph 5.5 – View to South of dredge trial underway, taken from the jetty at the seawall (Source: Author, March 2017)

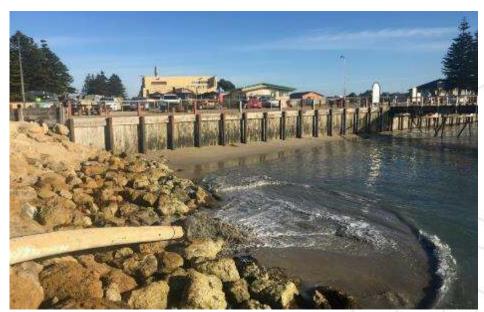
Photograph 5.6 – Sand slurry pumped onto the rock groyne adjacent to the jetty beach (Source: Author, March 2017)

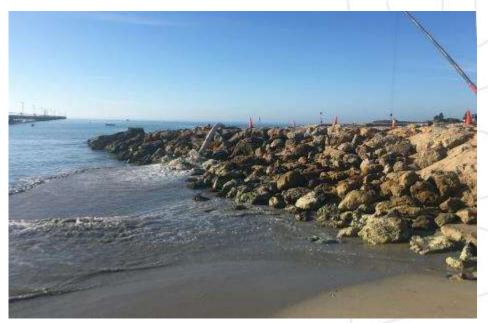
Photograph 5.7 – Sand slurry pumped onto the rock groyne adjacent to the jetty beach, with the build-up of sand evident along the length of the groyne (Source: Author, March 2017)

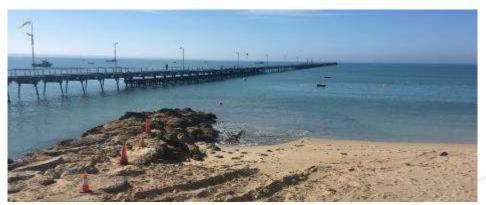
Photograph 5.8 – Dredge pipe placing sand slurry on the lower beach, with only minor local scour and no significant erosion (Source: Author, March 2017)

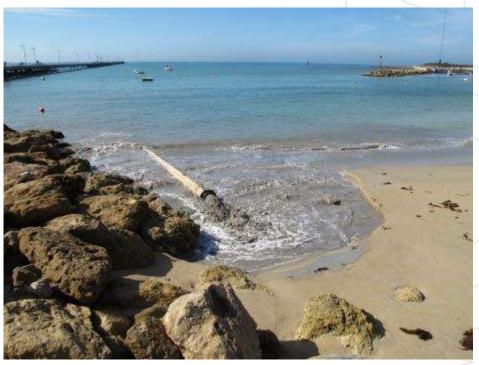
Photograph 5.9 – Dredge pipe placing sand slurry on the lower beach. The beach was almost immediately restored after pumping was ceased in this location (Source: Author, March 2017)

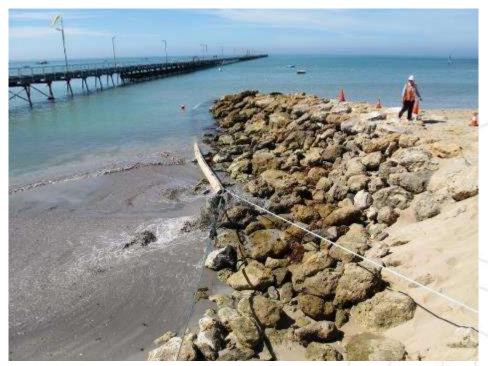
Photograph 5.10 – Sand slurry discharged onto the jetty beach with the HDPE pipe tethered to the vertical seawall using a bridle arrangement (Source: Author, March 2017)

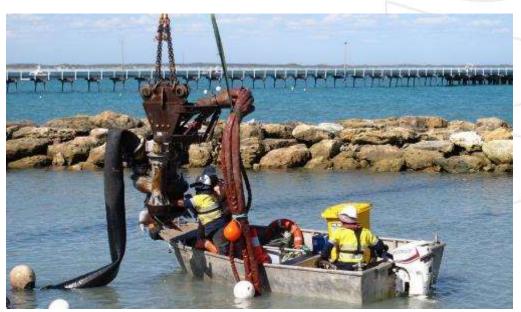
Photograph 5.11 – Dragflow pump being cleared of seaweed from the intake screen (Source: Author, March 2017)

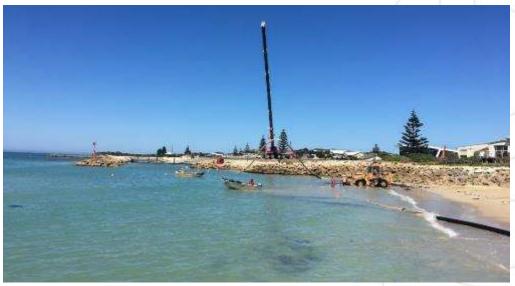
The dredge pipe was one of the major demands during the trial in terms of setup time. The original plan was to create a large 's-bend' in the floating pipe offshore from the beach to allow for easy movement of the crane and Dragflow. This plan was altered slightly after moderate swell conditions experienced during pipe placement and install whereby the pipe was beached on the dry sand overnight. This wasn't a problem in itself, but meant that moving the pipe later on the first day after finishing working the first area was more challenging and a front end loader was required to assist (refer Photograph 5.12 below).

Photograph 5.12 – Relocation of the dredge discharge pipe using the crane and a front end loader on the beach (Source: Author, March 2017)

A longer flexible hose from the Dragflow pump and a permanent HDPE land based pipe would offer significant improvements to the dredge arrangement if similar plant and equipment (including other types of dredge) were used on a more regular basis going forward. The wear rates for moving the small quantities involved are very low, so even second hand pipe could be considered to help keep costs down.

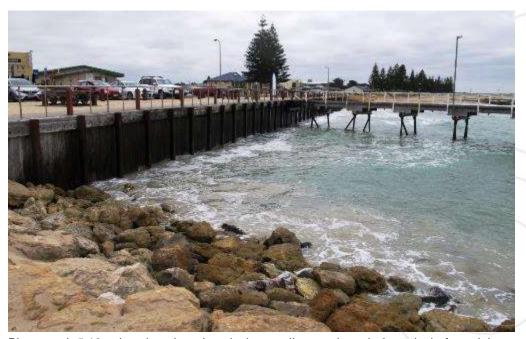
Photograph 5.13 – Jetty beach and vertical seawall approximately 2 weeks before trial (Source: Author, February 2017)

It is generally easier to assess the outcomes at the discharge end of the dredge pipe rather than the dredge end, as photographs allow for comparison. See Photograph 5.13 and 5.14 below for a comparison of before / after at the discharge location near the jetty.

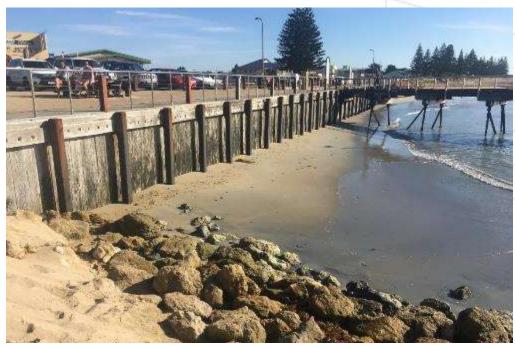
Photograph 5.14 – Jetty beach after dredge trial (Source: Author, March 2017)

As discussed earlier in this report section, there were no detrimental effects on the beach or rock groynes at the point of discharge. The outcomes assessed for placement of sand exceeded the best case scenarios predicted before the trial in every way. The amount of beach that was able to be built up at the jetty beach was noticeable, and lasted for many days before dissipating. The amenity in this area and reduced demand on the seawall was a favourable outcome, and was done in a less disruptive manner than trucking.

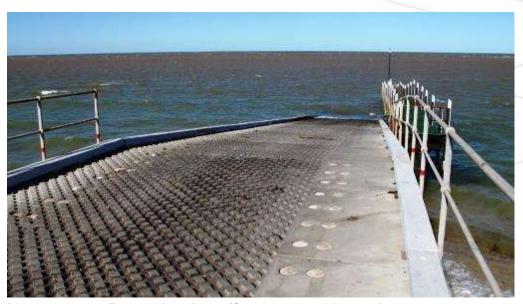
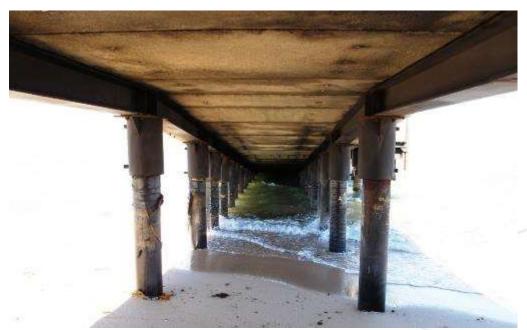
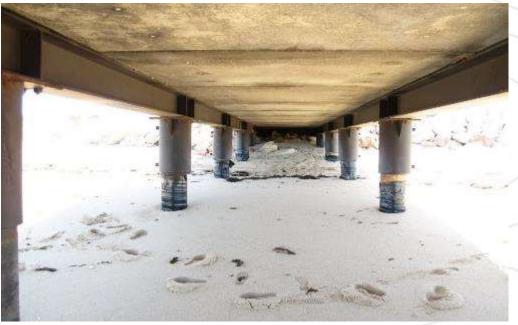
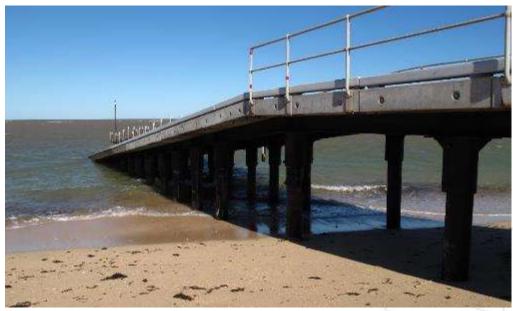
Photograph 6.1 – Exmouth Boat Ramp (Source: Author, May 2015)

Photograph 6.2 – Exmouth Boat Ramp (Source: Author, May 2015)

Photograph 6.3 – Exmouth Boat Ramp (Source: Author, May 2015)

Photograph 6.4 – Exmouth Boat Ramp (Source: Author, May 2015)

The ramp at Exmouth is on Exmouth Gulf and is a single lane ramp. There is no specific protection for this ramp, as there is no major swell that comes in to the gulf in normal conditions, and there are only wind driven (short fetch) waves. This is an important distinction relative to the requirements of a ramp at Beachport. Refer to Photographs 6.1 to 6.4 for further details of this ramp arrangement.

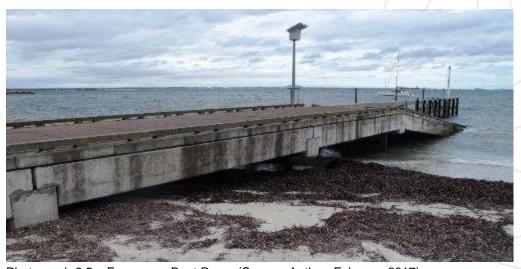
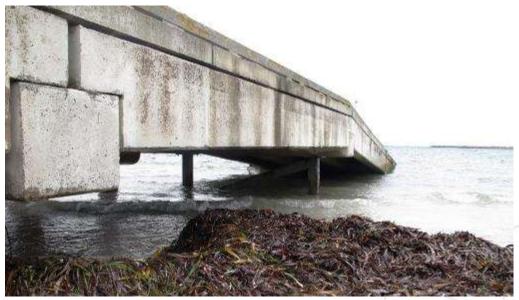
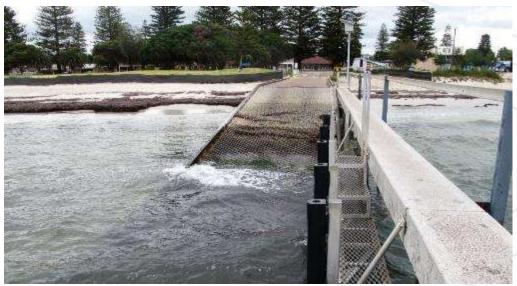
Photograph 6.5 – Esperance Boat Ramp (Source: Author, February 2017)

Photograph 6.6 – Esperance Boat Ramp (Source: Author, February 2017)

Photograph 6.7 - Esperance Boat Ramp (Source: Author, February 2017)

Another ramp built over the active beach profile to find deeper water is at Esperance. This is also a single ramp structure, and is in a more protected bay than Beachport, though conditions can be relatively demanding in certain weather events. Refer to Photographs 6.5 to 6.7 for further details regarding this ramp design.

It would be possible to design a similar type of boat ramp structure for Beachport, and it could certainly be done with a great reduction in the overall maintenance requirements, but there would be a significant reduction in protection offered against swell. Additionally, there would be numerous challenges to provide a 4 lane ramp that could cater for the same amount of ramp traffic as currently occurs.

This structure type is not affected by sedimentation because the typical coastal processes for the site are not interrupted. Greater width to the ramp, and any offshore protection such as a breakwater, modifies the coastal processes and generally tends towards more benign conditions and typically a flatter beach with more build-up of sand. It is therefore a balancing act between providing protection and comfort with ramp width, versus ongoing maintenance requirements. Given that expectations in Beachport from tourists and local users alike are that a facility with similar functionality to the current arrangement will be provided, it might be a very difficult process to take people back to something that is much more paired back.
