WATTLE RANGE COUNCIL

Appendix 1 - Rivoli Bay

Assessment of Existing Coastal Structures

301015-03541 – 001

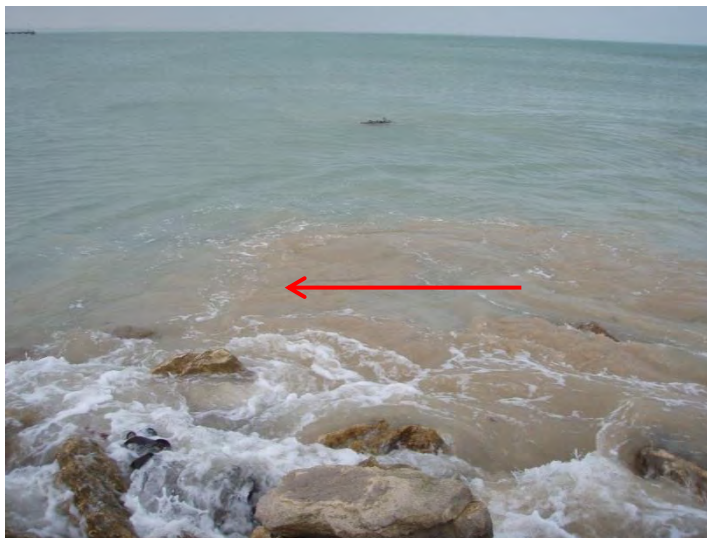
The dune between Glen Point and Groyne 2 was accreted, despite the presence of an erosion scarp having formed during the storm of 24 June. The dune was relatively well vegetated on both the updrift and downdrift sides of the groyne. Littoral drift was actively transported by wave action from around Glen Point, and around the tip of Groyne 2, as indicated in Figure 4 and Figure 5. There was also some minor erosion observed as a result of an informal access on the downdrift side of the groyne.

Figure 5 – Sand transport around tip of Groyne 2, 25 June

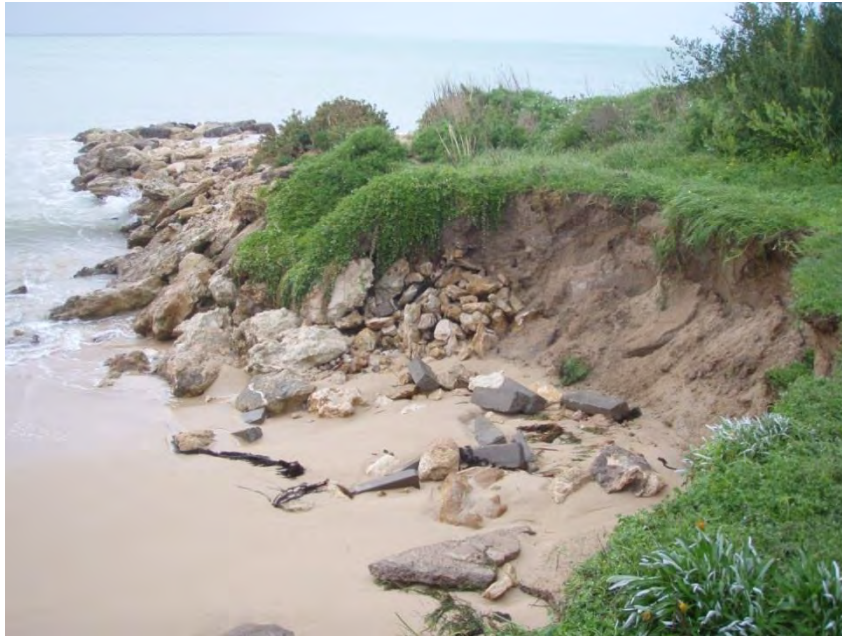
Groyne 3 was inspected on 25 June 2014 and was considered to be in poor condition. The groyne was covered with sand on the updrift side and was actively bypassing (Figure 6). The groyne comprised limestone armour rock with a median diameter of 1000 mm, but many smaller core/underlayer rocks were observed to have been exposed and the armour has slumped along sections of the groyne trunk (Figure 8). The groyne appeared to have a clay core which has become exposed and devoid of armour (Figure 9). On the downdrift side of the structure, at the landward end of the groyne severe erosion had occurred which is threatening to outflank the groyne on the landward side (Figure 7). Ad hoc rubble and concrete pieces were observed to have been placed at the base of this erosion escarpment, possibly in a previous attempt to arrest the erosion at this location. Given the height of the erosion escarpment on the landward edge of the groyne, it is considered that there is a risk of the erosion scarp collapsing and an associated risk of public injury. The dune within Beach 3 on the downdrift side of the groyne was observed to be suffering from severe erosion, with an erosion scarp around 1.5 m high, formed possibly as a result of the storm event on 24 June (Figure 10).

Figure 7 – Groyne 3 showing eroded area and ad-hoc rubble at downdrift landward side, 25 June

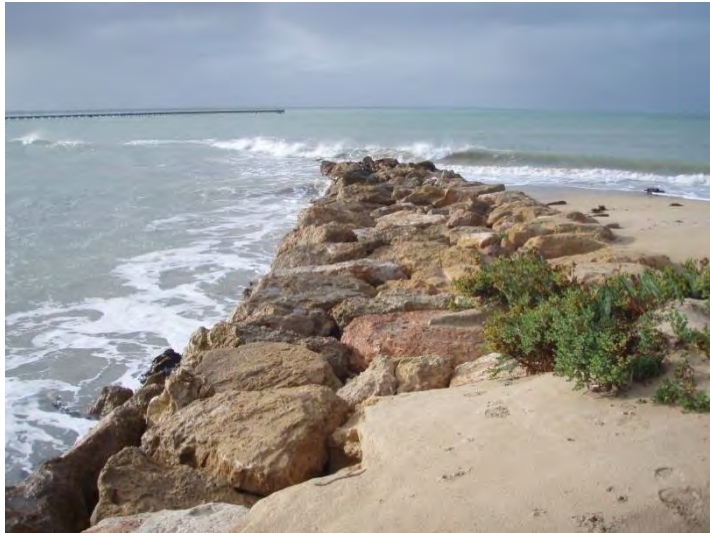
Groyne 5 was inspected on 25 June 2014 and was considered to be in good condition. The armour appeared to be well packed with good interlocking between individual stones (Figure 16). The groyne comprised rock armour of median diameter 1200 mm near the tip of the groyne, with a large vegetated dune and build up of sand within Beach 4 on the updrift side. Along the groyne trunk on the downdrift side, smaller rock armour of median diameter 800 mm was visible and erosion was occurring at the landward end of the groyne (Figure 17). There was evidence of breakage of individual armour stones within the groyne, as can be seen in Figure 18. A timber pedestrian walkway extended down onto Beach 5 and this was damaged in the large wave event of 22 June. The crest of the groyne was covered in road base to provide vehicular access to the end of the groyne and beach. Inundation due to wave runup was observed to be impacting on the landward side of this groyne during the large wave event of 24 June (Figure 19).

Figure 16 – Tip of Groyne 5 showing good interlock between armour stones and large sand buildup on updrift side

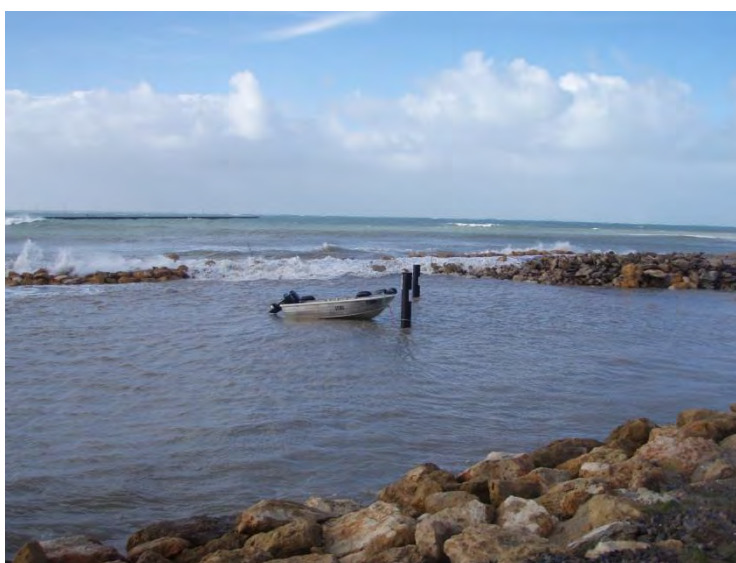
During the inspection on 24 June, waves were observed to be overtopping the shore-parallel section of groyne and swell waves were observed within the boat ramp area (Figure 22).

Figure 22 – Wave overtopping partially constructed Groyne 6 into boat ramp area, 24 June

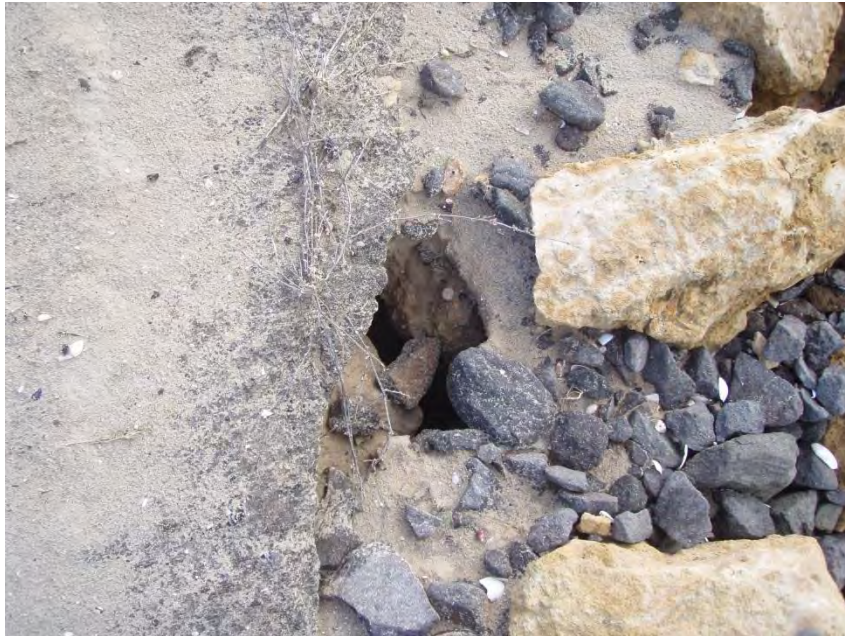
Figure 25 – Cavities behind revetment wall and visible small basalt underlayer rock

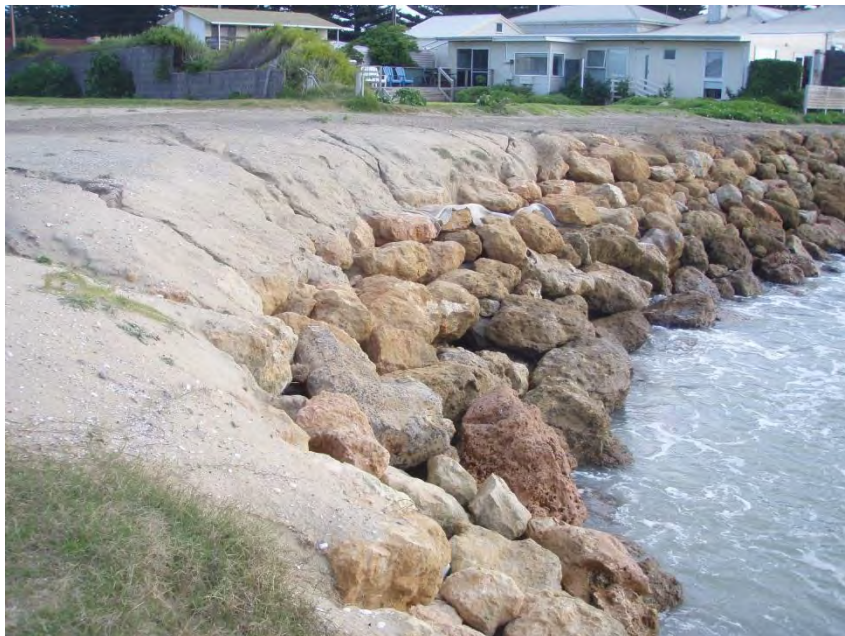
wave overtopping and rainfall (Figure 26). Beaches 6 and 7 were completely denuded of sand and waves were observed to be breaking directly onto the revetment (Figure 27). At the northern end of this revetment, a timber pedestrian access extended onto the beach and the rock revetment was backed by a vertical timber seawall (Figure 28).

Figure 26 – Erosion of unprotected fill at crest at bend in revetment at former Groyne 7 location

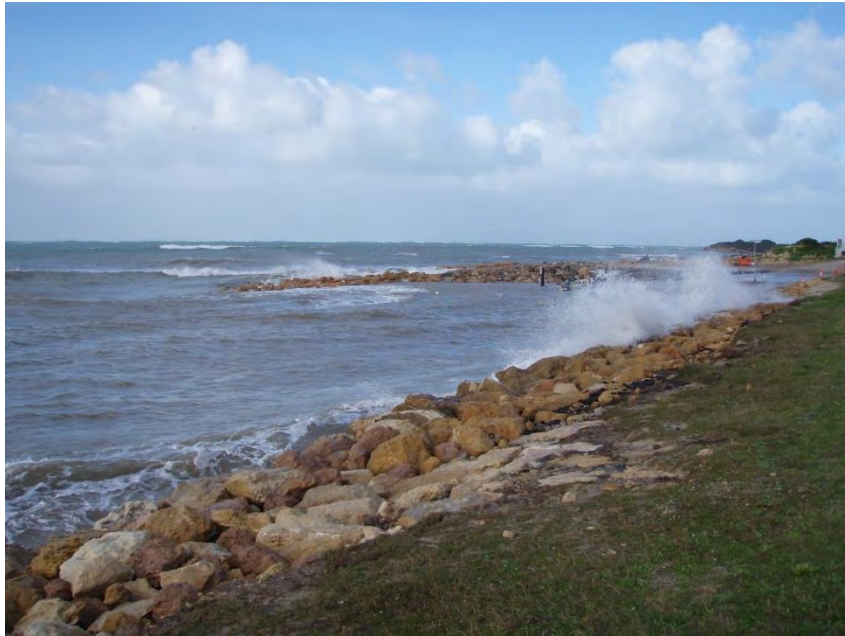
Figure 27 – Direct wave attack onto rock revetment at Beachport, Groyne 6 and boat ramp in background

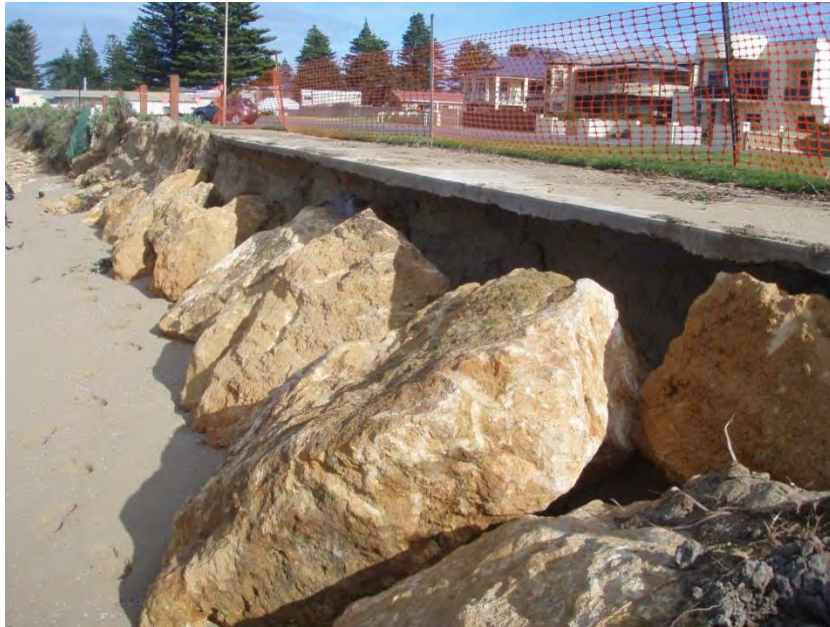
On the landward end of the northern (downdrift) side of the groyne, a 1.5 m sandy erosion scarp was evident along the landward side of the groyne trunk (Figure 37). Along the Beach 9 foreshore north of the groyne, a dilapidated timber sheet pile structure was observed at the base of the erosion escarpment (Figure 37). The concrete foreshore path in this area had been undermined by erosion with large rock armour (median diameter 1000 mm) placed as emergency coastal protection under the undermined path (Figure 38).

Figure 38 – Undermined concrete path along Beach 9 north of Groyne 9 with emergency rock protection

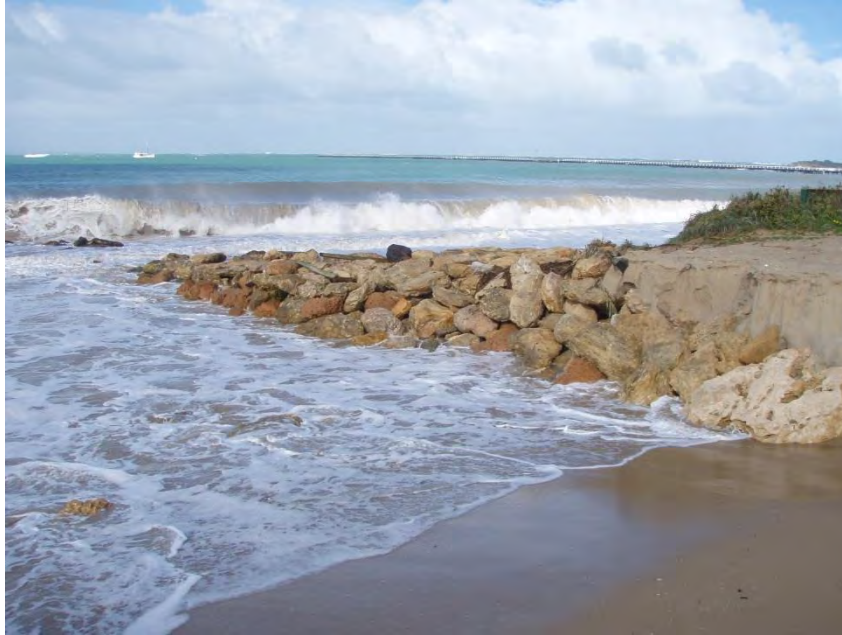
Groyne 10 was a relatively short rock groyne (approximately 40 m long) in fair condition (Figure 39). The median diameter of rock armour within this groyne was estimated to be around 1000 mm, with the rock armour comprising limestone. Concrete pieces were observed within the armour of the northern side of the groyne. The tip of the groyne was submerged and not visible. The groyne was partially covered in sand and was actively bypassing (Figure 40). Significant gaps between individual armour stones were visible, these gaps being filled with sand. The beach on the updrift (southern) side was backed by a vegetated dune which had been damaged by erosion, with a dune escarpment 1.5 m high.

Figure 39 – Groyne 10 looking south 24 June

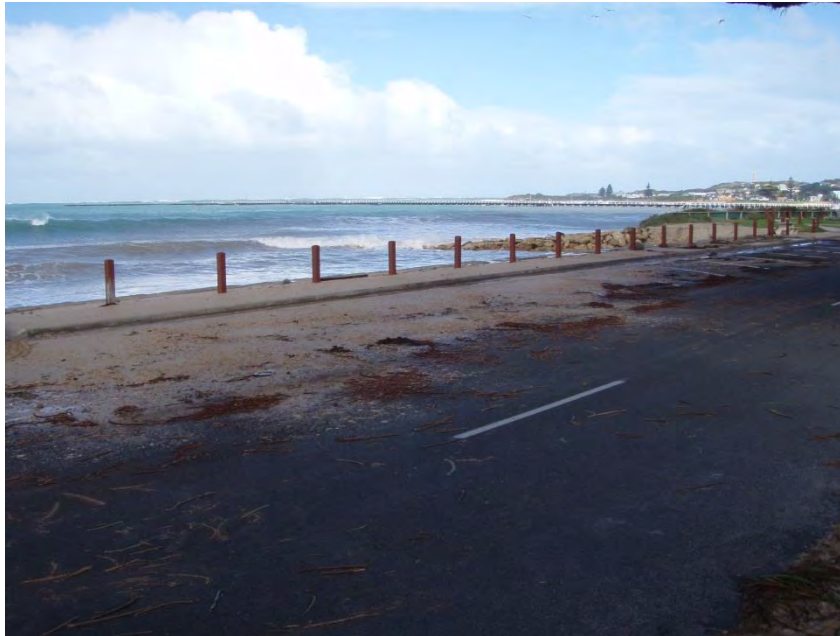
Figure 41 – Seawall adjacent to Groyne 10 indicating extent of overtopping onto Beach Road

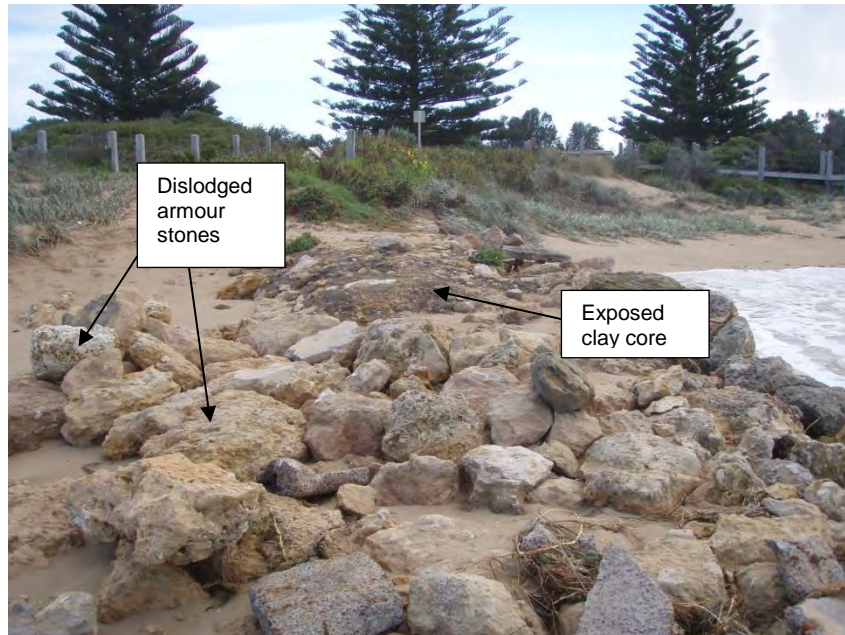
Figure 44 – Groyne 11 looking inland showing exposed clay core and dislodged armour rock

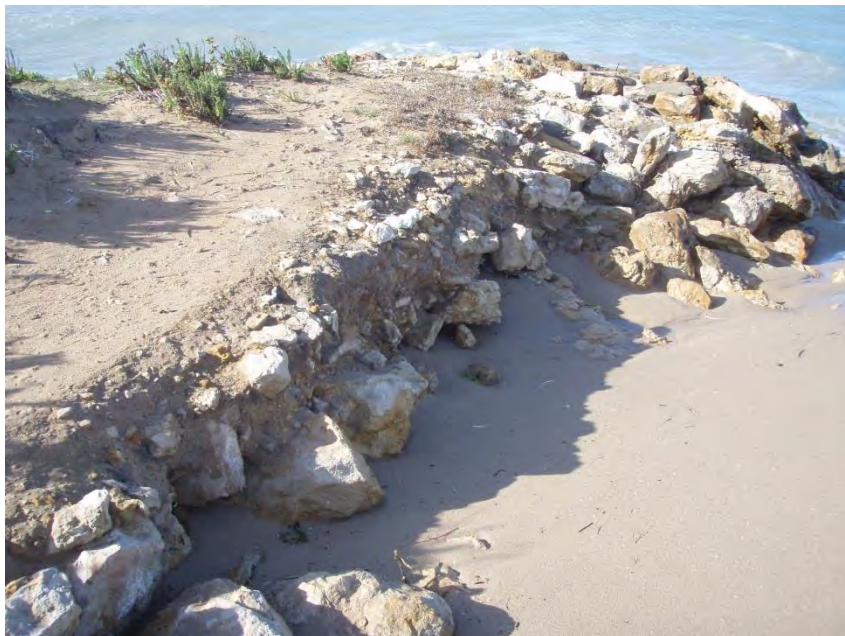
Figure 47 – Tip of Groyne 12 – note loss of armour from groyne trunk and exposure of clay core

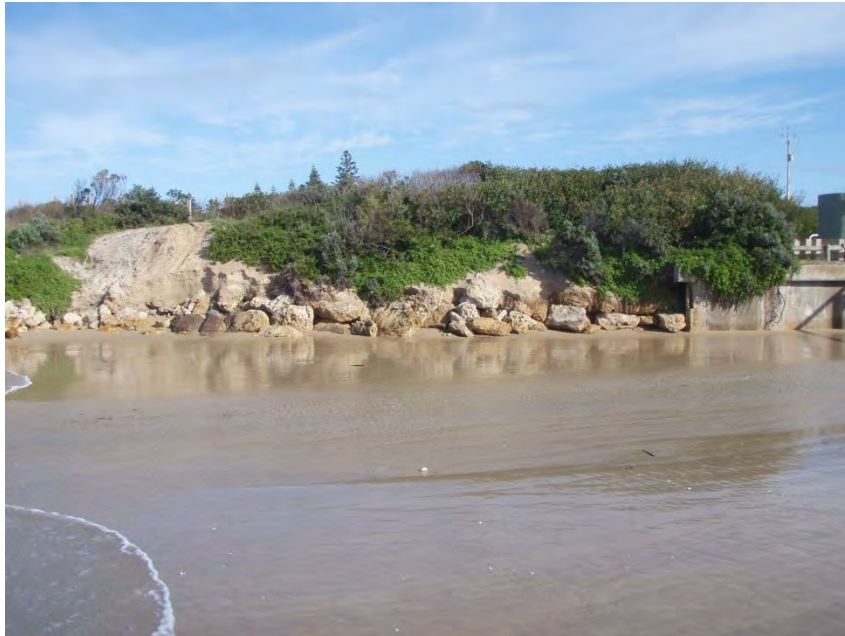
Figure 48 – Groyne 12 looking south from Lake George outlet – note build up of dune sand being carried into channel by wind

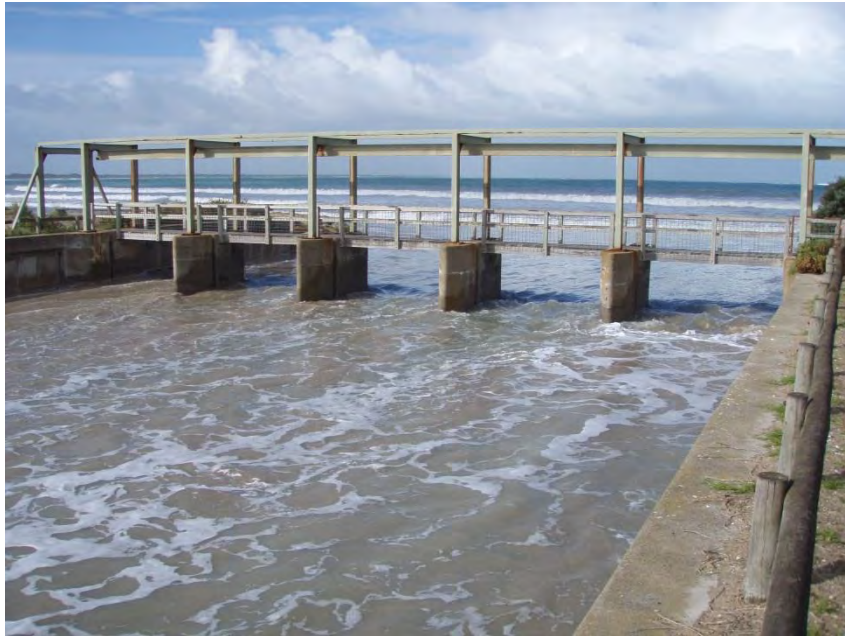
Figure 50 – Waves propagating upstream into Lake George channel

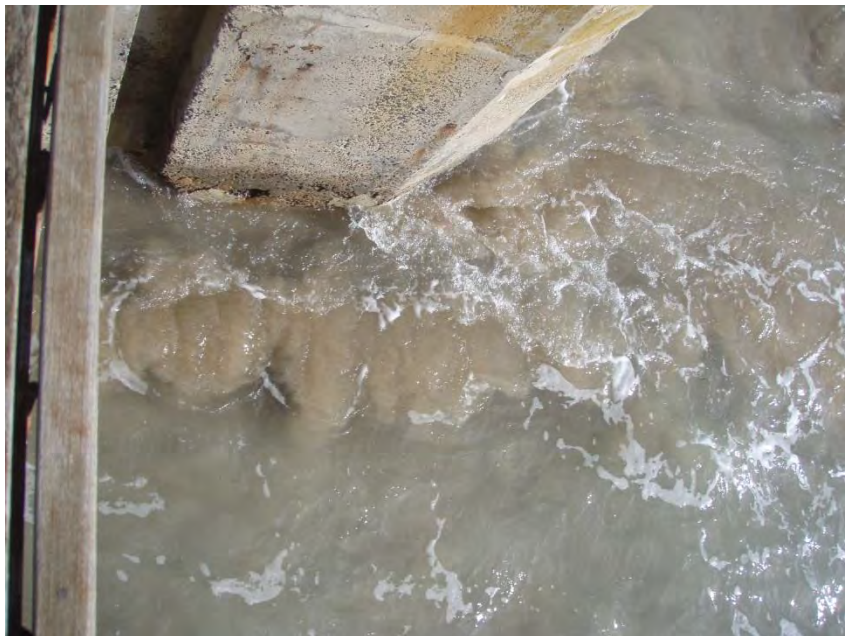
Figure 51 – Sand in suspension being carried by waves and tidal currents upstream into Lake George channel

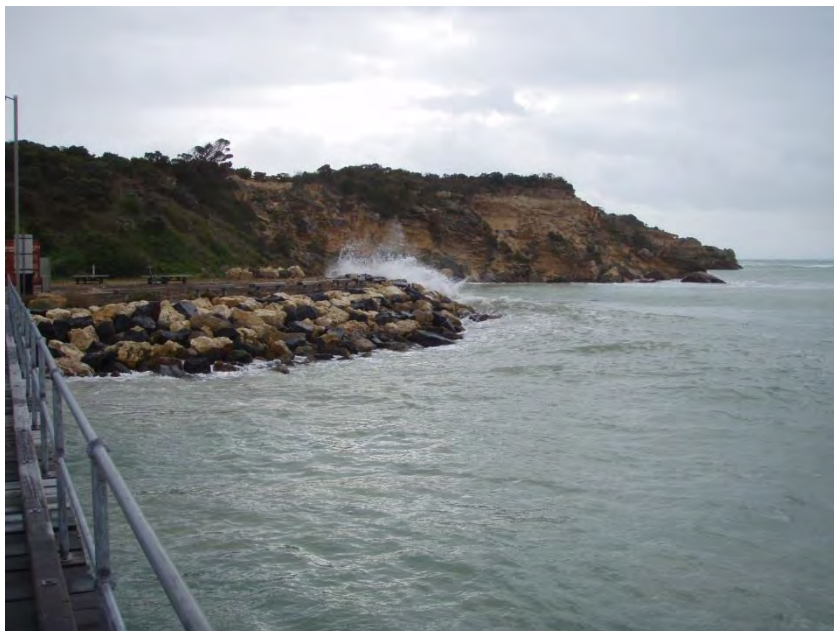
Figure 58 – Wave overtopping onto revetment at Southend jetty, 24 June

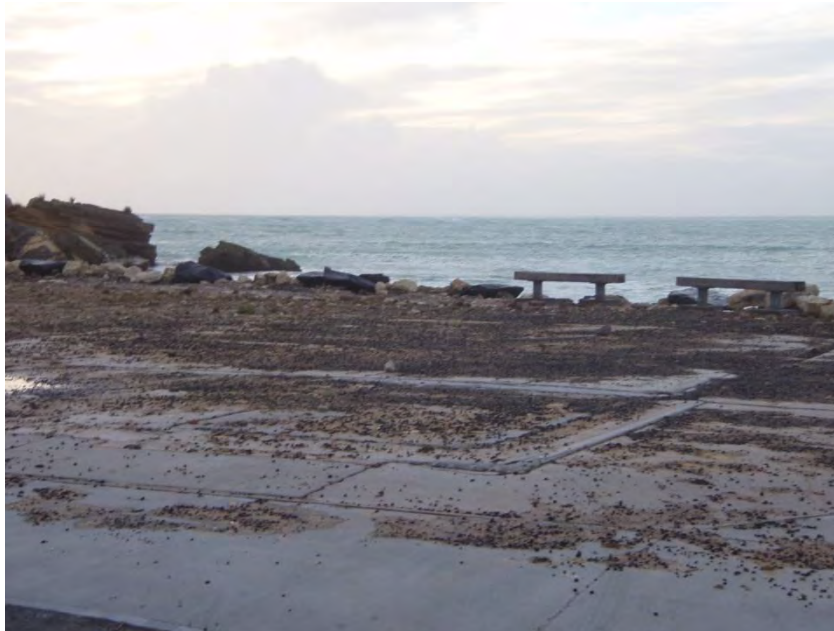
Figure 59 – Gravel debris indicating extent of wave overtopping in jetty carpark, Southend

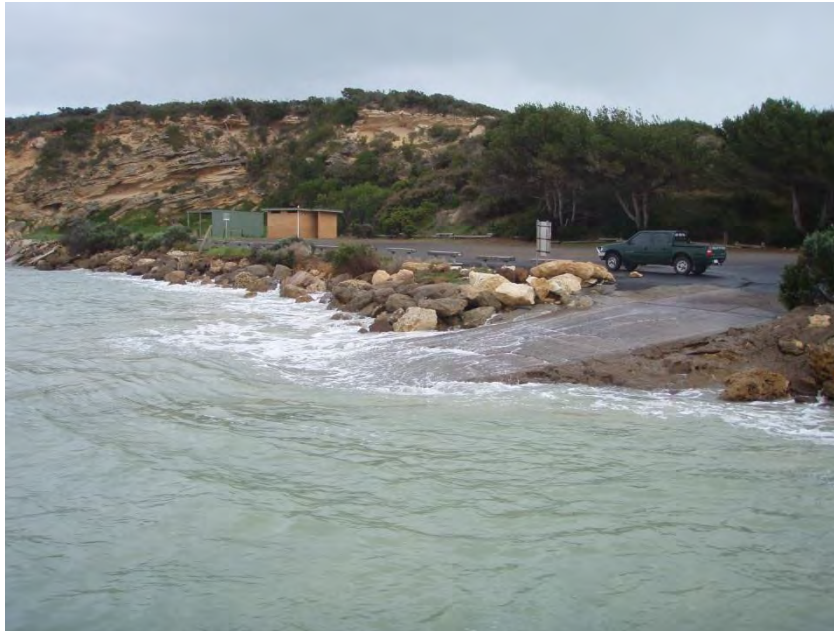
The concrete surface of the boat ramp had suffered some spalling and cracking (Figure 60) and waves were running up the surface of the boat ramp into the carpark on 24 June (Figure 61).

Figure 61 – Wave runup onto Southend boat ramp, 24 June

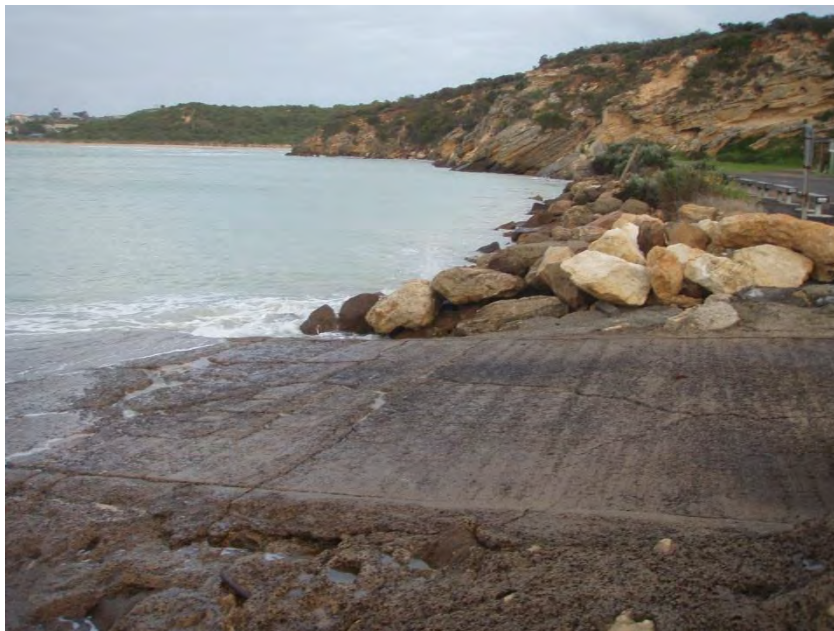
South of the boat ramp, a rock revetment comprising limestone armour of median diameter 1200 mm was subject to oblique wave attack – this revetment was at a slope of 1V:2H and was in poor condition, with the underlying fill material exposed and subject to erosion caused by wave overtopping (Figure 61 and Figure 62). At the southern end of the revetment, rock armour was replaced with ad hoc concrete and building rubble, as shown in Figure 63.

Figure 62 – Boat ramp and rock revetment looking south, Southend

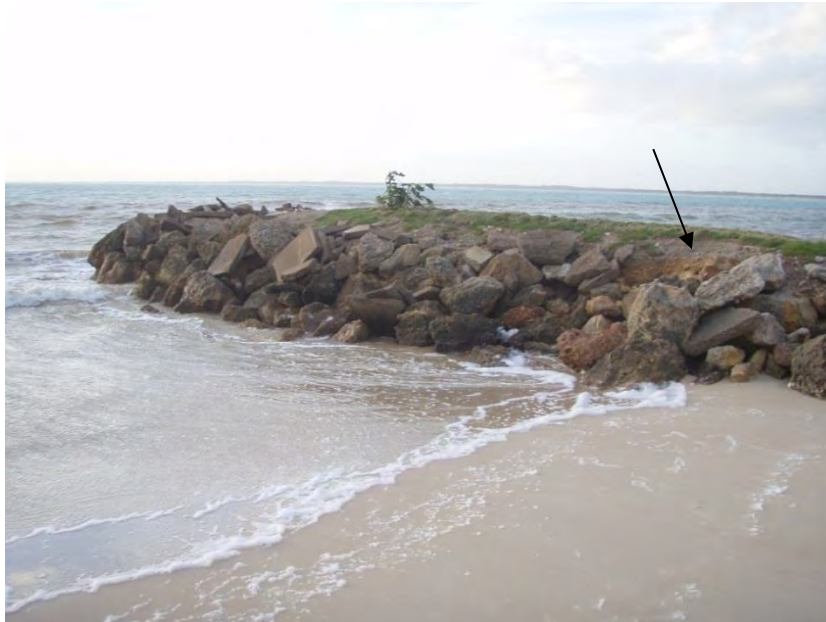
Figure 64 – Groyne at southern end of Lake Frome outlet. Note buildup of sand, slumped armour and use of concrete pieces as armour.

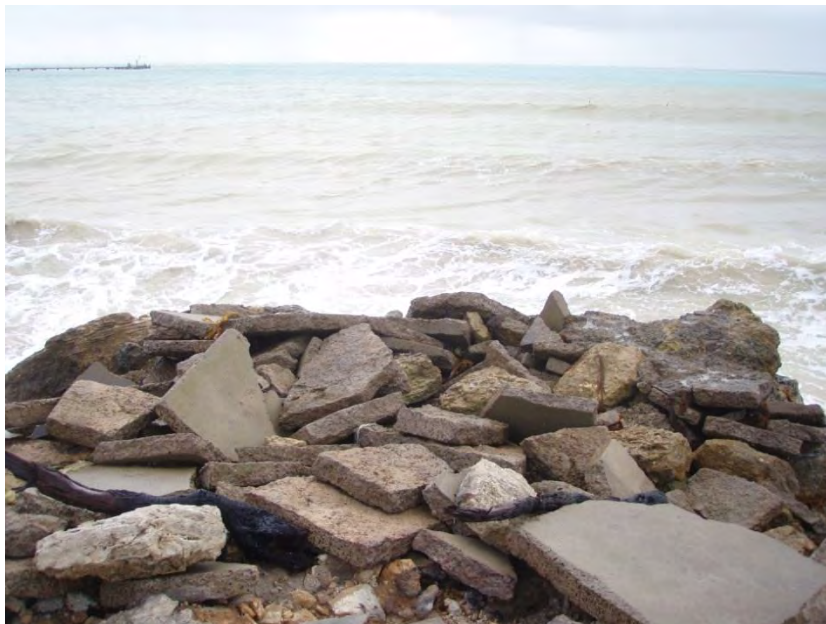
Figure 65 – Tip of groyne at southern end of Lake Frome outlet. Note use of concrete rubble as armour.

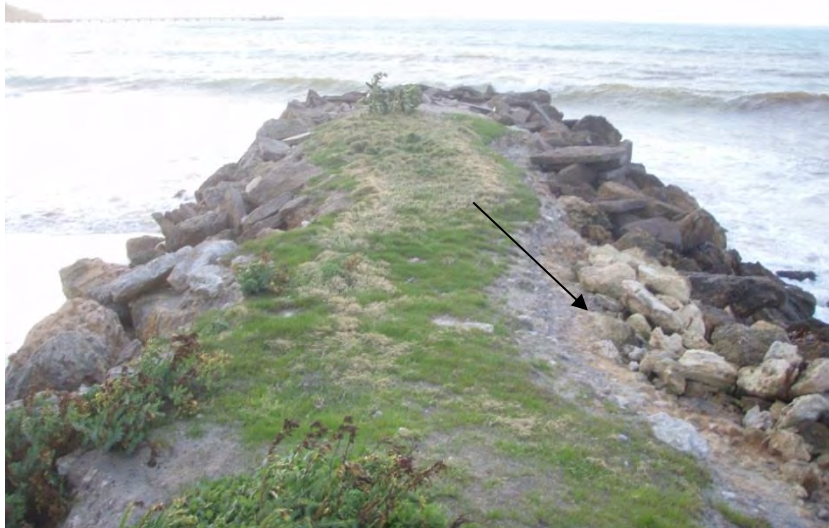
Figure 66 – Tip of groyne at southern side of Lake Frome outlet. Note eroded core and groyne cap as well as exposure of small armour stones on southern side of groyne

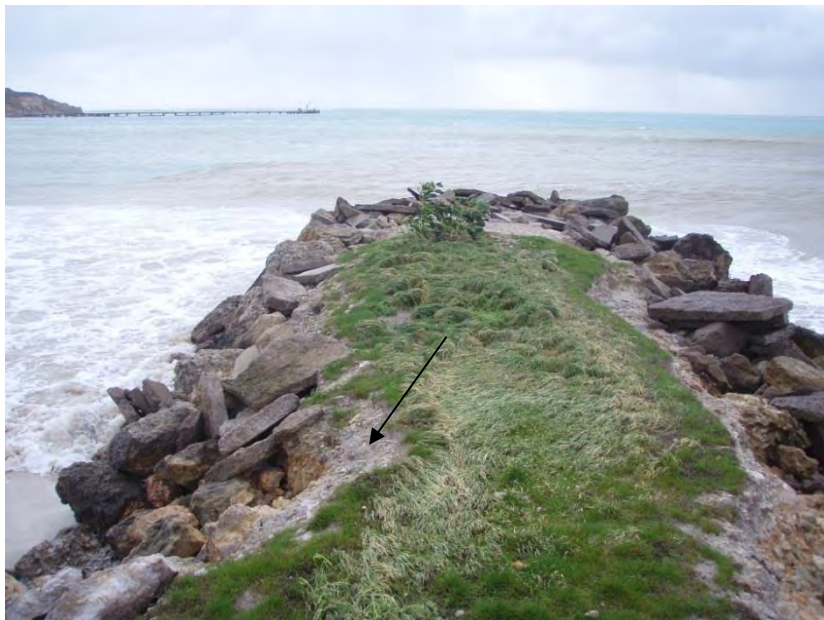
Figure 67 – Groyne at southern side of entrance to Lake Frome. Note eroded clay cap and exposure of smaller armour stone on northern side of groyne.

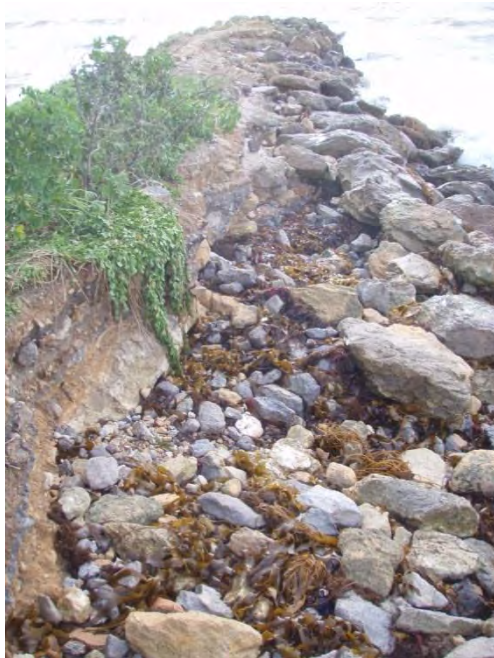
Figure 69 – Severe erosion on northern side of groyne at northern side of Lake Frome outlet. Note exposure of small core rock and erosion of the clay core.

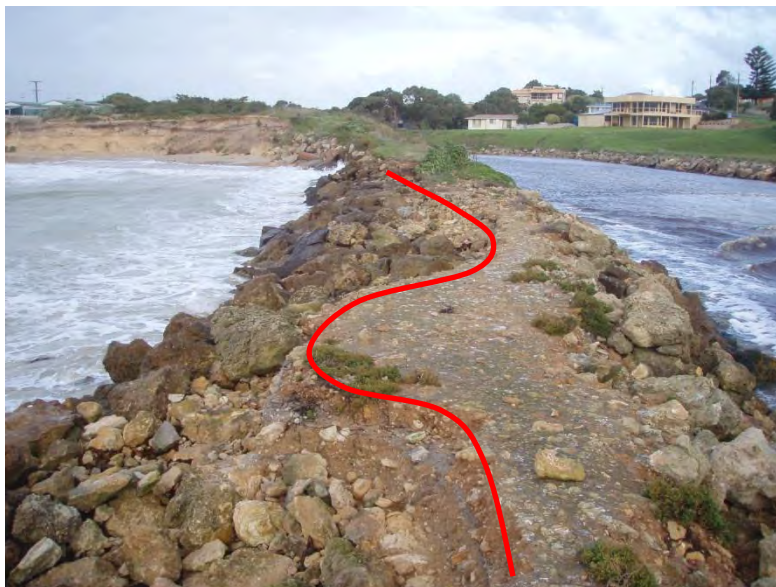
Figure 70 – Groyne at northern side of Lake Frome outlet. Note severe erosion of groyne trunk on northern side and exposure of small armourstones.

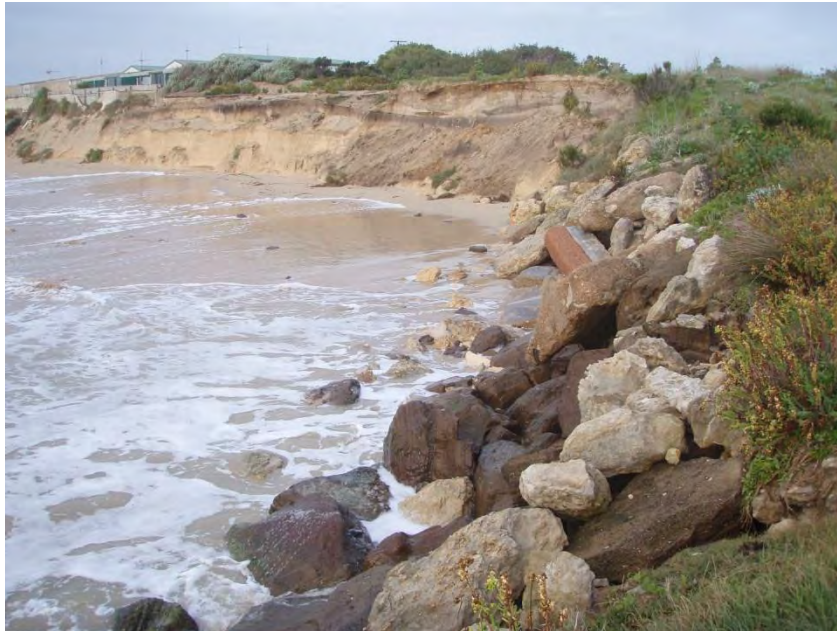
Figure 71 – Erosion at dune downdrift (north) of Lake Frome outlet threatening cabins

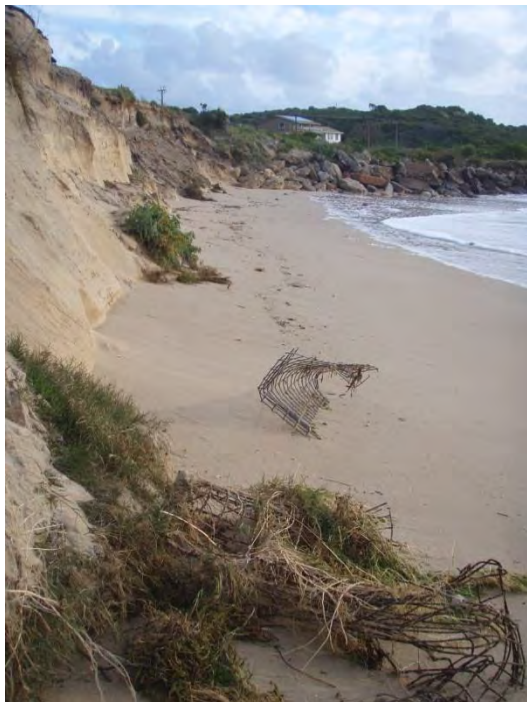
Figure 72 – Eroded foreshore and exposed debris

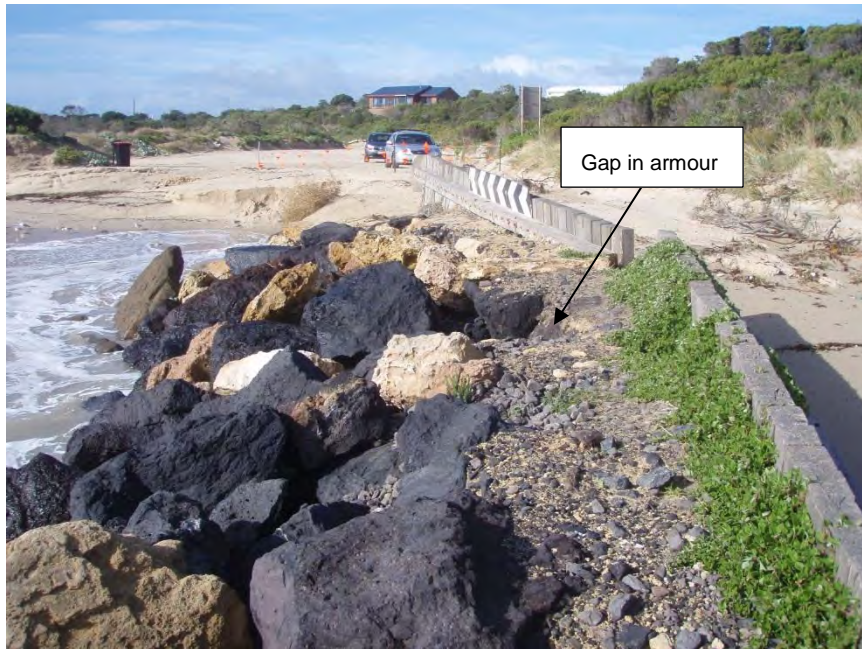
Vehicle access onto the beach in this location has been undermined and was closed off at the time of the site inspection (Figure 81). Despite the groyne being undermined on its landward side, the groyne was in fair condition. Some gaps in the armour were observed within the trunk of the groyne (Figure 82). Erosion at the landward end of the northern side of the groyne was severe at the time of the site inspection, threatening to outflank the groyne.

Figure 82 – Looking landward along Groyne 5

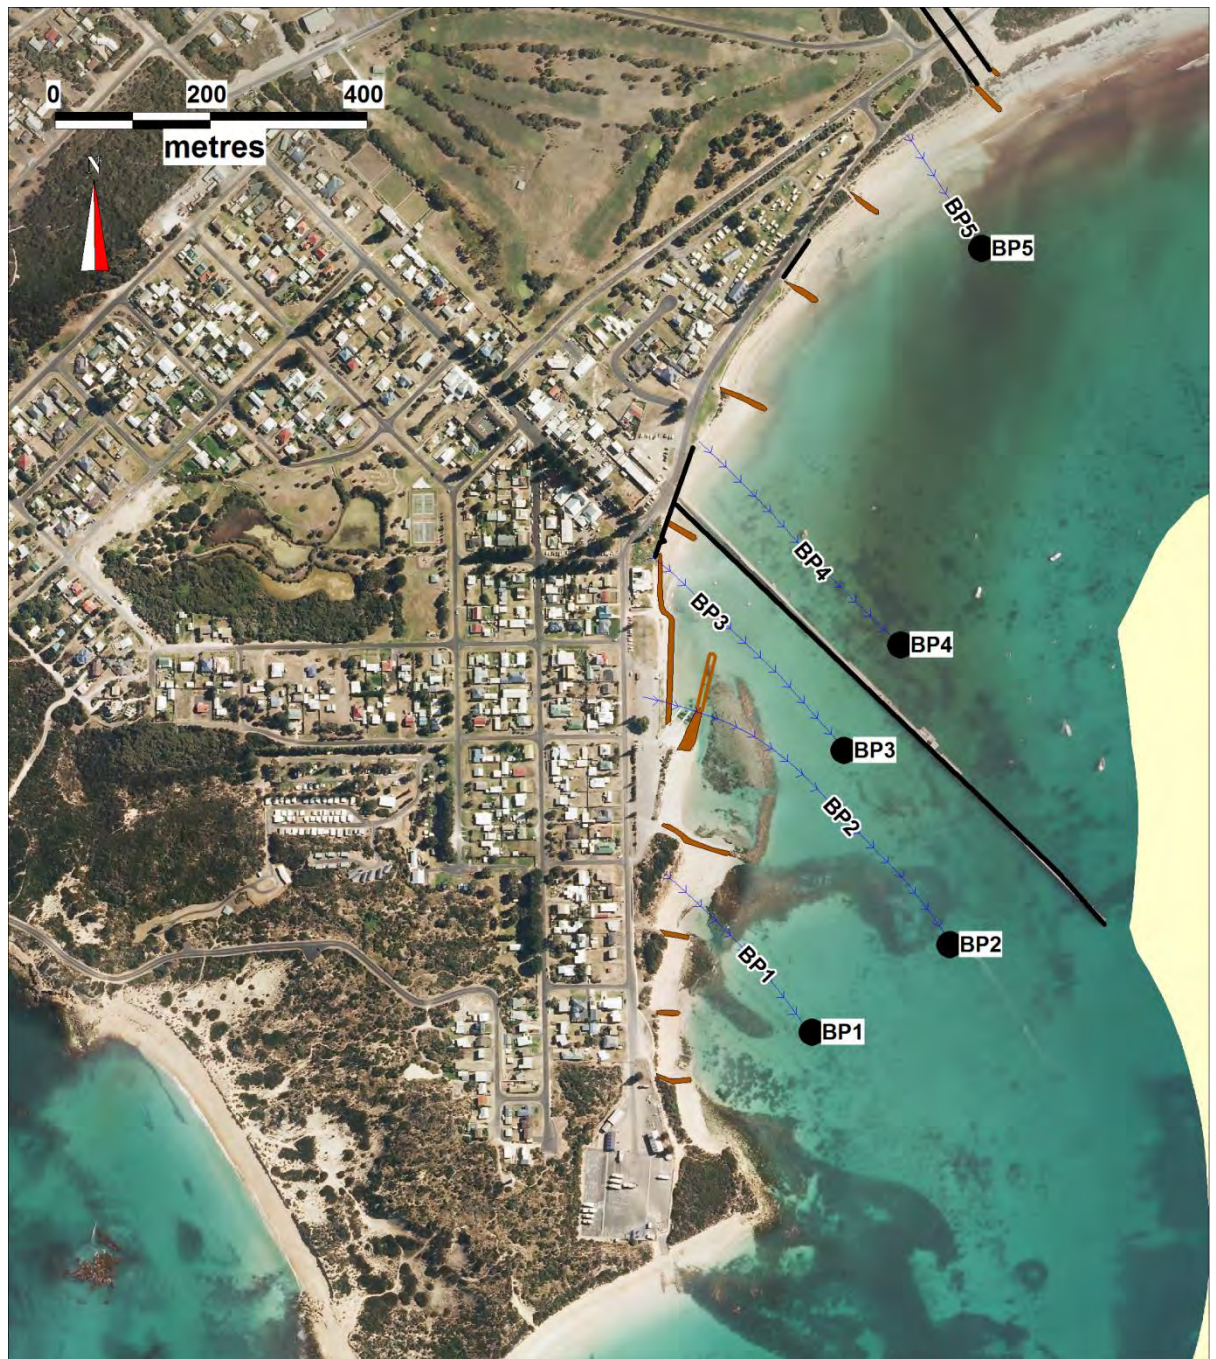
Figure 5: SBEACH profiles Beachport

- The largest wave heights along the Beachport foreshore occur at profile BP3 (i.e. immediately adjacent to the Beachport jetty - refer Figure 5 for the location of this profile). This is due to the deeper water available in this location immediately seaward of the vertical seawall at Beachport.

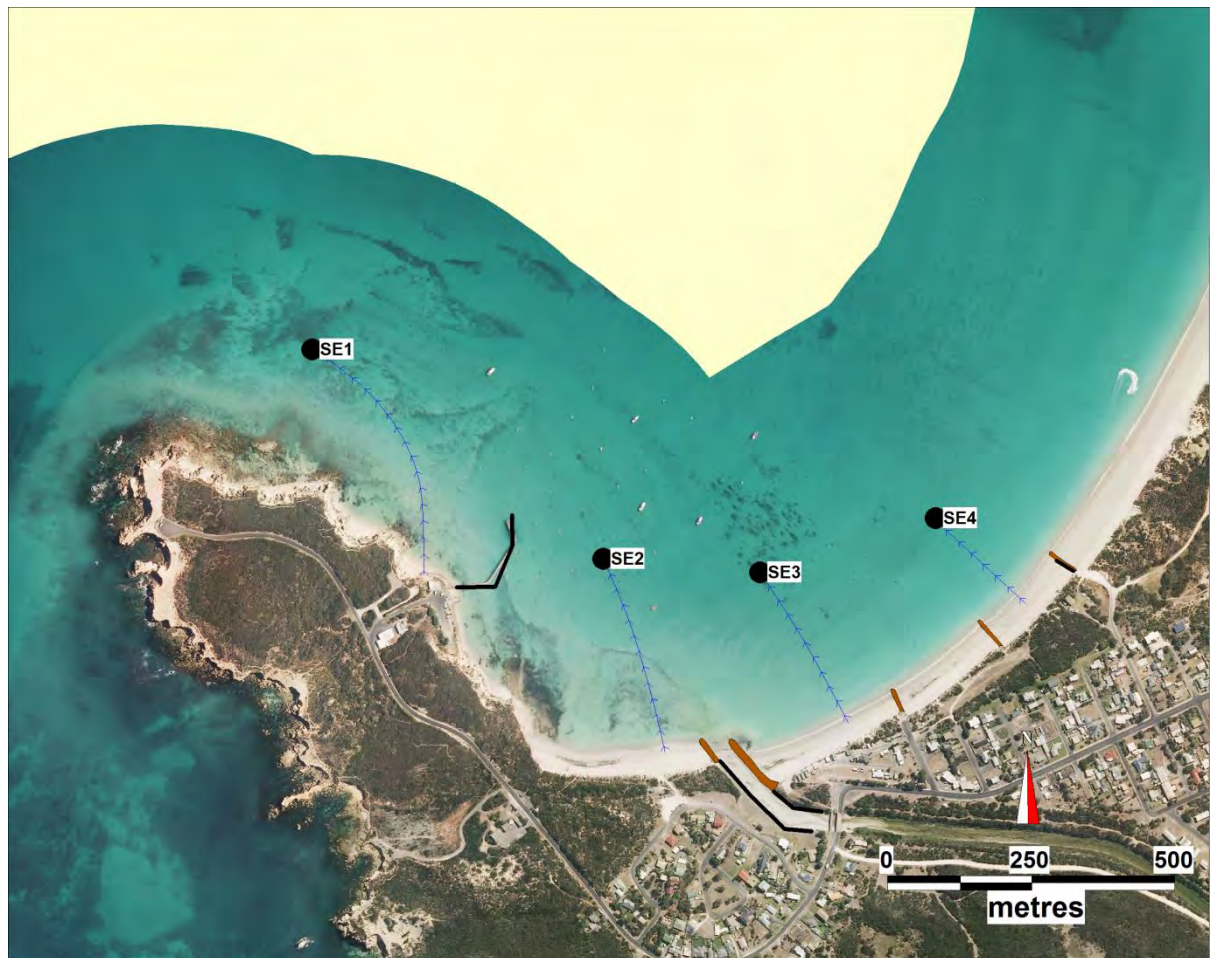
Figure 6 – SBEACH profiles Southend

- The largest wave heights along the Southend foreshore occur at profile SE1 (i.e. adjacent to the Southend jetty - refer Figure 6 for the location of this profile). This is due to the more exposed nature of this location where less wave refraction occurs than at the Southend beach foreshore.

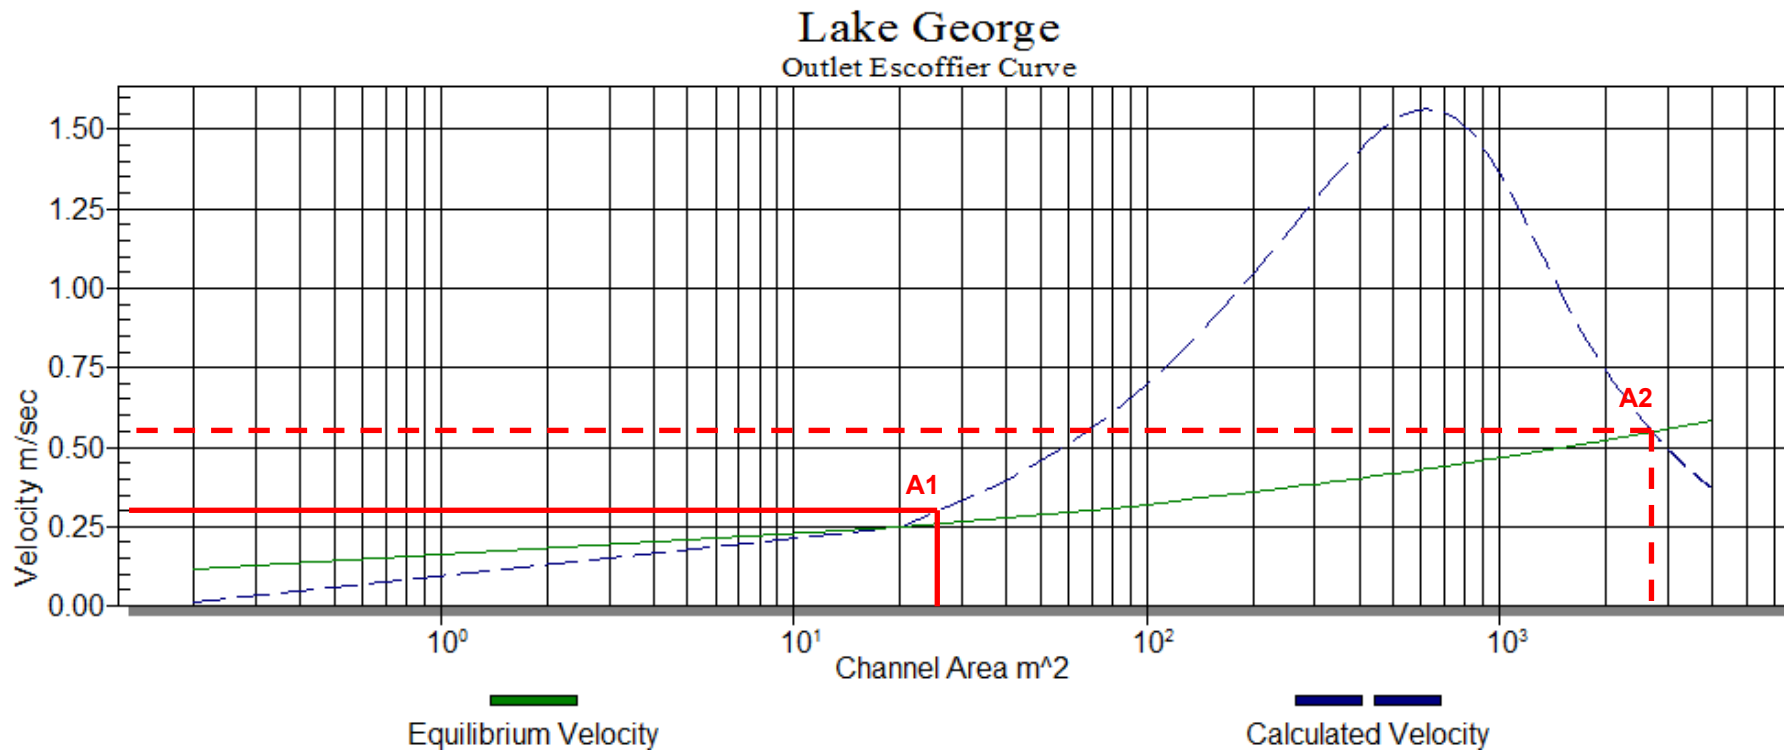
Figure 3 – Escoffier curve for Lake George outlet

The Escoffier curve resulting from the model is illustrated in Figure 3. From this figure, it is observed that the existing channel is unstable, with a cross-sectional area too low to maintain an open channel with the channel tending to close over time. Given the very low tidal range within the lake and therefore the low tidal prism, as well as the various dimensions of the channel entrance, the current velocities will be low and this would result in sand deposition within the entrance over time. Therefore the lake entrance tends to reduce and would eventually close if dredging is stopped. Flood events may increase the flow at the entrance and generate erosion that would deepen the entrance temporarily.
