Current Status and Management Options for Salmon Hole/Post Office Rock Beach

Report prepared for the Wattle Range Council

2018

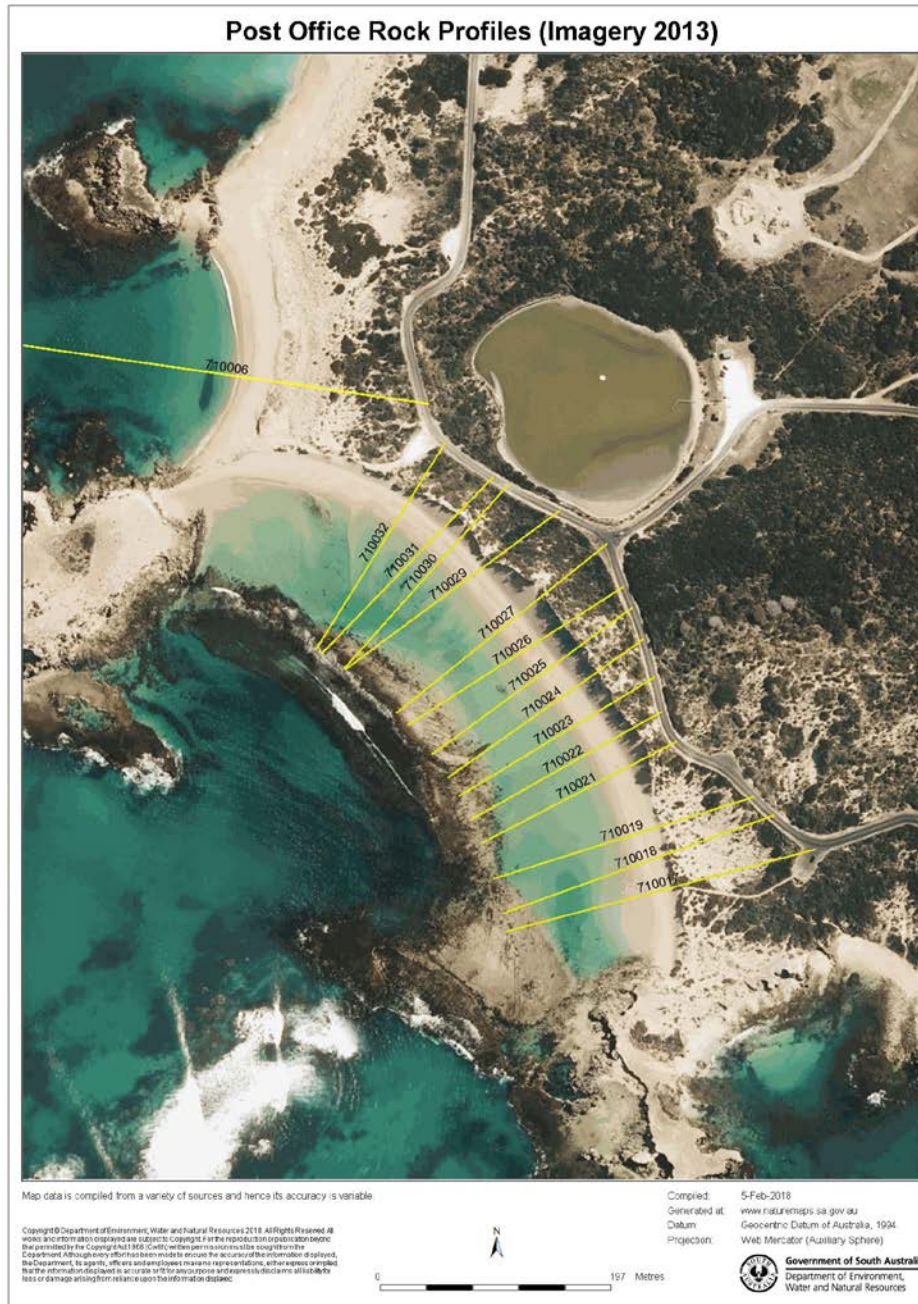
Figure 2: Profile locations at Post Office Rock. Each profile has an identification number.

A series of 15 topographic survey profile lines were established along the dune-beach system in 2001 by DEWNR in order to monitor the erosion rates and changes. The profiles were surveyed from the centre point of the road across the dunes to the water edge. They are spaced approximately 30 metres apart (Figure 2).

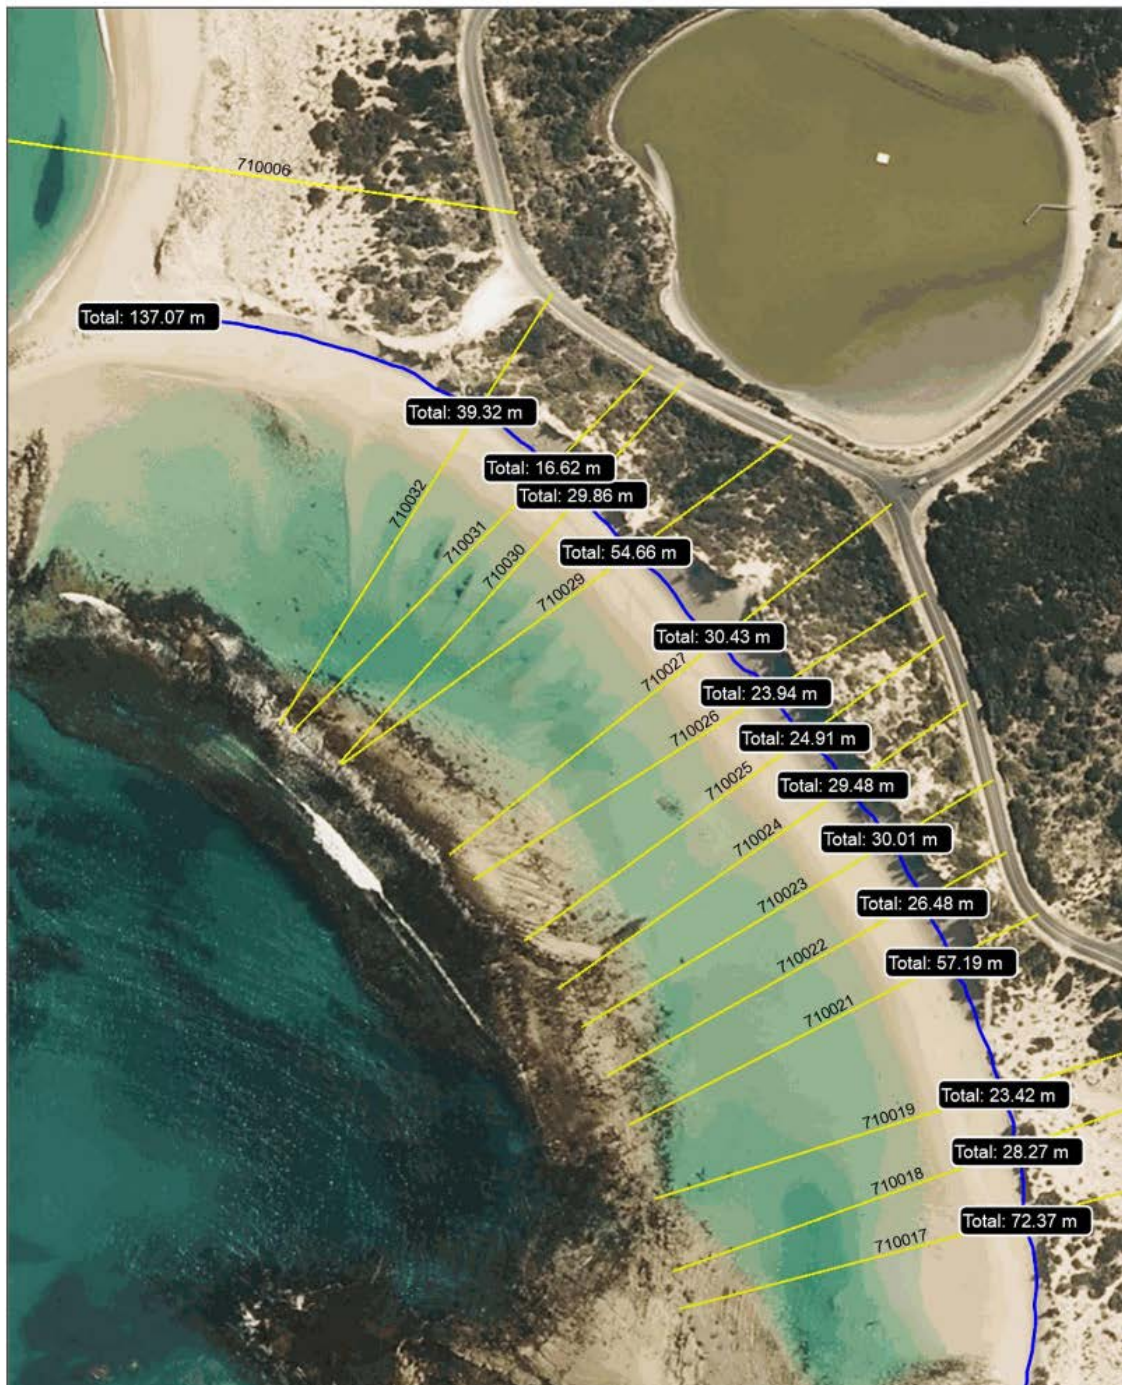
Figure 6. Distances measured along the beach to each profile line and used to calculate overall volumes for selected years.

The road is most vulnerable to erosion at profile 710021 near the southern end of the embayment (Figure 6). A plot of the 2017 profile is shown in Figure 12. This survey shows that the top of the erosion scarp was 19.46 metres from the centreline of the road. The profile, which starts at the centreline, extends across 4.12 m of bitumen, and the verge extends to 6.36 metres distance. The scarp toe is at 37.71 metres.

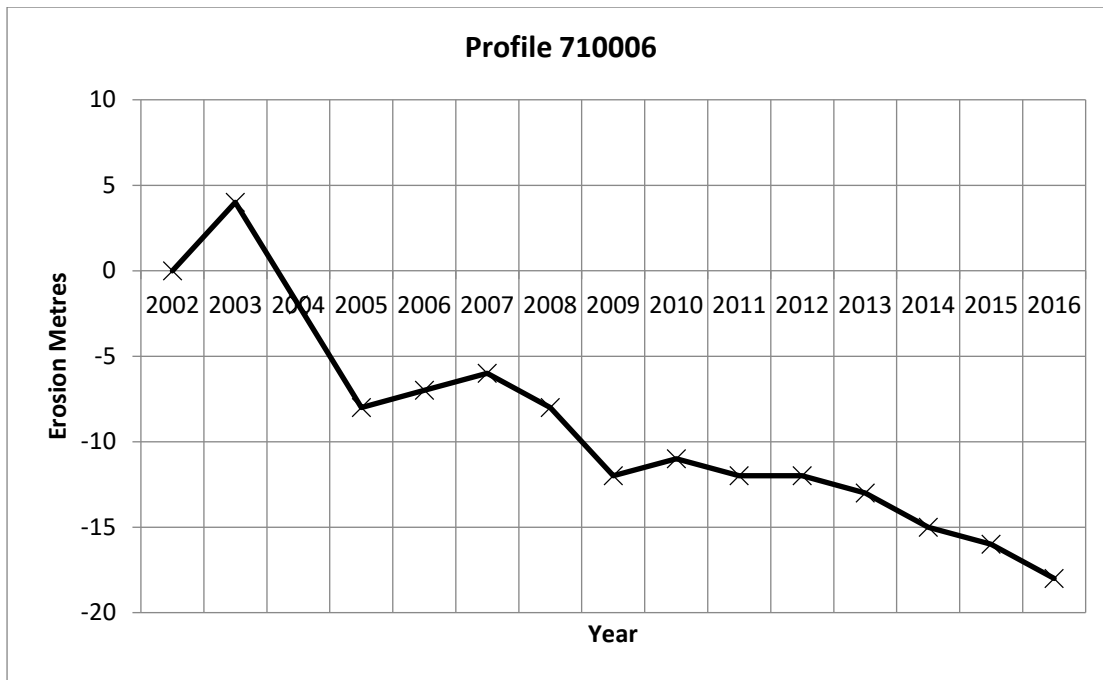
Figure 11. Cumulative erosion Profile 710006, 2002 to 2016.

Table 5. Erosion and volume losses, profile 710006, north of the embayment and groyne.
